Manhole Inspection Report

Date:	03/27/2018	Weather:		Coding:	RZMACP
MH#:	M-803-025	Owner:	NA	Len. Surveyed:	6.5
P.O.#:		Surveyor:	John Kuglmaier	Rim to Invert:	7.9
Customer:		Cert. #:	U-1215-07002349	Wall Material:	Concrete (reinforced)

Street:	67' North of High St. 168' East of Ohi	Project:	Hobart, IN
City:	Hobart, IN	GPS Northing:	0.0
Location:		GPS Easting:	0.0
Drain Area:	Northeast	GPS Accuracy:	Nearest Meter
Cover Shape:	Circular	Evidence of Surcharge:	Yes
Cover Size:	23.0	Potential for Runoff:	None
Comments:

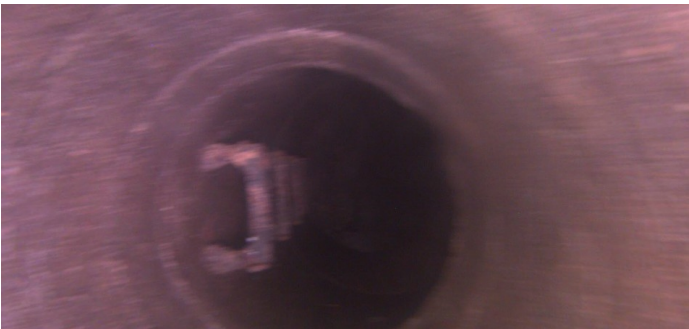
Code: **MGP**
Description: **General Photo**

Distance (ft): **.0**
Structural Grade: **0**
O&M Grade: **0**
Clock Start/From:
Clock To:
1st Value:
2nd Value:
Value Percent:
Step: **NO**
Remarks:

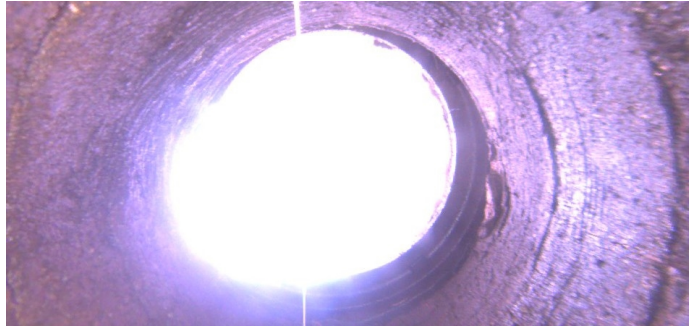
Code: **MGP**
Description: **General Photo**

Distance (ft): **2.2**
Structural Grade: **0**
O&M Grade: **0**
Clock Start/From:
Clock To:
1st Value:
2nd Value:
Value Percent:
Step: **NO**
Remarks:

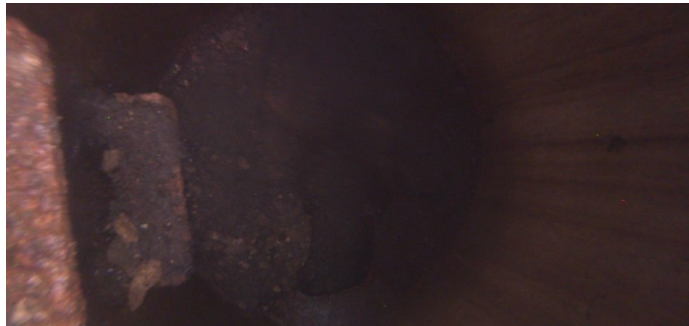
Code: **DAZ**
Description: **Deposits Attached Other**

Distance (ft): **4.3**
Structural Grade: **0**
O&M Grade: **3**
Clock Start/From: **12**
Clock To: **12**
1st Value:
2nd Value:
Value Percent: **15.000**
Step: **NO**
Remarks: **Mixed materials**

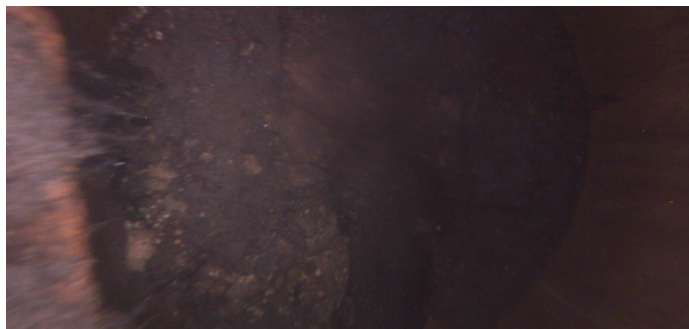
Code: **MGO**
Description: **General Observation**

Distance (ft): **5.5**
Structural Grade: **0**
O&M Grade: **0**
Clock Start/From:
Clock To:
1st Value:
2nd Value:
Value Percent:
Step: **NO**
Remarks: **Ins. Comp.**
