# Manhole Inspection Report

| MH#: | <b>M-803-026</b> | Owner: | <b>NA</b> | Len. Surveyed: | <b>8.9</b> |

| Street: | <b>Intersection of Ohio St. and 40th Av</b> | Project: | <b>Hobart, IN</b> |

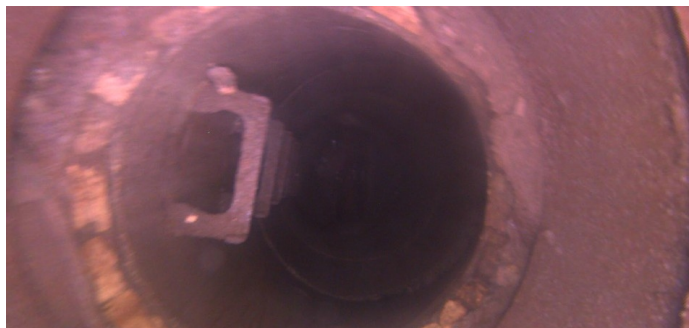
Code: **MGP**  
Description: **General Photo**

Distance (ft): **.0**  
Structural Grade: **0**  
O&M Grade: **0**  
Clock Start/From:  
Clock To:  
1st Value:  
2nd Value:  
Value Percent:  
Step: **NO**  
Remarks:

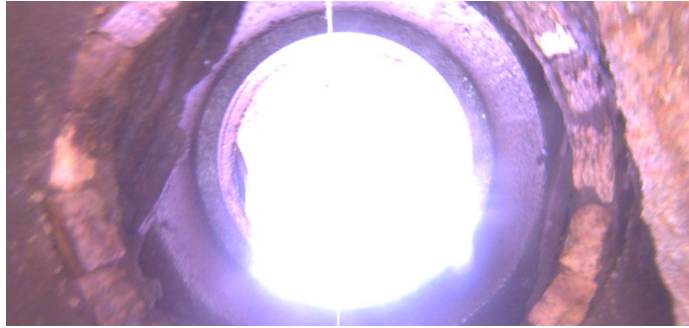
Code: **MGP**  
Description: **General Photo**

Distance (ft): **2.5**  
Structural Grade: **0**  
O&M Grade: **0**  
Clock Start/From:  
Clock To:  
1st Value:  
2nd Value:  
Value Percent:  
Step: **NO**  
Remarks:

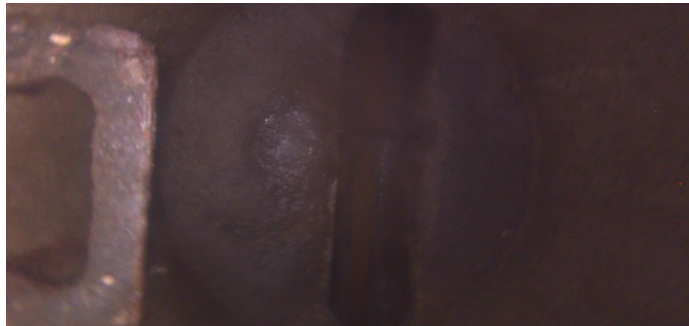
Code: **DSF**  
Description: **Deposits Settled Fine**

Distance (ft): **6.7**  
Structural Grade: **0**  
O&M Grade: **2**  
Clock Start/From: **12**  
Clock To: **12**  
1st Value:  
2nd Value:  
Value Percent: **10.000**  
Step: **NO**  
Remarks:

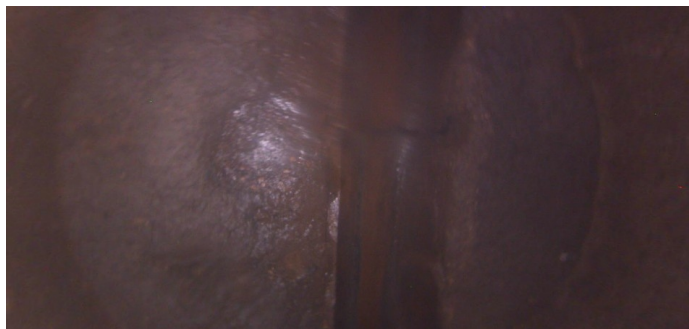
Code: **MGO**  
Description: **General Observation**

Distance (ft): **7.5**  
Structural Grade: **0**  
O&M Grade: **0**  
Clock Start/From:  
Clock To:  
1st Value:  
2nd Value:  
Value Percent:  
Step: **NO**  
Remarks: **Ins. Comp.**
