Manhole Inspection Report

Date:	03/28/2018	Weather:		Coding:	RZMACP
MH#:	M-803-027	Owner:	NA	Len. Surveyed:	11.0
P.O.#:		Surveyor:	John Kuglmaier	Rim to Invert:	11.7
Customer:		Cert. #:	U-1215-07002349	Wall Material:	Concrete (reinforced)

Street:	Intersection of Rand St. and Lawren	Project:	Hobart, IN
City:	Hobart, IN	GPS Northing:	0.0
Location:		GPS Easting:	0.0
Drain Area:	Northeast	GPS Accuracy:	Nearest Meter
Cover Shape:	Circular	Evidence of Surcharge:	No
Cover Size:	23.0	Potential for Runoff:	None
Comments:

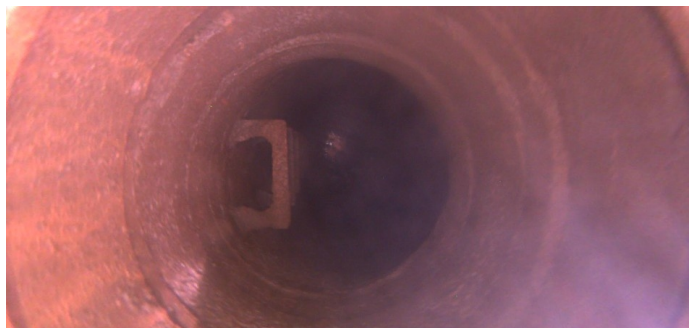
Code: **MGP**
Description: **General Photo**

Distance (ft): **.0**
Structural Grade: **0**
O&M Grade: **0**
Clock Start/From:
Clock To:
1st Value:
2nd Value:
Value Percent:
Step: **NO**
Remarks:

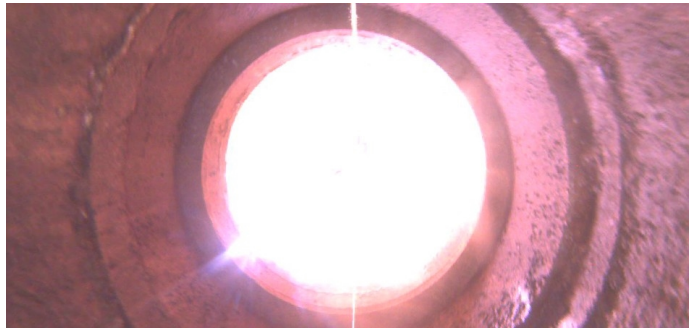
Code: **MGP**
Description: **General Photo**

Distance (ft): **2.4**
Structural Grade: **0**
O&M Grade: **0**
Clock Start/From:
Clock To:
1st Value:
2nd Value:
Value Percent:
Step: **NO**
Remarks:

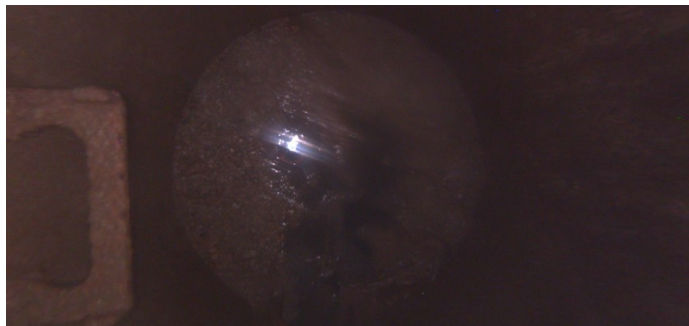
Code: **DAZ**
Description: **Deposits Attached Other**

Distance (ft): **8.0**
Structural Grade: **0**
O&M Grade: **2**
Clock Start/From: **12**
Clock To: **12**
1st Value:
2nd Value:
Value Percent: **10.000**
Step: **NO**
Remarks: **Mixed materials**

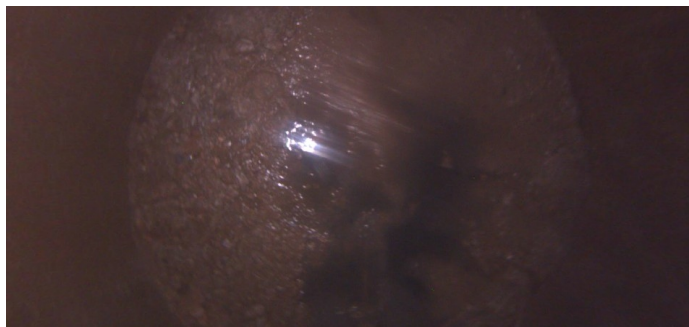
Code: **MGO**
Description: **General Observation**

Distance (ft): **9.2**
Structural Grade: **0**
O&M Grade: **0**
Clock Start/From:
Clock To:
1st Value:
2nd Value:
Value Percent:
Step: **NO**
Remarks: **Ins. Comp.**
