Manhole Inspection Report

Date:	03/28/2018	Weather:		Coding:	RZMACP
MH#:	M-803-030	Owner:	NA	Len. Surveyed:	9.7
P.O.#:		Surveyor:	John Kuglmaier	Rim to Invert:	10.4
Customer:		Cert. #:	U-1215-07002349	Wall Material:	Concrete (reinforced)

Street:	Rand St. 103' East of Ohio St.	Project:	Hobart, IN
City:	Hobart, IN	GPS Northing:	0.0
Location:		GPS Easting:	0.0
Drain Area:	Northeast	GPS Accuracy:	Nearest Meter
Cover Shape:	Circular	Evidence of Surcharge:	No
Cover Size:	23.0	Potential for Runoff:	None
Comments:

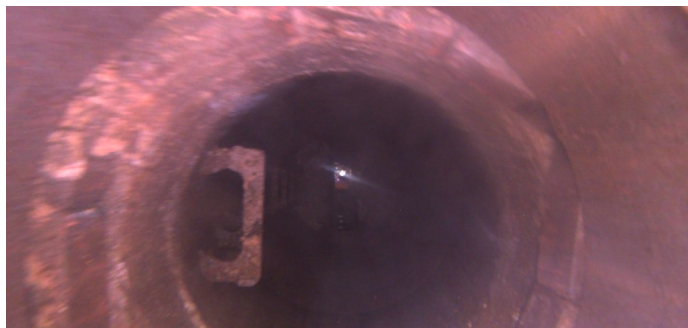
Code: **MGP**
Description: **General Photo**

Distance (ft): **.0**
Structural Grade: **0**
O&M Grade: **0**
Clock Start/From:
Clock To:
1st Value:
2nd Value:
Value Percent:
Step: **NO**
Remarks:

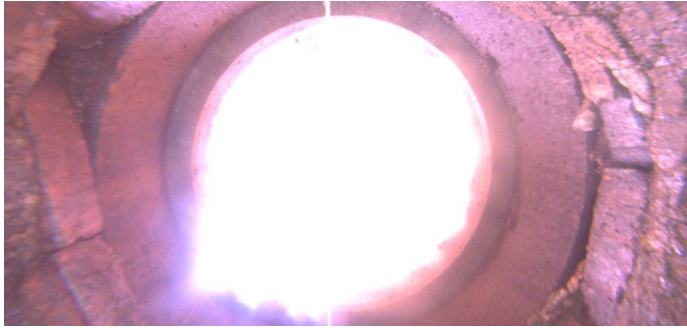
Code: **MGP**
Description: **General Photo**

Distance (ft): **2.1**
Structural Grade: **0**
O&M Grade: **0**
Clock Start/From:
Clock To:
1st Value:
2nd Value:
Value Percent:
Step: **NO**
Remarks:

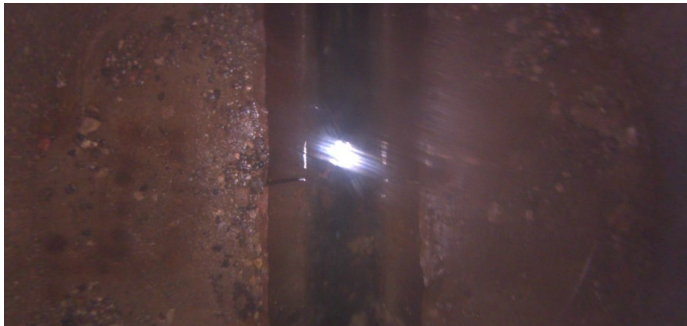
Code: **MGO**
Description: **General Observation**

Distance (ft): **8.1**
Structural Grade: **0**
O&M Grade: **0**
Clock Start/From:
Clock To:
1st Value:
2nd Value:
Value Percent:
Step: **NO**
Remarks: **Ins. Comp.**
