Manhole Inspection Report

Date:	03/29/2018	Weather:		Coding:	RZMACP
MH#:	M-803-032	Owner:	NA	Len. Surveyed:	6.7
P.O.#:		Surveyor:	John Kuglmaier	Rim to Invert:	8.0
Customer:		Cert. #:	U-1215-07002349	Wall Material:	Concrete (reinforced)

Street:	90' North of High St. 164' East of Ind	Project:	Hobart, IN
City:	Hobart, IN	GPS Northing:	0.0
Location:		GPS Easting:	0.0
Drain Area:	Northeast	GPS Accuracy:	Nearest Meter
Cover Shape:	Circular	Evidence of Surcharge:	Yes
Cover Size:	23.0	Potential for Runoff:	None
Comments:

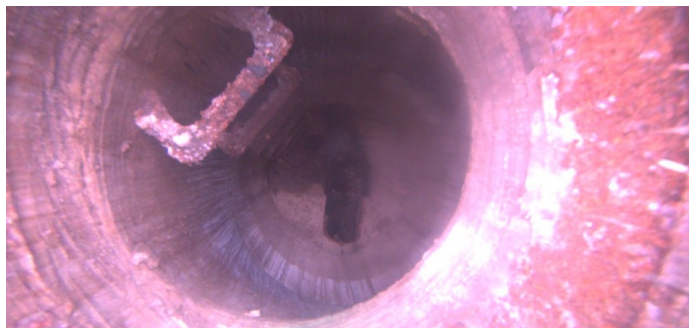
Code: **MGP**
 Description: **General Photo**

Distance (ft): **.0**
 Structural Grade: **0**
 O&M Grade: **0**
 Clock Start/From:
 Clock To:
 1st Value:
 2nd Value:
 Value Percent:
 Step: **NO**
 Remarks:

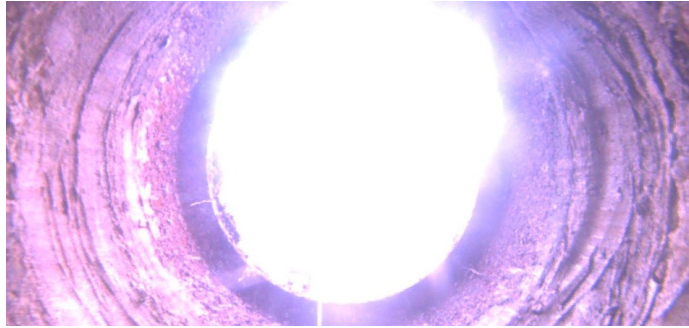
Code:	MGP
Description:	General Photo
Distance (ft):	2.2
Structural Grade:	0
O&M Grade:	0
Clock Start/From:	
Clock To:	
1st Value:	
2nd Value:	
Value Percent:	
Step:	NO
Remarks:

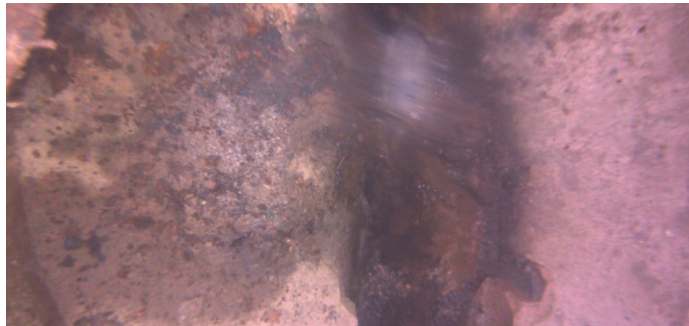
Code:	MGO
Description:	General Observation
Distance (ft):	6.1
Structural Grade:	0
O&M Grade:	0
Clock Start/From:	
Clock To:	
1st Value:	
2nd Value:	
Value Percent:	
Step:	NO
Remarks:	Ins. Comp.
