Manhole Inspection Report

Date:	03/29/2018	Weather:		Coding:	RZMACP
MH#:	M-803-033	Owner:	NA	Len. Surveyed:	7.0
P.O.#:		Surveyor:	John Kuglmaier	Rim to Invert:	8.7
Customer:		Cert. #:	U-1215-07002349	Wall Material:	Concrete (reinforced)

Street:	269' South of 40th Ave. 164' East Ind	Project:	Hobart, IN
City:	Hobart, IN	GPS Northing:	0.0
Location:		GPS Easting:	0.0
Drain Area:	Northeast	GPS Accuracy:	Nearest Meter
Cover Shape:	Circular	Evidence of Surcharge:	No
Cover Size:	23.0	Potential for Runoff:	None
Comments:

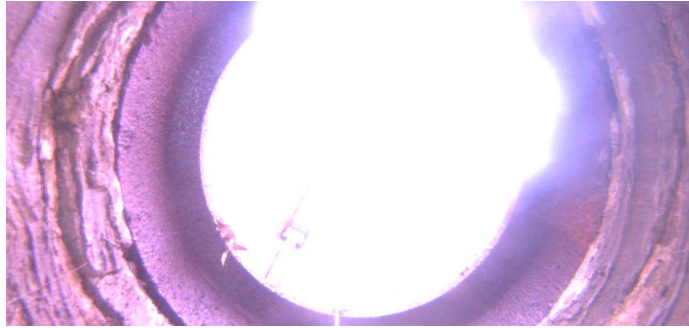
Code: **MGP**
Description: **General Photo**

Distance (ft): **1.9**
Structural Grade: **0**
O&M Grade: **0**
Clock Start/From:
Clock To:
1st Value:
2nd Value:
Value Percent:
Step: **NO**
Remarks:

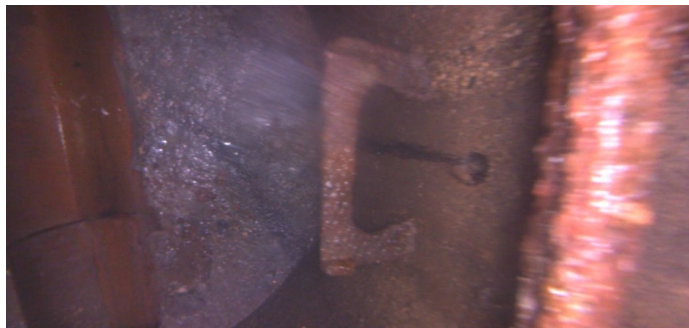
Code: **RFB**
Description: **Roots Fine Barrel**

Distance (ft): **5.3**
Structural Grade: **0**
O&M Grade: **2**
Clock Start/From: **4**
Clock To:
1st Value:
2nd Value:
Value Percent:
Step: **NO**
Remarks:

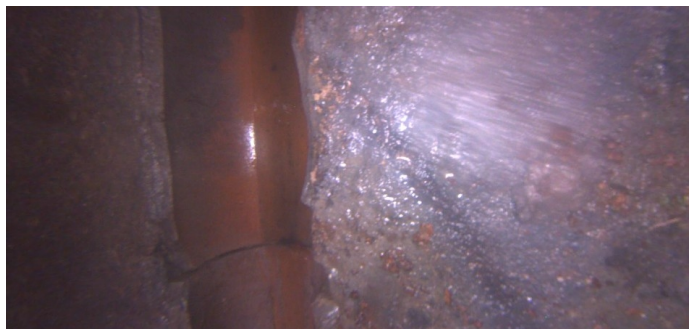
Code: **MGO**
Description: **General Observation**

Distance (ft): **6.6**
Structural Grade: **0**
O&M Grade: **0**
Clock Start/From:
Clock To:
1st Value:
2nd Value:
Value Percent:
Step: **NO**
Remarks: **Ins. Comp.**
