Manhole Inspection Report

Date:	03/27/2018	Weather:		Coding:	RZMACP
MH#:	M-803-034	Owner:	NA	Len. Surveyed:	8.0
P.O.#:		Surveyor:	John Kuglmaier	Rim to Invert:	10.0
Customer:		Cert. #:	U-1215-07002349	Wall Material:	Concrete (reinforced)

Street:	40th Ave. 162' East of Indiana St.	Project:	Hobart, IN
City:	Hobart, IN	GPS Northing:	0.0
Location:		GPS Easting:	0.0
Drain Area:	Northeast	GPS Accuracy:	Nearest Meter
Cover Shape:	Circular	Evidence of Surcharge:	Yes
Cover Size:	23.0	Potential for Runoff:	None
Comments:

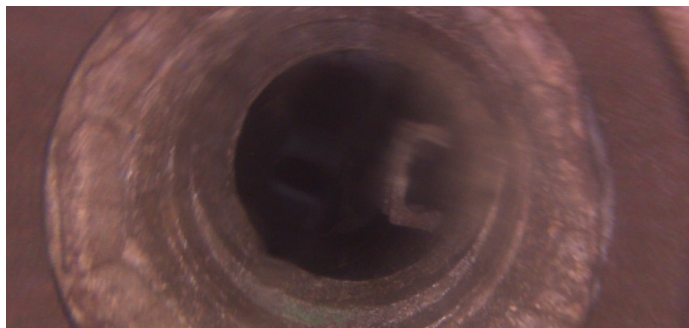
Code: **MGP**
Description: **General Photo**

Distance (ft): **.0**
Structural Grade: **0**
O&M Grade: **0**
Clock Start/From:
Clock To:
1st Value:
2nd Value:
Value Percent:
Step: **NO**
Remarks:

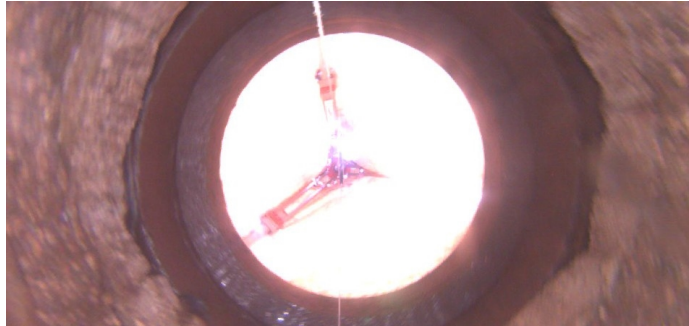
Code: **MGP**
Description: **General Photo**

Distance (ft): **2.1**
Structural Grade: **0**
O&M Grade: **0**
Clock Start/From:
Clock To:
1st Value:
2nd Value:
Value Percent:
Step: **NO**
Remarks:

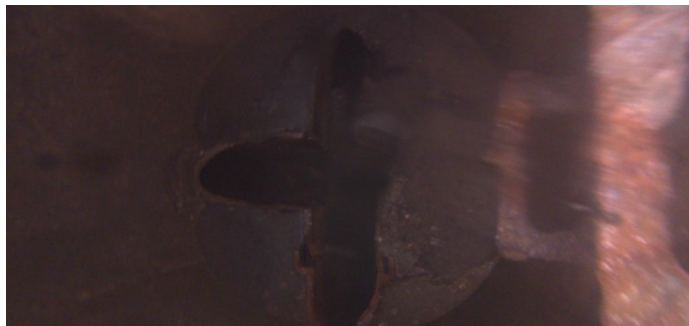
Code: **DSF**
Description: **Deposits Settled Fine**

Distance (ft): **5.9**
Structural Grade: **0**
O&M Grade: **3**
Clock Start/From: **12**
Clock To: **12**
1st Value:
2nd Value:
Value Percent: **15.000**
Step: **NO**
Remarks:

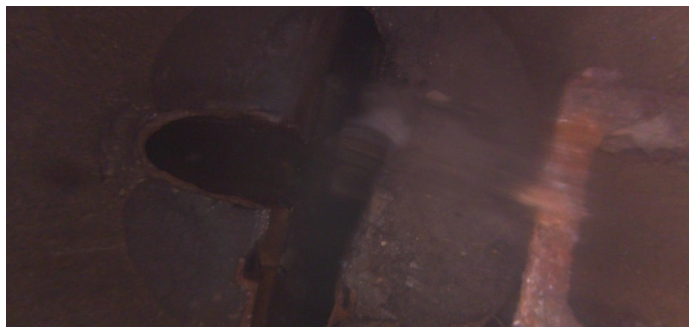
Code: **MGO**
Description: **General Observation**

Distance (ft): **6.6**
Structural Grade: **0**
O&M Grade: **0**
Clock Start/From:
Clock To:
1st Value:
2nd Value:
Value Percent:
Step: **NO**
Remarks: **Ins. Comp.**
