Manhole Inspection Report

Date:	03/29/2018	Weather:		Coding:	RZMACP
MH#:	M-803-035	Owner:	NA	Len. Surveyed:	7.1
P.O.#:		Surveyor:	John Kuglmaier	Rim to Invert:	9.0
Customer:		Cert. #:	U-1215-07002349	Wall Material:	Concrete (reinforced)

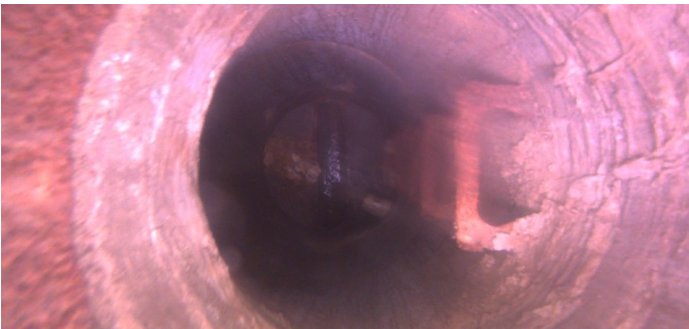
Code: **MGP**
 Description: **General Photo**

Distance (ft): **.0**
 Structural Grade: **0**
 O&M Grade: **0**
 Clock Start/From:
 Clock To:
 1st Value:
 2nd Value:
 Value Percent:
 Step: **NO**
 Remarks:

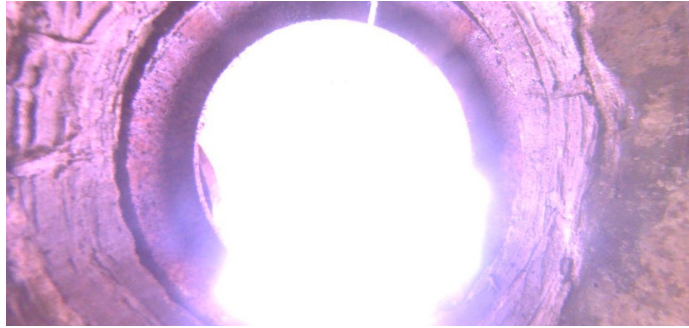
Code: **MGP**
Description: **General Photo**

Distance (ft): **2.2**
Structural Grade: **0**
O&M Grade: **0**
Clock Start/From:
Clock To:
1st Value:
2nd Value:
Value Percent:
Step: **NO**
Remarks:

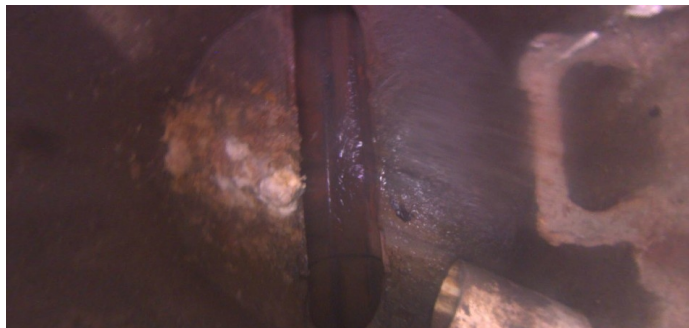
Code: **DAZ**
Description: **Deposits Attached Other**

Distance (ft): **5.3**
Structural Grade: **0**
O&M Grade: **2**
Clock Start/From: **12**
Clock To: **12**
1st Value:
2nd Value:
Value Percent: **5.000**
Step: **NO**
Remarks: **Mixed materials**

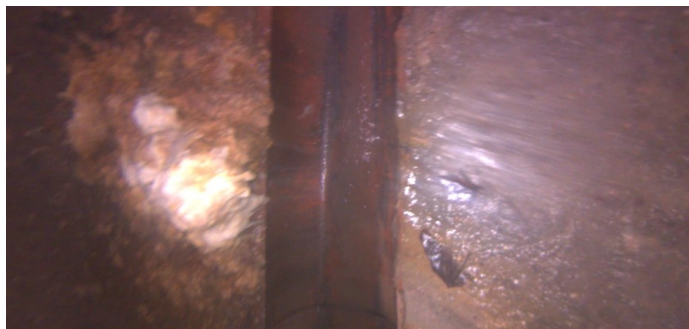
Code: **MGO**
Description: **General Observation**

Distance (ft): **6.7**
Structural Grade: **0**
O&M Grade: **0**
Clock Start/From:
Clock To:
1st Value:
2nd Value:
Value Percent:
Step: **NO**
Remarks: **Ins. Comp.**
