Manhole Inspection Report

Date:	03/28/2018	Weather:		Coding:	RZMACP
MH#:	M-803-039	Owner:	NA	Len. Surveyed:	5.2
P.O.#:		Surveyor:	John Kuglmaier	Rim to Invert:	6.4
Customer:		Cert. #:	U-1215-07002349	Wall Material:	Concrete (reinforced)

Street:	Intersection of Rand St. and Indiana	Project:	Hobart, IN
City:	Hobart, IN	GPS Northing:	0.0
Location:		GPS Easting:	0.0
Drain Area:	Northeast	GPS Accuracy:	Nearest Meter
Cover Shape:	Circular	Evidence of Surcharge:	No
Cover Size:	23.0	Potential for Runoff:	None
Comments:

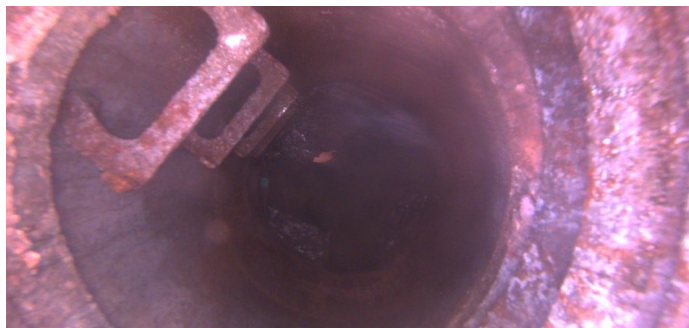
Code: **MGP**
Description: **General Photo**

Distance (ft): **.0**
Structural Grade: **0**
O&M Grade: **0**
Clock Start/From:
Clock To:
1st Value:
2nd Value:
Value Percent:
Step: **NO**
Remarks:

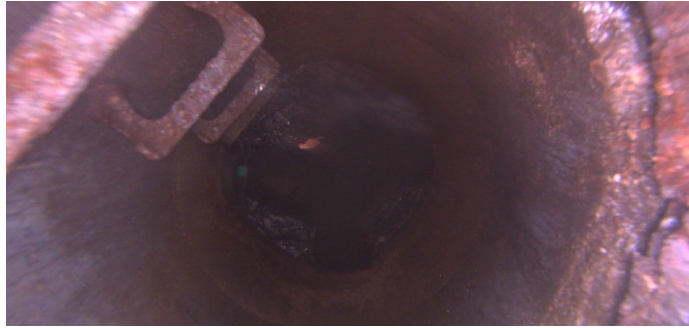
Code: **IS**
Description: **Infil Stain**

Distance (ft): **.7**
Structural Grade: **0**
O&M Grade: **0**
Clock Start/From: **12**
Clock To: **12**
1st Value:
2nd Value:
Value Percent:
Step: **NO**
Remarks:

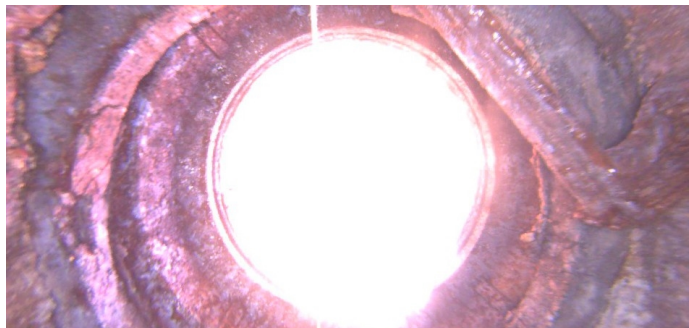
Code: **MGP**
Description: **General Photo**

Distance (ft): **2.3**
Structural Grade: **0**
O&M Grade: **0**
Clock Start/From:
Clock To:
1st Value:
2nd Value:
Value Percent:
Step: **NO**
Remarks:

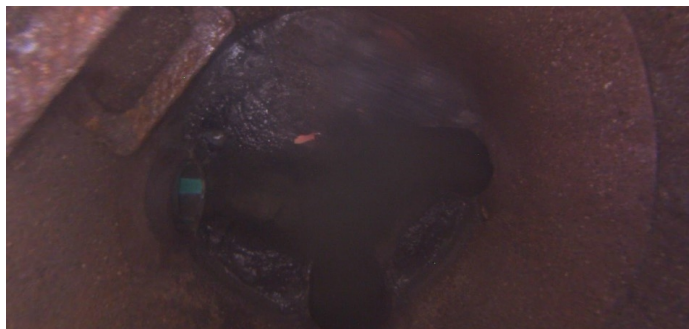
Code: **DSF**
Description: **Deposits Settled Fine**

Distance (ft): **2.5**
Structural Grade: **0**
O&M Grade: **2**
Clock Start/From: **12**
Clock To: **12**
1st Value:
2nd Value:
Value Percent: **5.000**
Step: **NO**
Remarks:

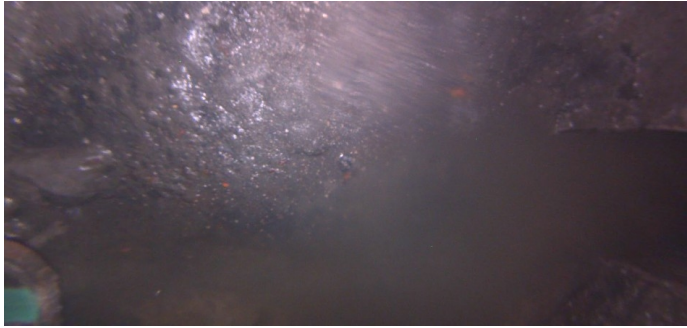
Code:	MGO
Description:	General Observation
Distance (ft):	4.8
Structural Grade:	0
O&M Grade:	0
Clock Start/From:	
Clock To:	
1st Value:	
2nd Value:	
Value Percent:	
Step:	NO
Remarks:	Ins. Comp.
