Manhole Inspection Report

M-803-040

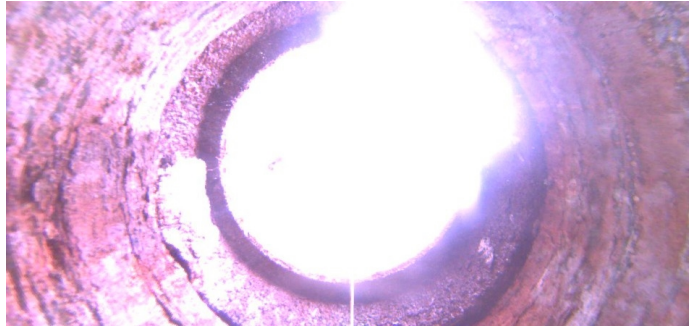
Code:	MGP
Description:	General Photo

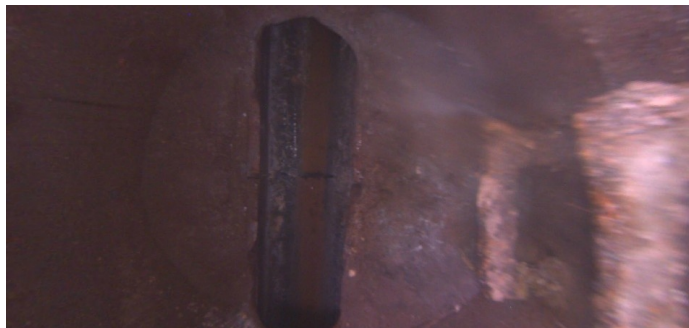
Code: **MGP**
Description: **General Photo**

Distance (ft): **2.5**
Structural Grade: **0**
O&M Grade: **0**
Clock Start/From:
Clock To:
1st Value:
2nd Value:
Value Percent:
Step: **NO**
Remarks:

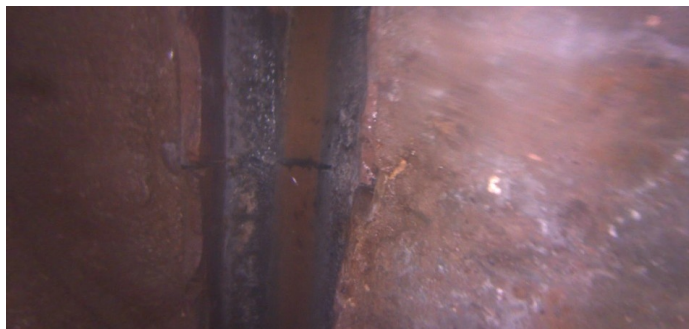
Code: **DSF**
Description: **Deposits Settled Fine**

Distance (ft): **4.3**
Structural Grade: **0**
O&M Grade: **2**
Clock Start/From: **12**
Clock To: **12**
1st Value:
2nd Value:
Value Percent: **10.000**
Step: **NO**
Remarks:
