# Manhole Inspection Report

Date:	<b>03/29/2018</b>	Weather:		Coding:	<b>RZMACP</b>
MH#:	<b>M-803-041</b>	Owner:	<b>NA</b>	Len. Surveyed:	<b>8.0</b>
P.O.#:		Surveyor:	<b>John Kuglmaier</b>	Rim to Invert:	<b>9.8</b>
Customer:		Cert. #:	<b>U-1215-07002349</b>	Wall Material:	<b>Concrete (reinforced)</b>

Street:	<b>215' North of 40th Ave. 167' East of</b>	Project:	<b>Hobart, IN</b>
City:	<b>Hobart, IN</b>	GPS Northing:	<b>0.0</b>
Location:		GPS Easting:	<b>0.0</b>
Drain Area:	<b>Northeast</b>	GPS Accuracy:	<b>Nearest Meter</b>
Cover Shape:	<b>Circular</b>	Evidence of Surcharge:	<b>Yes</b>
Cover Size:	<b>23.0</b>	Potential for Runoff:	<b>None</b>
Comments:

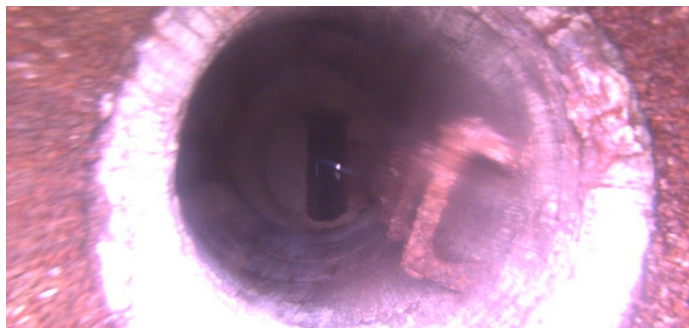
Code: **MGP**  
Description: **General Photo**

Distance (ft): **.0**  
Structural Grade: **0**  
O&M Grade: **0**  
Clock Start/From:  
Clock To:  
1st Value:  
2nd Value:  
Value Percent:  
Step: **NO**  
Remarks:

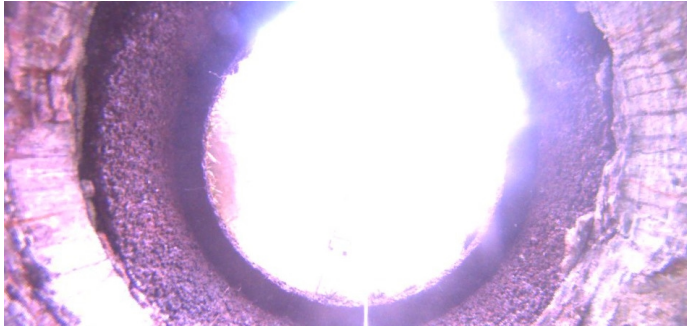
Code: **MGP**  
Description: **General Photo**

Distance (ft): **2.2**  
Structural Grade: **0**  
O&M Grade: **0**  
Clock Start/From:  
Clock To:  
1st Value:  
2nd Value:  
Value Percent:  
Step: **NO**  
Remarks:

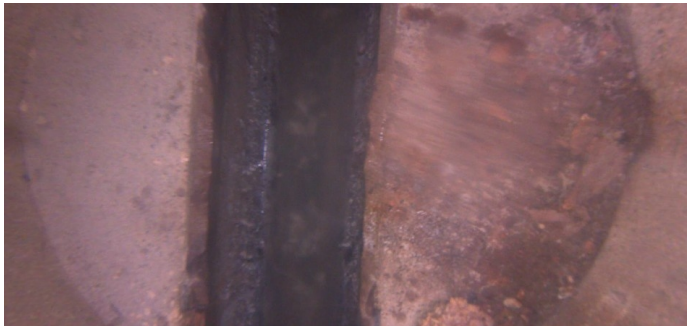
Code: **MGO**  
Description: **General Observation**

Distance (ft): **7.3**  
Structural Grade: **0**  
O&M Grade: **0**  
Clock Start/From:  
Clock To:  
1st Value:  
2nd Value:  
Value Percent:  
Step: **NO**  
Remarks: **Ins. Comp.**
