Manhole Inspection Report

Date:	03/27/2018	Weather:		Coding:	RZMACP
MH#:	M-803-042	Owner:	NA	Len. Surveyed:	10.5
P.O.#:		Surveyor:	John Kuglmaier	Rim to Invert:	11.8
Customer:		Cert. #:	U-1215-07002349	Wall Material:	Concrete (reinforced)

Street:	40th Ave. 165' East of Kelly St.	Project:	Hobart, IN
City:	Hobart, IN	GPS Northing:	0.0
Location:		GPS Easting:	0.0
Drain Area:	Northeast	GPS Accuracy:	Nearest Meter
Cover Shape:	Circular	Evidence of Surcharge:	Yes
Cover Size:	23.0	Potential for Runoff:	None
Comments:

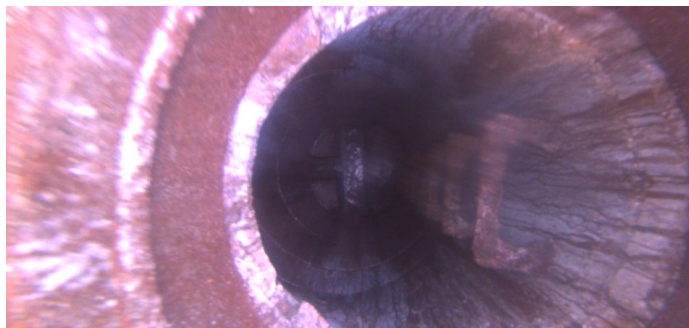
Code: **MGP**
Description: **General Photo**

Distance (ft): **.0**
Structural Grade: **0**
O&M Grade: **0**
Clock Start/From:
Clock To:
1st Value:
2nd Value:
Value Percent:
Step: **NO**
Remarks:

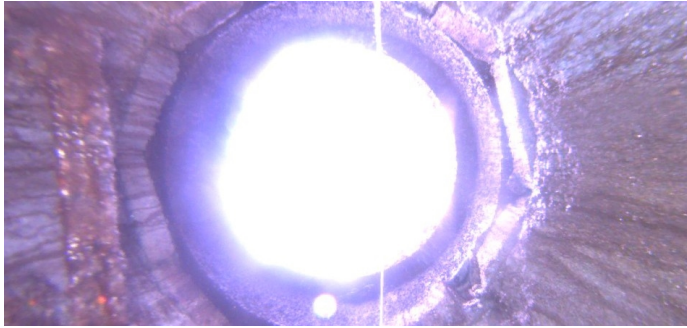
Code:	MGP
Description:	General Photo
Distance (ft):	2.8
Structural Grade:	0
O&M Grade:	0
Clock Start/From:	
Clock To:	
1st Value:	
2nd Value:	
Value Percent:	
Step:	NO
Remarks:

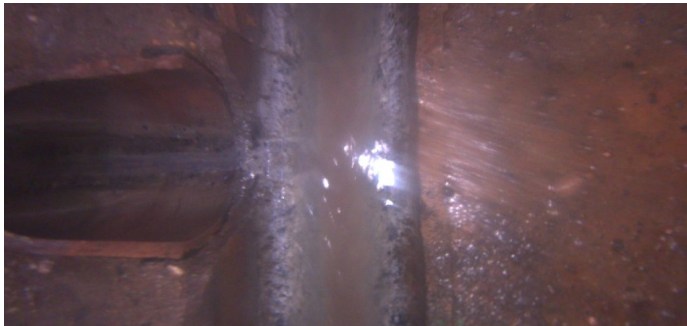
Code:	MGO
Description:	General Observation
Distance (ft):	9.8
Structural Grade:	0
O&M Grade:	0
Clock Start/From:	
Clock To:	
1st Value:	
2nd Value:	
Value Percent:	
Step:	NO
Remarks:	Ins. Comp.
