Manhole Inspection Report

Date:	03/26/2018	Weather:		Coding:	RZMACP
MH#:	M-803-048	Owner:	NA	Len. Surveyed:	4.7
P.O.#:		Surveyor:	John Kuglmaier	Rim to Invert:	5.7
Customer:		Cert. #:	U-1215-07002349	Wall Material:	Concrete (reinforced)

Street:	Kelly St. 214' North of High St.	Project:	Hobart, IN
City:	Hobart, IN	GPS Northing:	0.0
Location:		GPS Easting:	0.0
Drain Area:	Northeast	GPS Accuracy:	Nearest Meter
Cover Shape:	Circular	Evidence of Surcharge:	No
Cover Size:	23.0	Potential for Runoff:	None
Comments:

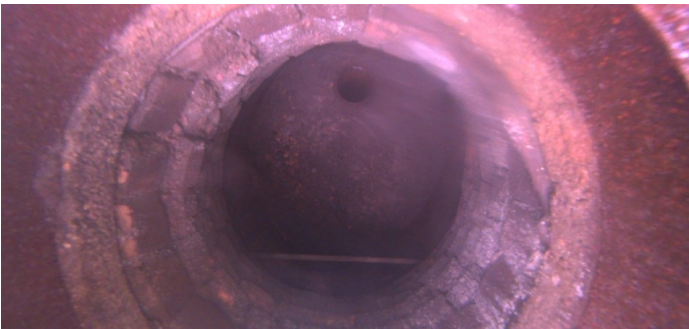
Code: **MGP**
 Description: **General Photo**

Distance (ft): **.0**
 Structural Grade: **0**
 O&M Grade: **0**
 Clock Start/From:
 Clock To:
 1st Value:
 2nd Value:
 Value Percent:
 Step: **NO**
 Remarks:

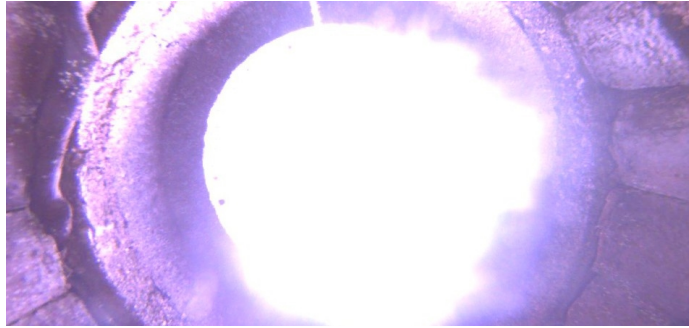
Code: **MGP**
Description: **General Photo**

Distance (ft): **2.4**
Structural Grade: **0**
O&M Grade: **0**
Clock Start/From:
Clock To:
1st Value:
2nd Value:
Value Percent:
Step: **NO**
Remarks:

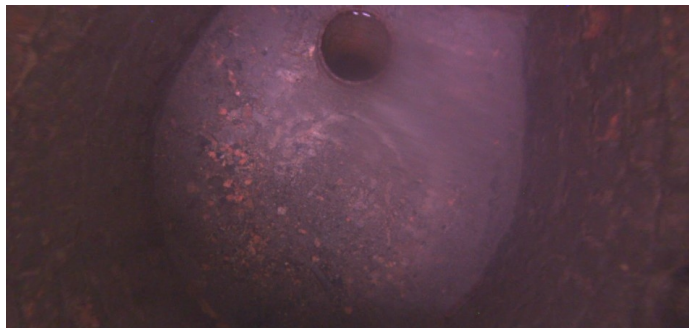
Code: **DSF**
Description: **Deposits Settled Fine**

Distance (ft): **2.6**
Structural Grade: **0**
O&M Grade: **2**
Clock Start/From: **12**
Clock To: **12**
1st Value:
2nd Value:
Value Percent: **5.000**
Step: **NO**
Remarks:

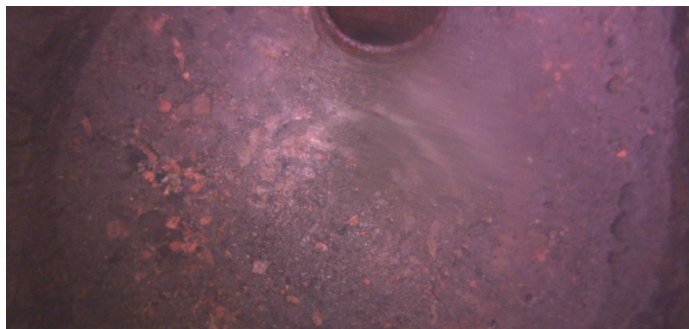
Code: **MGO**
Description: **General Observation**

Distance (ft): **3.7**
Structural Grade: **0**
O&M Grade: **0**
Clock Start/From:
Clock To:
1st Value:
2nd Value:
Value Percent:
Step: **NO**
Remarks: **Ins. Comp.**
