Manhole Inspection Report

Date:	03/26/2018	Weather:		Coding:	RZMACP
MH#:	M-803-049	Owner:	NA	Len. Surveyed:	7.2
P.O.#:		Surveyor:	John Kuglmaier	Rim to Invert:	8.4
Customer:		Cert. #:	U-1215-07002349	Wall Material:	Concrete (reinforced)

Street:	Kelly St. 264' North of High St.	Project:	Hobart, IN
City:	Hobart, IN	GPS Northing:	0.0
Location:		GPS Easting:	0.0
Drain Area:	Northeast	GPS Accuracy:	Nearest Meter
Cover Shape:	Circular	Evidence of Surcharge:	No
Cover Size:	23.0	Potential for Runoff:	None
Comments:

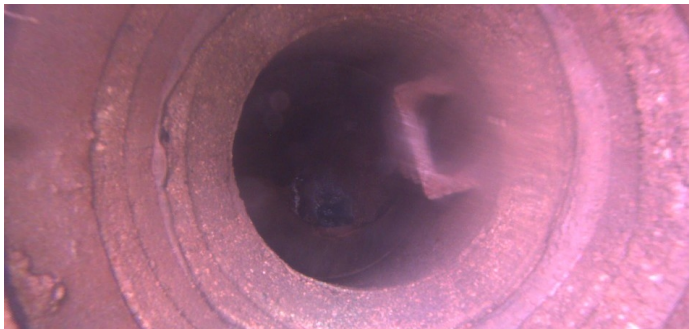
Code: **MGP**
Description: **General Photo**

Distance (ft): **.0**
Structural Grade: **0**
O&M Grade: **0**
Clock Start/From:
Clock To:
1st Value:
2nd Value:
Value Percent:
Step: **NO**
Remarks:

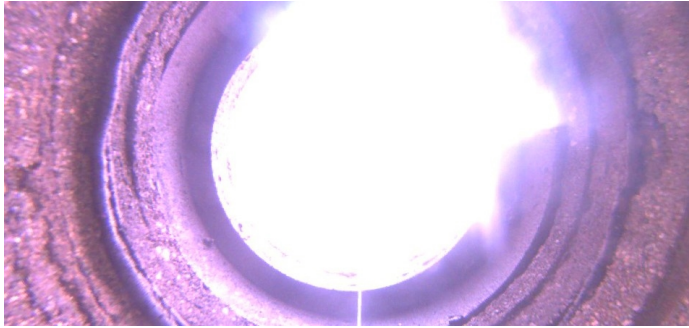
Code: **MGP**
Description: **General Photo**

Distance (ft): **2.2**
Structural Grade: **0**
O&M Grade: **0**
Clock Start/From:
Clock To:
1st Value:
2nd Value:
Value Percent:
Step: **NO**
Remarks:

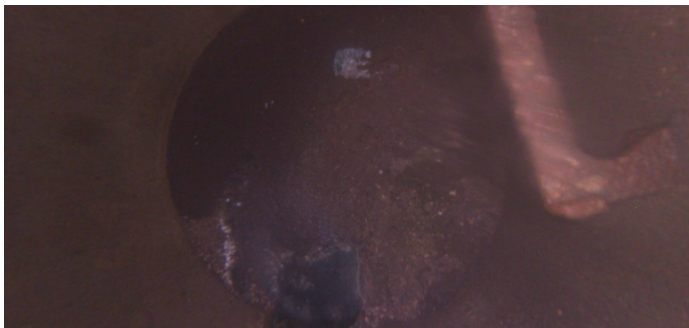
Code: **DSF**
Description: **Deposits Settled Fine**

Distance (ft): **5.0**
Structural Grade: **0**
O&M Grade: **2**
Clock Start/From: **12**
Clock To: **12**
1st Value:
2nd Value:
Value Percent: **10.000**
Step: **NO**
Remarks:

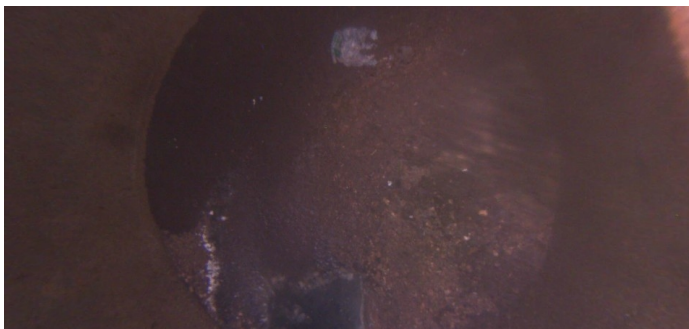
Code: **MGO**
Description: **General Observation**

Distance (ft): **5.8**
Structural Grade: **0**
O&M Grade: **0**
Clock Start/From:
Clock To:
1st Value:
2nd Value:
Value Percent:
Step: **NO**
Remarks: **Ins. Comp.**
