Manhole Inspection Report

Date:	03/26/2018	Weather:		Coding:	RZMACP
MH#:	M-803-051	Owner:	NA	Len. Surveyed:	8.1
P.O.#:		Surveyor:	John Kuglmaier	Rim to Invert:	9.1
Customer:		Cert. #:	U-1215-07002349	Wall Material:	Concrete (reinforced)

Street:	Intersection of 40th Ave. and Kelly S	Project:	Hobart, IN
City:	Hobart, IN	GPS Northing:	0.0
Location:		GPS Easting:	0.0
Drain Area:	Northeast	GPS Accuracy:	Nearest Meter
Cover Shape:	Circular	Evidence of Surcharge:	No
Cover Size:	23.0	Potential for Runoff:	None
Comments:

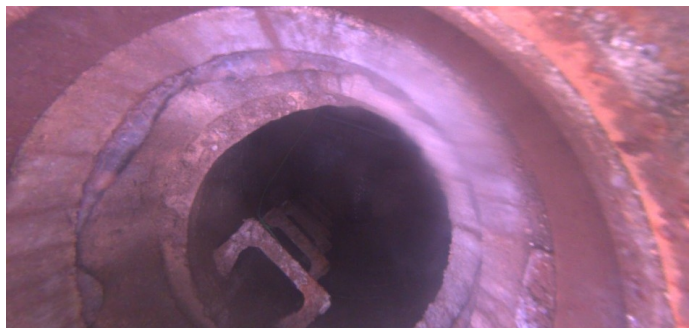
Code: **MGP**
Description: **General Photo**

Distance (ft): **.0**
Structural Grade: **0**
O&M Grade: **0**
Clock Start/From:
Clock To:
1st Value:
2nd Value:
Value Percent:
Step: **NO**
Remarks:

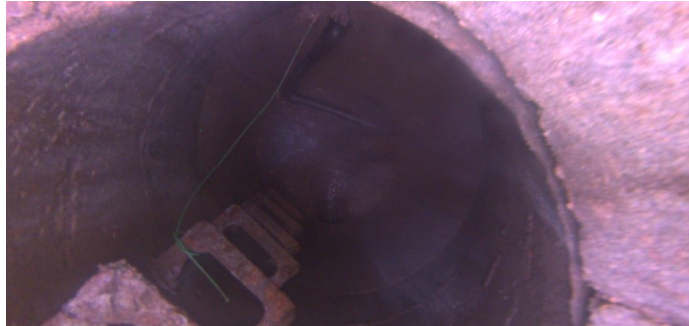
Code: **OBZ**
Description: **Obstacle Other**

Distance (ft): **1.2**
Structural Grade: **0**
O&M Grade: **2**
Clock Start/From: **8**
Clock To: **11**
1st Value:
2nd Value:
Value Percent: **5.000**
Step: **NO**
Remarks: **Wire**

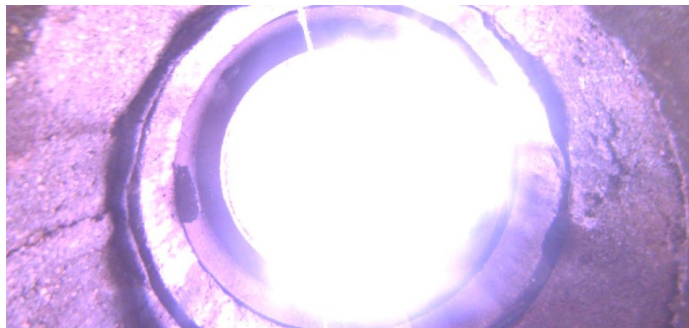
Code: **MGP**
Description: **General Photo**

Distance (ft): **2.5**
Structural Grade: **0**
O&M Grade: **0**
Clock Start/From:
Clock To:
1st Value:
2nd Value:
Value Percent:
Step: **NO**
Remarks:

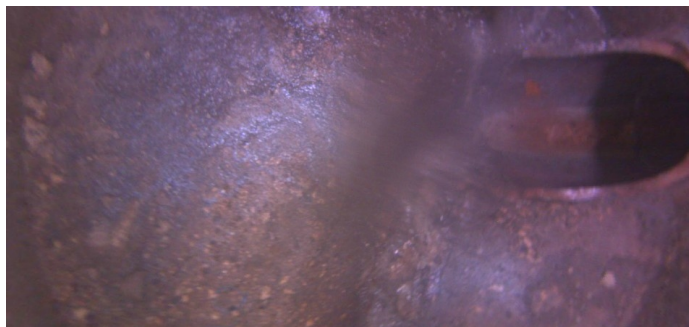
Code: **MGO**
Description: **General Observation**

Distance (ft): **7.2**
Structural Grade: **0**
O&M Grade: **0**
Clock Start/From:
Clock To:
1st Value:
2nd Value:
Value Percent:
Step: **NO**
Remarks: **Ins. Comp.**
