Manhole Inspection Report

Date:	03/28/2018	Weather:		Coding:	RZMACP
MH#:	M-803-055	Owner:	NA	Len. Surveyed:	10.7
P.O.#:		Surveyor:	John Kuglmaier	Rim to Invert:	12.1
Customer:		Cert. #:	U-1215-07002349	Wall Material:	Concrete (reinforced)

Street:	Intersection of Rand St. and Liberty	Project:	Hobart, IN
City:	Hobart, IN	GPS Northing:	0.0
Location:		GPS Easting:	0.0
Drain Area:	Northeast	GPS Accuracy:	Nearest Meter
Cover Shape:	Circular	Evidence of Surcharge:	No
Cover Size:	23.0	Potential for Runoff:	None
Comments:

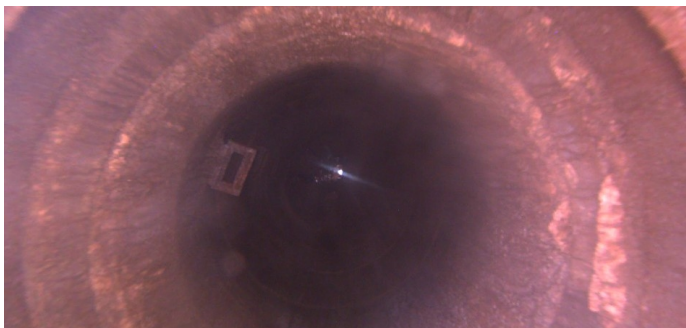
Code:	MGP
Description:	General Photo

Distance (ft):	.0
Structural Grade:	0
O&M Grade:	0
Clock Start/From:	
Clock To:	
1st Value:	
2nd Value:	
Value Percent:	
Step:	NO
Remarks:

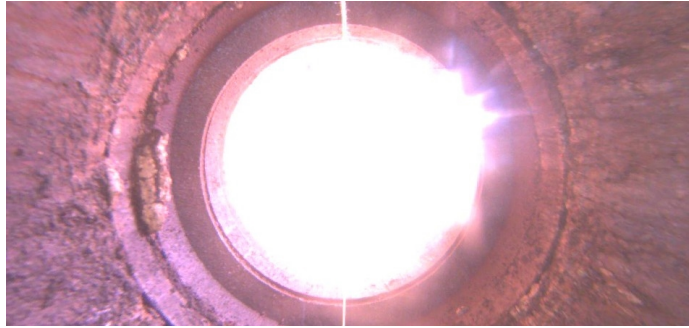
Code: **MGP**
Description: **General Photo**

Distance (ft): **2.4**
Structural Grade: **0**
O&M Grade: **0**
Clock Start/From:
Clock To:
1st Value:
2nd Value:
Value Percent:
Step: **NO**
Remarks:

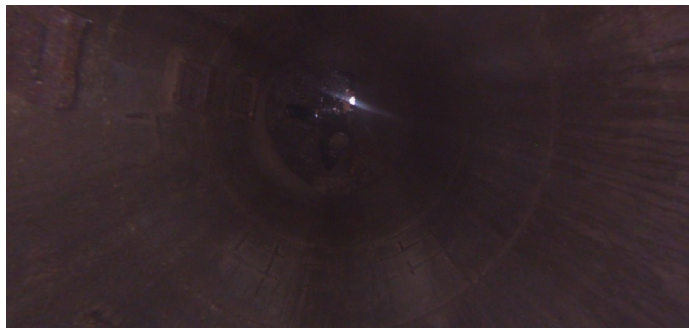
Code: **SRV**
Description: **Surface Reinforcement Visible**

Distance (ft): **4.2**
Structural Grade: **5**
O&M Grade: **0**
Clock Start/From: **5**
Clock To: **7**
1st Value:
2nd Value:
Value Percent:
Step: **NO**
Remarks:

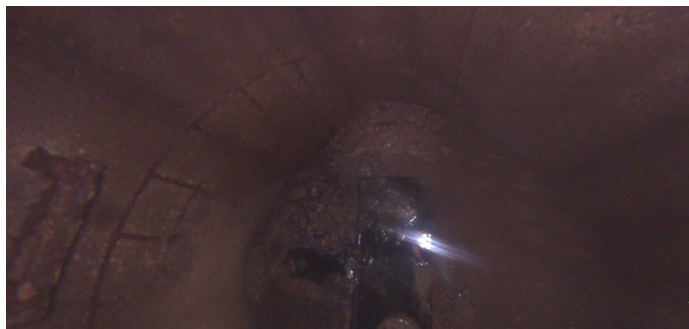
Code: **SRV**
Description: **Surface Reinforcement Visible**

Distance (ft): **8.2**
Structural Grade: **5**
O&M Grade: **0**
Clock Start/From: **9**
Clock To: **11**
1st Value:
2nd Value:
Value Percent:
Step: **NO**
Remarks:

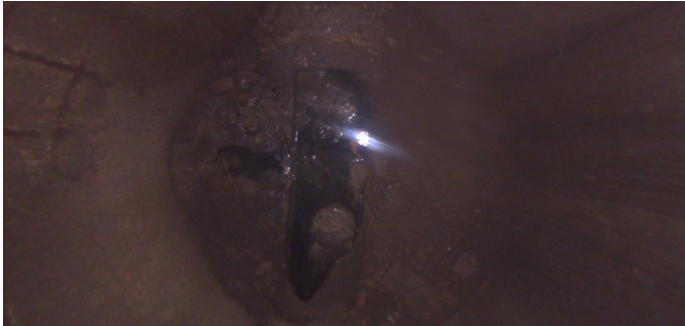
Code:	DAZ
Description:	Deposits Attached Other

Distance (ft):	8.4
Structural Grade:	0
O&M Grade:	2
Clock Start/From:	12
Clock To:	12
1st Value:	
2nd Value:	
Value Percent:	10.000
Step:	NO
Remarks:	Mixed materials

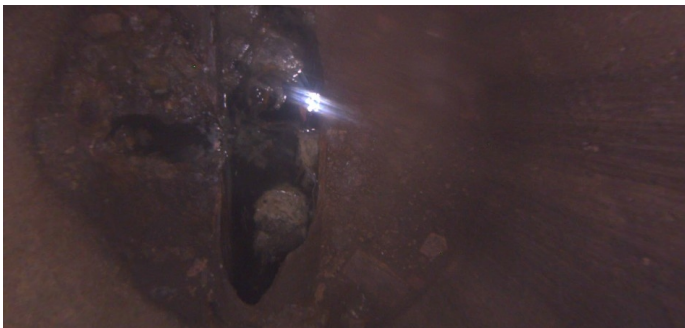
Code:	OBB
Description:	Obstacle Brick

Distance (ft):	9.0
Structural Grade:	0
O&M Grade:	2
Clock Start/From:	5
Clock To:	
1st Value:	
2nd Value:	
Value Percent:	5.000
Step:	NO
Remarks:

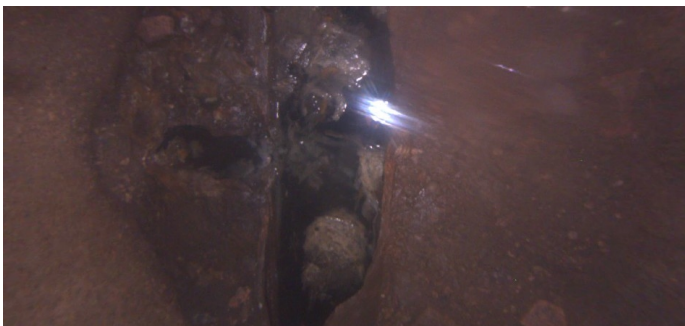
Code:	MGO
Description:	General Observation

Distance (ft):	9.7
Structural Grade:	0
O&M Grade:	0
Clock Start/From:	
Clock To:	
1st Value:	
2nd Value:	
Value Percent:	
Step:	NO
Remarks:	Ins. Comp.
