Manhole Inspection Report

Date:	03/21/2018	Weather:		Coding:	RZMACP
MH#:	M-803-060	Owner:	NA	Len. Surveyed:	6.2
P.O.#:		Surveyor:	John Kuglmaier	Rim to Invert:	7.7
Customer:		Cert. #:	U-1215-07002349	Wall Material:	Concrete (reinforced)

Street:	227' S Hwy 6.	Project:	Hobart, IN
City:	Hobart, IN	GPS Northing:	0.0
Location:		GPS Easting:	0.0
Drain Area:	Northeast	GPS Accuracy:	Nearest Meter
Cover Shape:	Circular	Evidence of Surcharge:	Yes
Cover Size:	23.0	Potential for Runoff:	None
Comments:

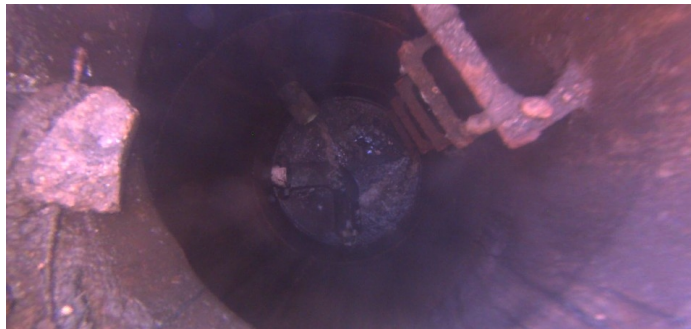
Code: **MGP**
Description: **General Photo**

Distance (ft): **.0**
Structural Grade: **0**
O&M Grade: **0**
Clock Start/From:
Clock To:
1st Value:
2nd Value:
Value Percent:
Step: **NO**
Remarks:

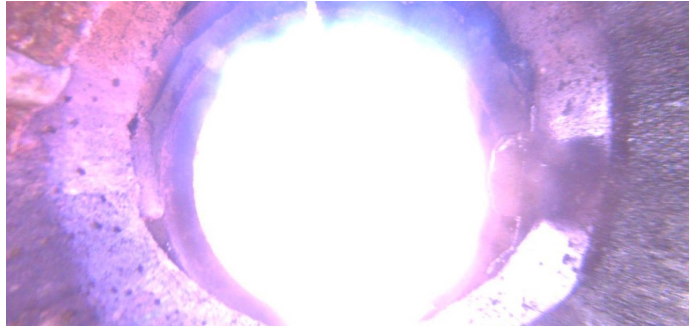
Code: **MGP**
Description: **General Photo**

Distance (ft): **2.1**
Structural Grade: **0**
O&M Grade: **0**
Clock Start/From:
Clock To:
1st Value:
2nd Value:
Value Percent:
Step: **NO**
Remarks:

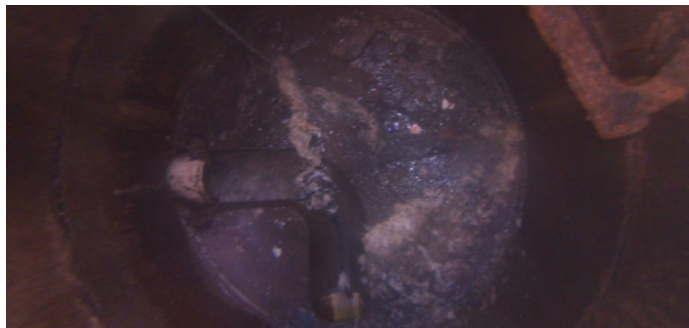
Code: **DAZ**
Description: **Deposits Attached Other**

Distance (ft): **4.3**
Structural Grade: **0**
O&M Grade: **2**
Clock Start/From: **12**
Clock To: **12**
1st Value:
2nd Value:
Value Percent: **10.000**
Step: **NO**
Remarks: **Mixed materials**

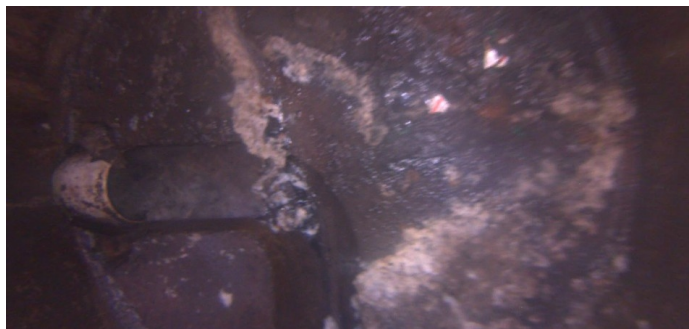
Code: **MGO**
Description: **General Observation**

Distance (ft): **5.3**
Structural Grade: **0**
O&M Grade: **0**
Clock Start/From:
Clock To:
1st Value:
2nd Value:
Value Percent:
Step: **NO**
Remarks: **Ins. Comp.**
