Manhole Inspection Report

Date:	03/21/2018	Weather:		Coding:	RZMACP
MH#:	M-803-061	Owner:	NA	Len. Surveyed:	6.0
P.O.#:		Surveyor:	John Kuglmaier	Rim to Invert:	7.2
Customer:		Cert. #:	U-1215-07002349	Wall Material:	Concrete (reinforced)

Street:	363' S Hwy 6. The West Side.	Project:	Hobart, IN
City:	Hobart, IN	GPS Northing:	0.0
Location:		GPS Easting:	0.0
Drain Area:	Northeast	GPS Accuracy:	Nearest Meter
Cover Shape:	Circular	Evidence of Surcharge:	No
Cover Size:	23.0	Potential for Runoff:	None
Comments:

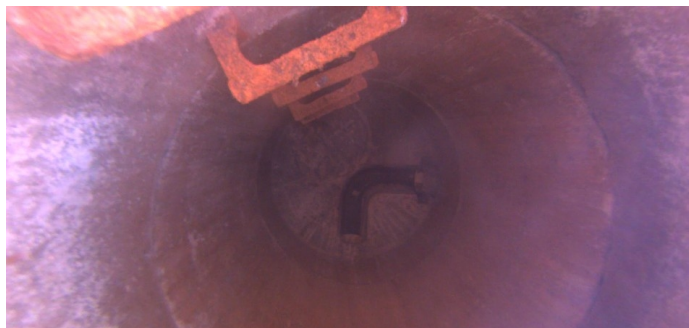
Code: **MGP**
Description: **General Photo**

Distance (ft): **.0**
Structural Grade: **0**
O&M Grade: **0**
Clock Start/From:
Clock To:
1st Value:
2nd Value:
Value Percent:
Step: **NO**
Remarks:

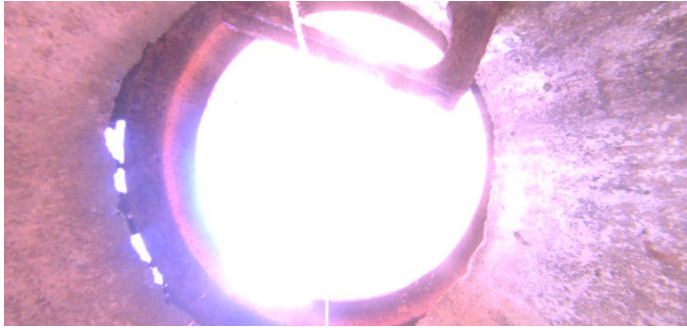
Code:	MGP
Description:	General Photo
Distance (ft):	1.8
Structural Grade:	0
O&M Grade:	0
Clock Start/From:	
Clock To:	
1st Value:	
2nd Value:	
Value Percent:	
Step:	NO
Remarks:

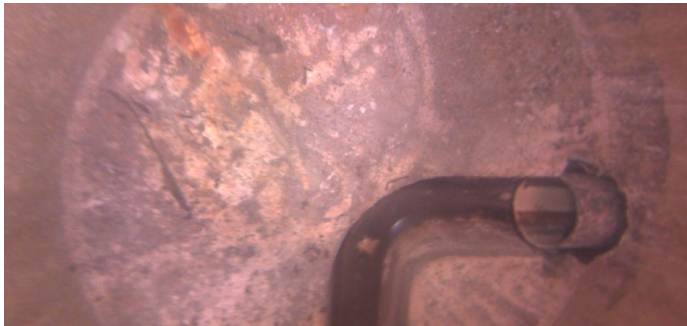
Code:	MGO
Description:	General Observation
Distance (ft):	4.7
Structural Grade:	0
O&M Grade:	0
Clock Start/From:	
Clock To:	
1st Value:	
2nd Value:	
Value Percent:	
Step:	NO
Remarks:	Ins. Comp.
