# Manhole Inspection Report

Date:	<b>03/24/2018</b>	Weather:		Coding:	<b>RZMACP</b>
MH#:	<b>M-803-062</b>	Owner:	<b>NA</b>	Len. Surveyed:	<b>5.8</b>
P.O.#:		Surveyor:	<b>John Kuglmaier</b>	Rim to Invert:	<b>7.4</b>
Customer:		Cert. #:	<b>U-1215-07002349</b>	Wall Material:	<b>Concrete (reinforced)</b>

Street:	<b>218'S Hwy 6. The East Side.</b>	Project:	<b>Hobart, IN</b>
City:	<b>Hobart, IN</b>	GPS Northing:	<b>0.0</b>
Location:		GPS Easting:	<b>0.0</b>
Drain Area:	<b>Northeast</b>	GPS Accuracy:	<b>Nearest Meter</b>
Cover Shape:	<b>Circular</b>	Evidence of Surcharge:	<b>No</b>
Cover Size:	<b>23.0</b>	Potential for Runoff:	<b>None</b>
Comments:

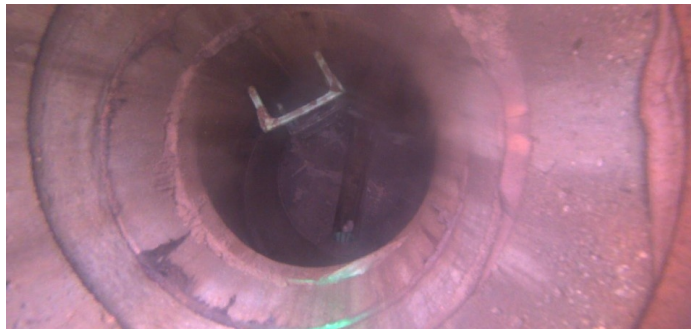
Code: **MGP**  
Description: **General Photo**

Distance (ft): **.0**  
Structural Grade: **0**  
O&M Grade: **0**  
Clock Start/From:  
Clock To:  
1st Value:  
2nd Value:  
Value Percent:  
Step: **NO**  
Remarks:

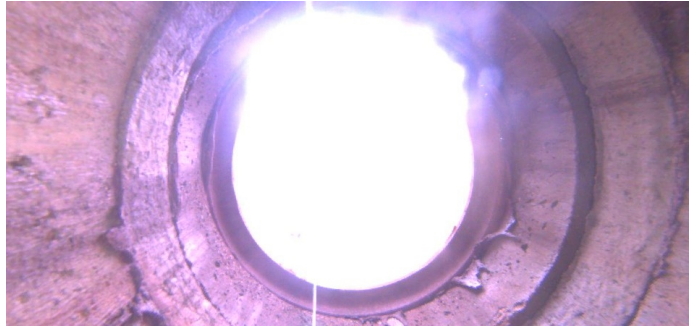
Code: **MGP**  
Description: **General Photo**

Distance (ft): **2.4**  
Structural Grade: **0**  
O&M Grade: **0**  
Clock Start/From:  
Clock To:  
1st Value:  
2nd Value:  
Value Percent:  
Step: **NO**  
Remarks:

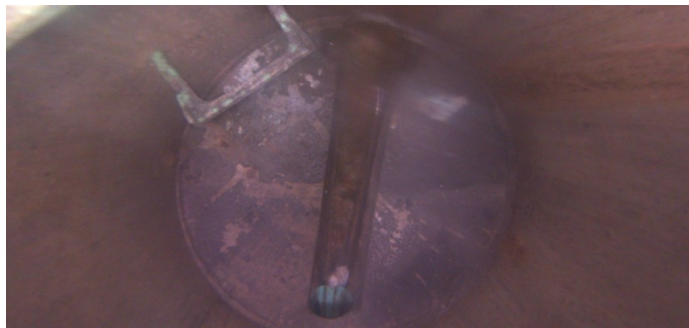
Code: **DSF**  
Description: **Deposits Settled Fine**

Distance (ft): **3.8**  
Structural Grade: **0**  
O&M Grade: **2**  
Clock Start/From: **12**  
Clock To: **12**  
1st Value:  
2nd Value:  
Value Percent: **5.000**  
Step: **NO**  
Remarks:

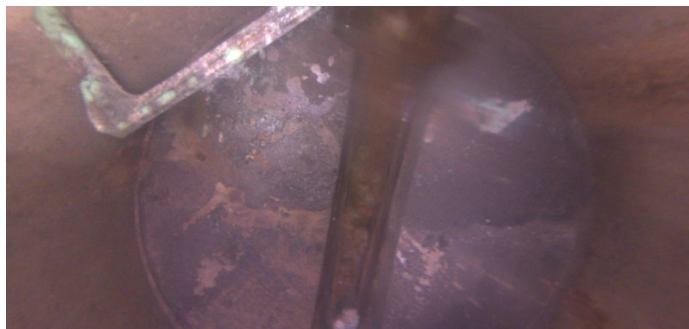
Code: **MGO**  
Description: **General Observation**

Distance (ft): **4.5**  
Structural Grade: **0**  
O&M Grade: **0**  
Clock Start/From:  
Clock To:  
1st Value:  
2nd Value:  
Value Percent:  
Step: **NO**  
Remarks: **Ins. Comp.**
