Manhole Inspection Report

Date:	03/24/2018	Weather:		Coding:	RZMACP
MH#:	M-803-063	Owner:	NA	Len. Surveyed:	7.4
P.O.#:		Surveyor:	John Kuglmaier	Rim to Invert:	8.0
Customer:		Cert. #:	U-1215-07002349	Wall Material:	Concrete (reinforced)

Street:	218' S Hwy 6. The East Side.	Project:	Hobart, IN
City:	Hobart, IN	GPS Northing:	0.0
Location:		GPS Easting:	0.0
Drain Area:	Northeast	GPS Accuracy:	Nearest Meter
Cover Shape:	Circular	Evidence of Surcharge:	No
Cover Size:	23.0	Potential for Runoff:	None
Comments:

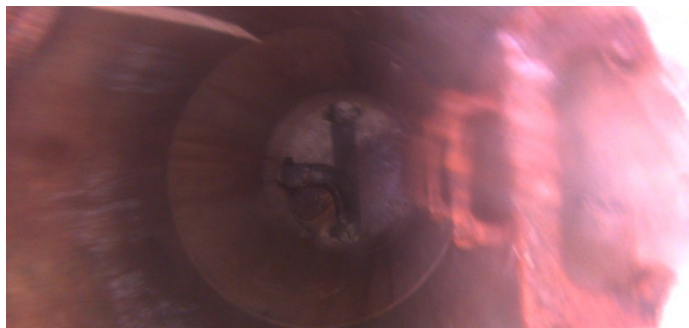
Code: **MGP**
Description: **General Photo**

Distance (ft): **.0**
Structural Grade: **0**
O&M Grade: **0**
Clock Start/From:
Clock To:
1st Value:
2nd Value:
Value Percent:
Step: **NO**
Remarks:

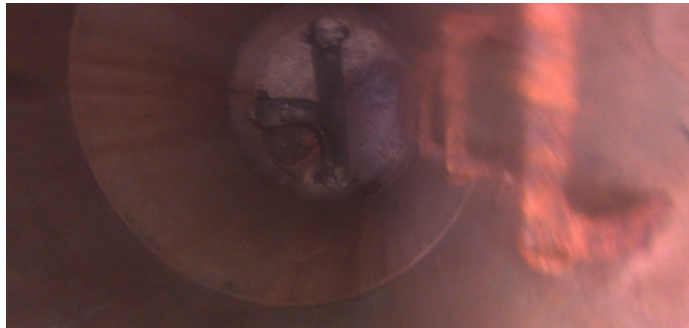
Code: **IS**
Description: **Infil Stain**

Distance (ft): **1.1**
Structural Grade: **0**
O&M Grade: **0**
Clock Start/From: **5**
Clock To: **6**
1st Value:
2nd Value:
Value Percent:
Step: **NO**
Remarks:

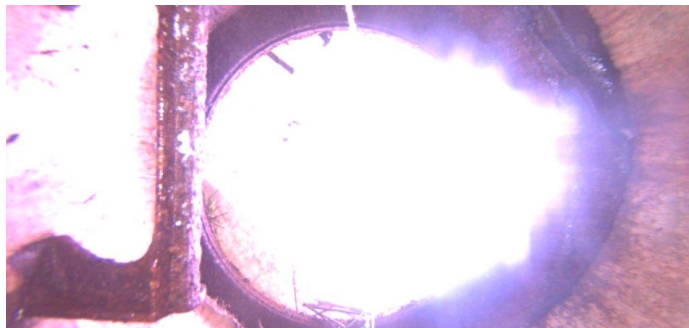
Code: **MGP**
Description: **General Photo**

Distance (ft): **1.9**
Structural Grade: **0**
O&M Grade: **0**
Clock Start/From:
Clock To:
1st Value:
2nd Value:
Value Percent:
Step: **NO**
Remarks:

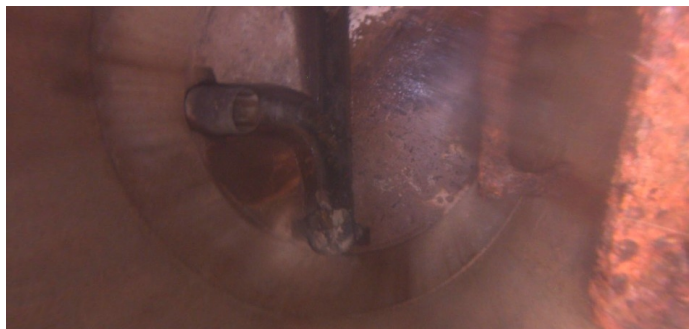
Code: **IS**
Description: **Infil Stain**

Distance (ft): **4.4**
Structural Grade: **0**
O&M Grade: **0**
Clock Start/From: **5**
Clock To:
1st Value:
2nd Value:
Value Percent:
Step: **NO**
Remarks:

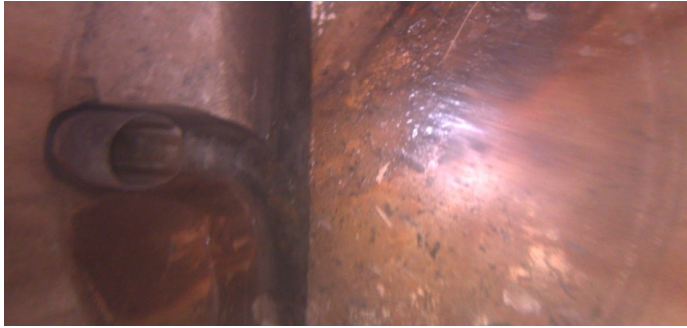
Code:	MGO
Description:	General Observation
Distance (ft):	6.3
Structural Grade:	0
O&M Grade:	0
Clock Start/From:	
Clock To:	
1st Value:	
2nd Value:	
Value Percent:	
Step:	NO
Remarks:	Ins. Comp.
