# Manhole Inspection Report

Date:	<b>03/21/2018</b>	Weather:		Coding:	<b>RZMACP</b>
MH#:	<b>M-803-064</b>	Owner:	<b>NA</b>	Len. Surveyed:	<b>2.6</b>
P.O.#:		Surveyor:	<b>John Kuglmaier</b>	Rim to Invert:	<b>3.4</b>
Customer:		Cert. #:	<b>U-1215-07002349</b>	Wall Material:	<b>Concrete (reinforced)</b>

Street:	<b>182' South of Hwy 6. 487' West of H</b>	Project:	<b>Hobart, IN</b>
City:	<b>Hobart, IN</b>	GPS Northing:	<b>0.0</b>
Location:		GPS Easting:	<b>0.0</b>
Drain Area:	<b>Northeast</b>	GPS Accuracy:	<b>Nearest Meter</b>
Cover Shape:	<b>Circular</b>	Evidence of Surcharge:	<b>No</b>
Cover Size:	<b>23.0</b>	Potential for Runoff:	<b>None</b>
Comments:

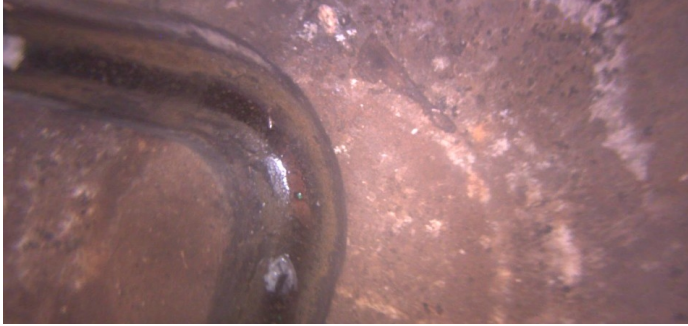
Code:	<b>MGO</b>
Description:	<b>General Observation</b>
Distance (ft):	<b>2.1</b>
Structural Grade:	<b>0</b>
O&M Grade:	<b>0</b>
Clock Start/From:	
Clock To:	
1st Value:	
2nd Value:	
Value Percent:	
Step:	<b>NO</b>
Remarks:	<b>Ins. Comp.</b>
