Manhole Inspection Report

Date:	10/07/2022	Weather:		Coding:	RZMACP
MH#:	M-803-066	Owner:	NA	Len. Surveyed:	3.0
P.O.#:		Surveyor:	Todd Machine	Rim to Invert:	4.5
Customer:		Cert. #:	P0038859-082022	Wall Material:

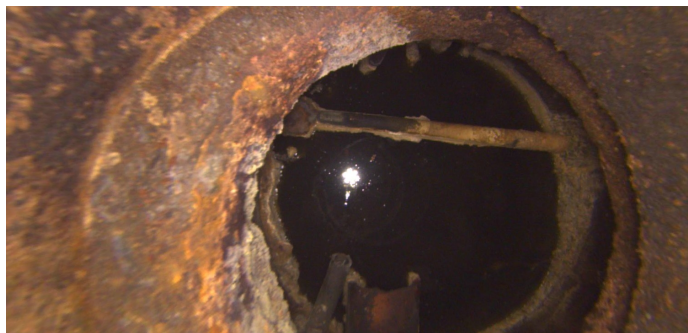
Code: **MGO**
Description: **General Observation**

Distance (ft): **.0**
Structural Grade: **0**
O&M Grade: **0**
Clock Start/From:
Clock To:
1st Value:
2nd Value:
Value Percent:
Step: **NO**
Remarks: **access mh**

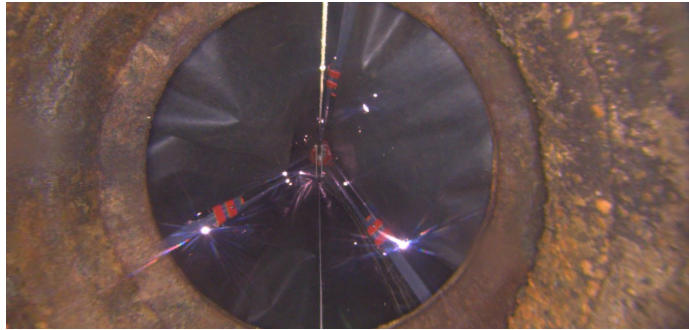
Code: **MSA**
Description: **Abandoned Survey**

Distance (ft): **1.4**
Structural Grade: **0**
O&M Grade: **0**
Clock Start/From:
Clock To:
1st Value:
2nd Value:
Value Percent:
Step: **NO**
Remarks: **Underside Of Frame**

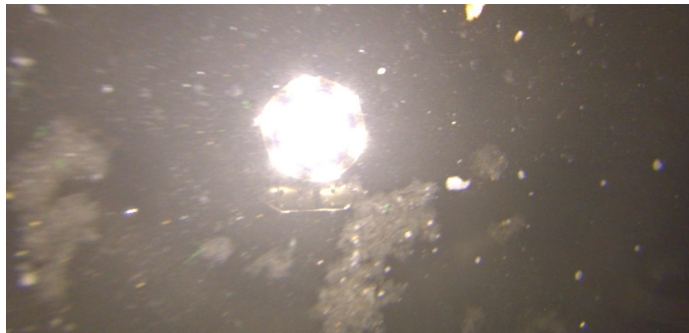
Code: **MSA**
Description: **Abandoned Survey**

Distance (ft): **3.0**
Structural Grade: **0**
O&M Grade: **0**
Clock Start/From:
Clock To:
1st Value:
2nd Value:
Value Percent:
Step: **NO**
Remarks: **Surcharged**
