# Manhole Inspection Report

Date:	<b>03/29/2018</b>	Weather:		Coding:	<b>RZMACP</b>
MH#:	<b>M-803-067</b>	Owner:	<b>NA</b>	Len. Surveyed:	<b>16.0</b>
P.O.#:		Surveyor:	<b>John Kuglmaier</b>	Rim to Invert:	<b>18.0</b>
Customer:		Cert. #:	<b>U-1215-07002349</b>	Wall Material:	<b>Concrete (reinforced)</b>

Street:	<b>North Side of Hwy 6, and Colonial Dr</b>	Project:	<b>Hobart, IN</b>
City:	<b>Hobart, IN</b>	GPS Northing:	<b>0.0</b>
Location:		GPS Easting:	<b>0.0</b>
Drain Area:	<b>Northeast</b>	GPS Accuracy:	<b>Nearest Meter</b>
Cover Shape:	<b>Circular</b>	Evidence of Surcharge:	<b>No</b>
Cover Size:	<b>23.0</b>	Potential for Runoff:	<b>None</b>
Comments:

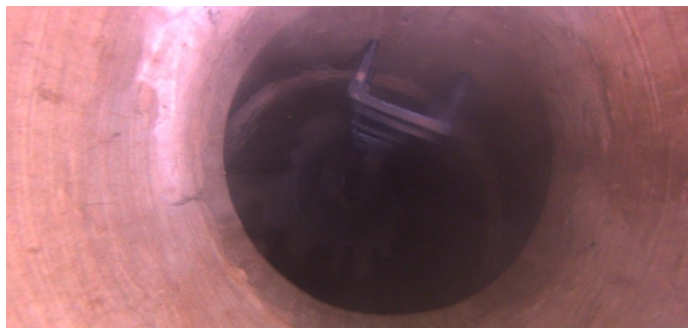
Code: **MGP**  
Description: **General Photo**

Distance (ft): **.0**  
Structural Grade: **0**  
O&M Grade: **0**  
Clock Start/From:  
Clock To:  
1st Value:  
2nd Value:  
Value Percent:  
Step: **NO**  
Remarks:

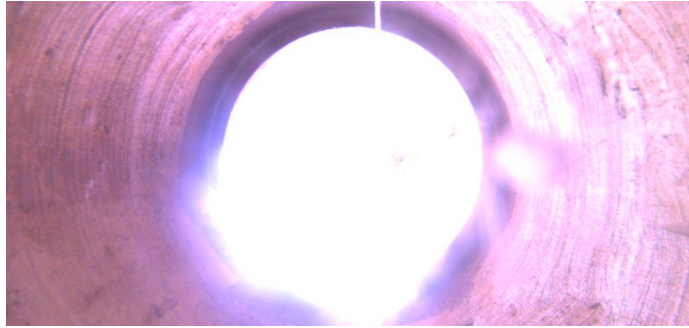
Code: **MGP**  
Description: **General Photo**

Distance (ft): **2.0**  
Structural Grade: **0**  
O&M Grade: **0**  
Clock Start/From:  
Clock To:  
1st Value:  
2nd Value:  
Value Percent:  
Step: **NO**  
Remarks:

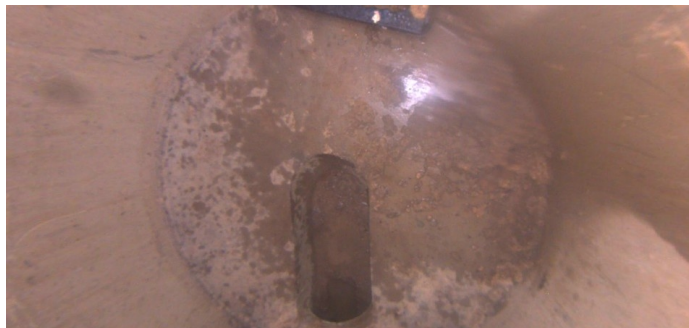
Code: **MGO**  
Description: **General Observation**

Distance (ft): **14.3**  
Structural Grade: **0**  
O&M Grade: **0**  
Clock Start/From:  
Clock To:  
1st Value:  
2nd Value:  
Value Percent:  
Step: **NO**  
Remarks: **Ins. Comp.**
