# Manhole Inspection Report

Date:	<b>03/29/2018</b>	Weather:		Coding:	<b>RZMACP</b>
MH#:	<b>M-803-069</b>	Owner:	<b>NA</b>	Len. Surveyed:	<b>19.3</b>
P.O.#:		Surveyor:	<b>John Kuglmaier</b>	Rim to Invert:	<b>21.6</b>
Customer:		Cert. #:	<b>U-1215-07002349</b>	Wall Material:	<b>Concrete (reinforced)</b>

Street:	<b>Colonial Drive. 76' South of Hwy 6.</b>	Project:	<b>Hobart, IN</b>
City:	<b>Hobart, IN</b>	GPS Northing:	<b>0.0</b>
Location:		GPS Easting:	<b>0.0</b>
Drain Area:	<b>Northeast</b>	GPS Accuracy:	<b>Nearest Meter</b>
Cover Shape:	<b>Circular</b>	Evidence of Surcharge:	<b>No</b>
Cover Size:	<b>23.0</b>	Potential for Runoff:	<b>None</b>
Comments:

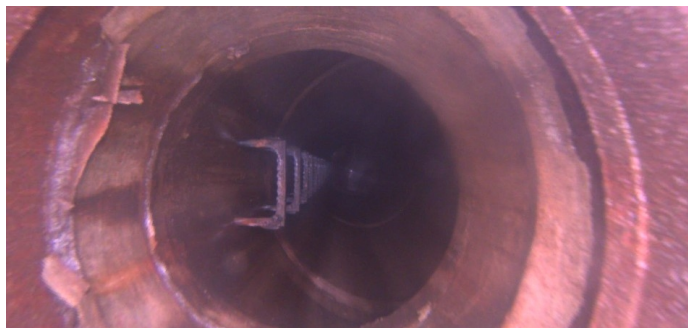
Code: **MGP**  
Description: **General Photo**

Distance (ft): **.0**  
Structural Grade: **0**  
O&M Grade: **0**  
Clock Start/From:  
Clock To:  
1st Value:  
2nd Value:  
Value Percent:  
Step: **NO**  
Remarks:

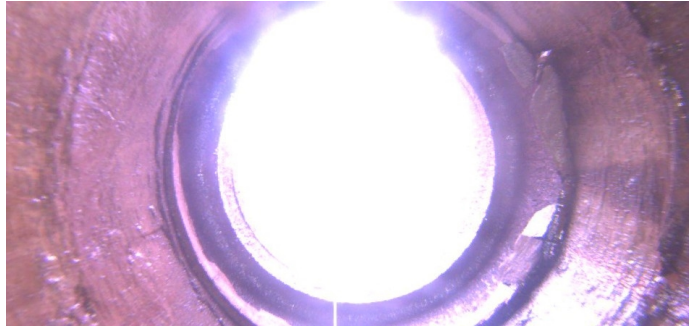
Code: **MGP**  
Description: **General Photo**

Distance (ft): **2.5**  
Structural Grade: **0**  
O&M Grade: **0**  
Clock Start/From:  
Clock To:  
1st Value:  
2nd Value:  
Value Percent:  
Step: **NO**  
Remarks:

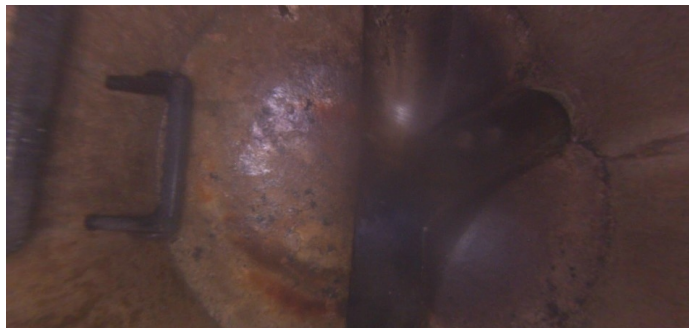
Code: **MGO**  
Description: **General Observation**

Distance (ft): **18.0**  
Structural Grade: **0**  
O&M Grade: **0**  
Clock Start/From:  
Clock To:  
1st Value:  
2nd Value:  
Value Percent:  
Step: **NO**  
Remarks: **Ins. Comp.**
