Manhole Inspection Report

Date:	03/29/2018	Weather:		Coding:	RZMACP
MH#:	M-803-069	Owner:	NA	Len. Surveyed:	15.7
P.O.#:		Surveyor:	John Kuglmaier	Rim to Invert:	17.3
Customer:		Cert. #:	U-1215-07002349	Wall Material:	Concrete (reinforced)

Street:	Colonial Drive. 76' South of Hwy 6.	Project:	Hobart, IN
City:	Hobart, IN	GPS Northing:	0.0
Location:		GPS Easting:	0.0
Drain Area:	Northeast	GPS Accuracy:	Nearest Meter
Cover Shape:	Circular	Evidence of Surcharge:	No
Cover Size:	23.0	Potential for Runoff:	None
Comments:

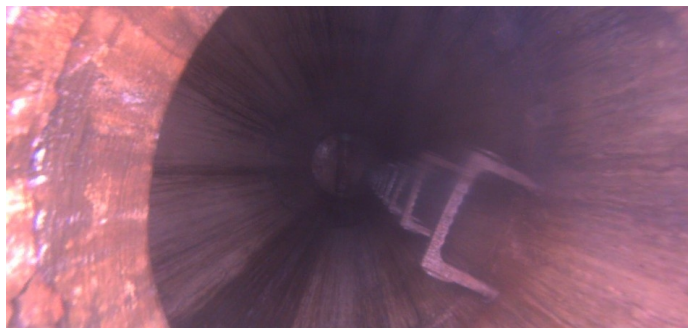
Code: **MGP**
Description: **General Photo**

Distance (ft): **.0**
Structural Grade: **0**
O&M Grade: **0**
Clock Start/From:
Clock To:
1st Value:
2nd Value:
Value Percent:
Step: **NO**
Remarks:

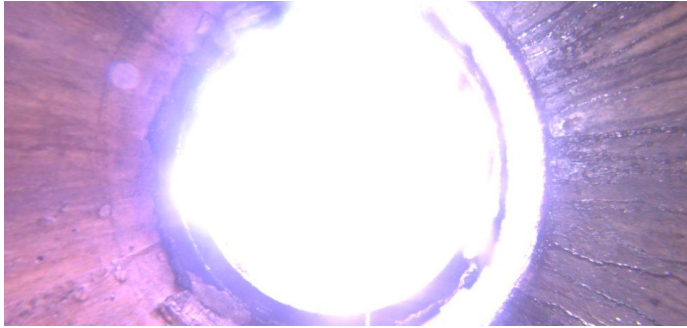
Code:	MGP
Description:	General Photo
Distance (ft):	2.0
Structural Grade:	0
O&M Grade:	0
Clock Start/From:	
Clock To:	
1st Value:	
2nd Value:	
Value Percent:	
Step:	NO
Remarks:

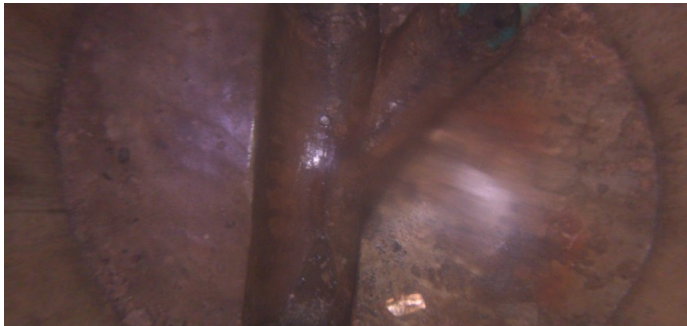
Code:	MGO
Description:	General Observation
Distance (ft):	14.4
Structural Grade:	0
O&M Grade:	0
Clock Start/From:	
Clock To:	
1st Value:	
2nd Value:	
Value Percent:	
Step:	NO
Remarks:	Ins. Comp.
