# Manhole Inspection Report

Date:	<b>03/29/2018</b>	Weather:		Coding:	<b>RZMACP</b>
MH#:	<b>M-803-070</b>	Owner:	<b>NA</b>	Len. Surveyed:	<b>16.0</b>
P.O.#:		Surveyor:	<b>John Kuglmaier</b>	Rim to Invert:	<b>18.0</b>
Customer:		Cert. #:	<b>U-1215-07002349</b>	Wall Material:	<b>Concrete (reinforced)</b>

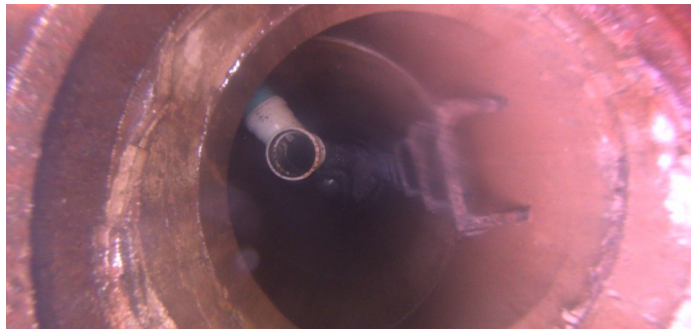
Code: **MGP**  
Description: **General Photo**

Distance (ft): **.0**  
Structural Grade: **0**  
O&M Grade: **0**  
Clock Start/From:  
Clock To:  
1st Value:  
2nd Value:  
Value Percent:  
Step: **NO**  
Remarks:

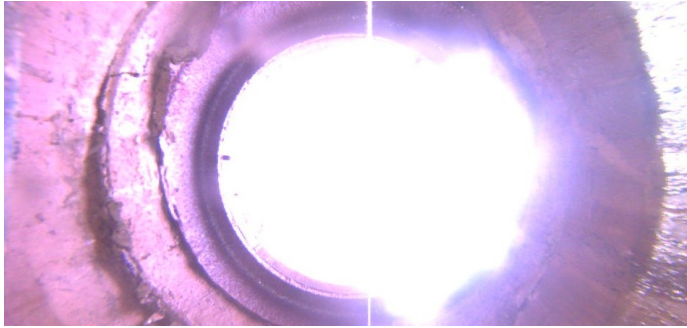
Code: **MGP**  
Description: **General Photo**

Distance (ft): **2.5**  
Structural Grade: **0**  
O&M Grade: **0**  
Clock Start/From:  
Clock To:  
1st Value:  
2nd Value:  
Value Percent:  
Step: **NO**  
Remarks:

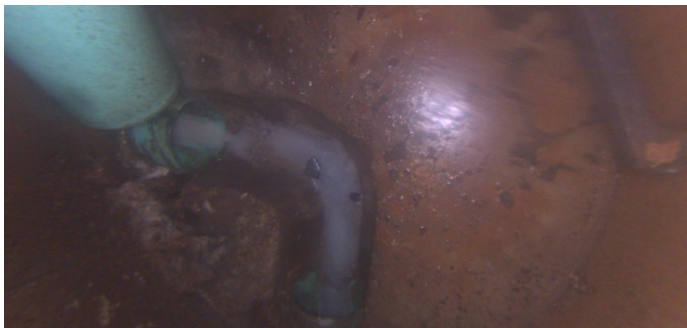
Code: **MGO**  
Description: **General Observation**

Distance (ft): **15.0**  
Structural Grade: **0**  
O&M Grade: **0**  
Clock Start/From:  
Clock To:  
1st Value:  
2nd Value:  
Value Percent:  
Step: **NO**  
Remarks: **Ins. Comp.**
