Manhole Inspection Report

Date:	03/29/2018	Weather:		Coding:	RZMACP
MH#:	M-803-071	Owner:	NA	Len. Surveyed:	15.1
P.O.#:		Surveyor:	John Kuglmaier	Rim to Invert:	17.1
Customer:		Cert. #:	U-1215-07002349	Wall Material:	Concrete (reinforced)

Street:	West of Colonial Drive Cul De Sac. S	Project:	Hobart, IN
City:	Hobart, IN	GPS Northing:	0.0
Location:		GPS Easting:	0.0
Drain Area:	Northeast	GPS Accuracy:	Nearest Meter
Cover Shape:	Circular	Evidence of Surcharge:	No
Cover Size:	23.0	Potential for Runoff:	None
Comments:

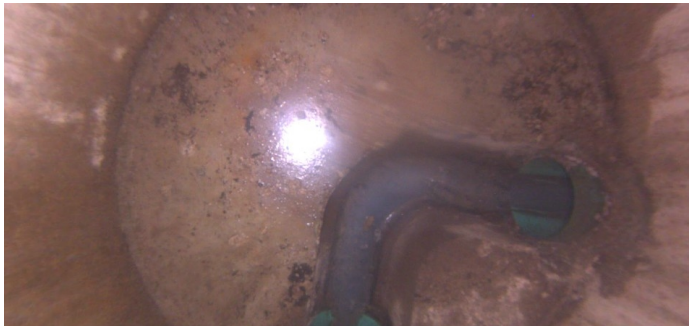
Code: **MGP**
Description: **General Photo**

Distance (ft): **2.3**
Structural Grade: **0**
O&M Grade: **0**
Clock Start/From:
Clock To:
1st Value:
2nd Value:
Value Percent:
Step: **NO**
Remarks:
