Manhole Inspection Report

Date:	05/07/2018	Weather:		Coding:	RZMACP
MH#:	M-804-003	Owner:	NA	Len. Surveyed:	6.7
P.O.#:		Surveyor:	Jen Costello	Rim to Invert:	7.4
Customer:		Cert. #:	U-907-5518	Wall Material:	Concrete (reinforced)

Street:	Cleveland Ave. 116' West of Liberty	Project:	Hobart, IN
City:	Hobart, IN	GPS Northing:	2908969.079
Location:		GPS Easting:	2908969.079
Drain Area:	South	GPS Accuracy:	Sub-Meter
Cover Shape:	Circular	Evidence of Surcharge:	No
Cover Size:	22.5	Potential for Runoff:	None
Comments:

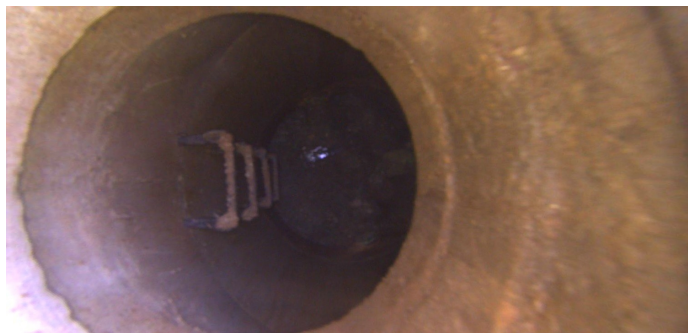
Code: **MGP**
Description: **General Photo**

Distance (ft): **.0**
Structural Grade: **0**
O&M Grade: **0**
Clock Start/From:
Clock To:
1st Value:
2nd Value:
Value Percent:
Step: **NO**
Remarks: **ACCESS MH**

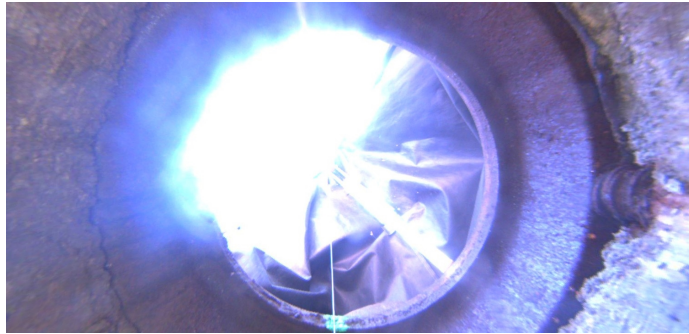
Code: **MGO**
Description: **General Observation**

Distance (ft): **1.5**
Structural Grade: **0**
O&M Grade: **0**
Clock Start/From:
Clock To:
1st Value:
2nd Value:
Value Percent:
Step: **NO**
Remarks: **UNDERSIDE OF FRAME**

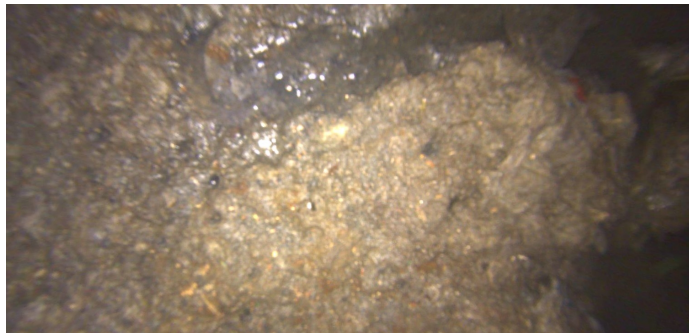
Code: **DSF**
Description: **Deposits Settled Fine**

Distance (ft): **6.5**
Structural Grade: **0**
O&M Grade: **2**
Clock Start/From: **12**
Clock To: **12**
1st Value:
2nd Value:
Value Percent: **10.000**
Step: **NO**
Remarks:

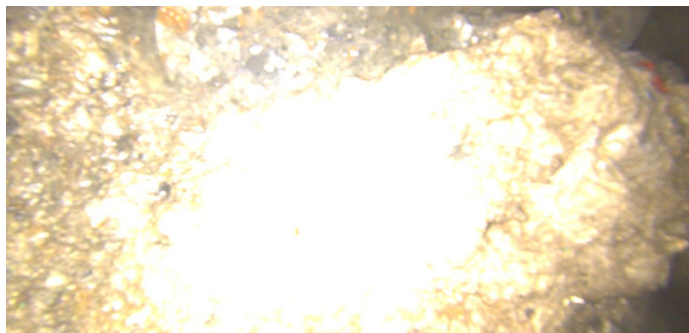
Code: **MGO**
Description: **General Observation**

Distance (ft): **6.7**
Structural Grade: **0**
O&M Grade: **0**
Clock Start/From:
Clock To:
1st Value:
2nd Value:
Value Percent:
Step: **NO**
Remarks: **END SURVEY**
