Manhole Inspection Report

Date:	05/07/2018	Weather:		Coding:	RZMACP
MH#:	M-804-004	Owner:	NA	Len. Surveyed:	6.8
P.O.#:		Surveyor:	Jen Costello	Rim to Invert:	7.2
Customer:		Cert. #:	U-907-5518	Wall Material:	Concrete (reinforced)

Street:	South of Jackson St. 785' West of H	Project:	Hobart, IN
City:	Hobart, IN	GPS Northing:	2908972.634
Location:		GPS Easting:	2908972.634
Drain Area:	South	GPS Accuracy:	Sub-Meter
Cover Shape:	Circular	Evidence of Surcharge:	No
Cover Size:	22.5	Potential for Runoff:	None
Comments:

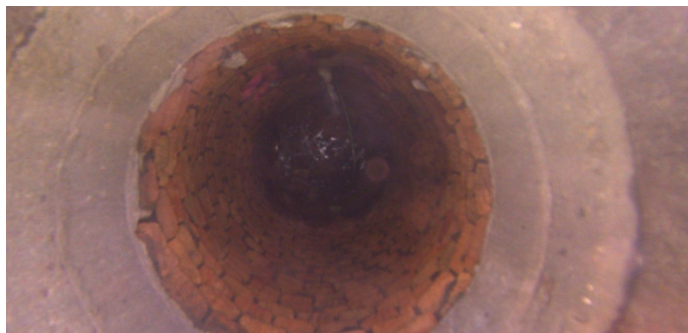
Code: **MGP**
Description: **General Photo**

Distance (ft): **.0**
Structural Grade: **0**
O&M Grade: **0**
Clock Start/From:
Clock To:
1st Value:
2nd Value:
Value Percent:
Step: **NO**
Remarks: **access MH**

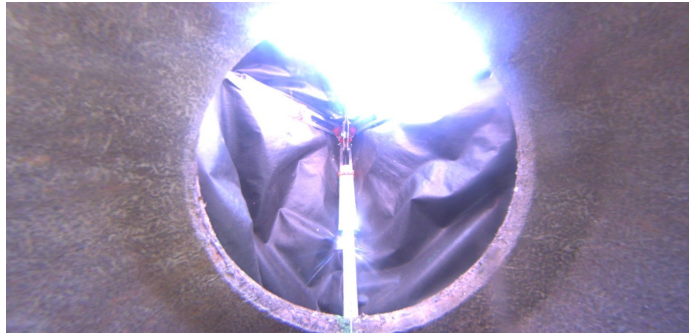
Code:	MGO
Description:	General Observation
Distance (ft):	1.4
Structural Grade:	0
O&M Grade:	0
Clock Start/From:	
Clock To:	
1st Value:	
2nd Value:	
Value Percent:	
Step:	NO
Remarks:	UNDERSIDE OF FRAME

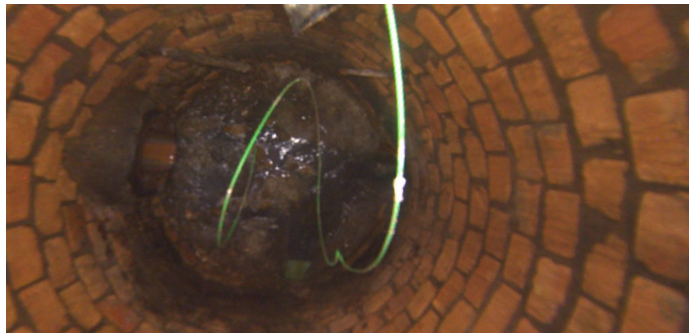
Code:	OBZ
Description:	Obstacle Other
Distance (ft):	3.5
Structural Grade:	0
O&M Grade:	2
Clock Start/From:	6
Clock To:	6
1st Value:	
2nd Value:	
Value Percent:	5.000
Step:	NO
Remarks:	TWINE

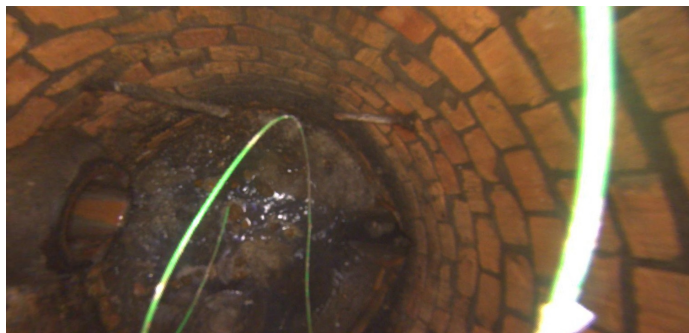
Code:	MGO
Description:	General Observation
Distance (ft):	4.0
Structural Grade:	0
O&M Grade:	0
Clock Start/From:	
Clock To:	
1st Value:	
2nd Value:	
Value Percent:	
Step:	NO
Remarks:	BROKEN STEP

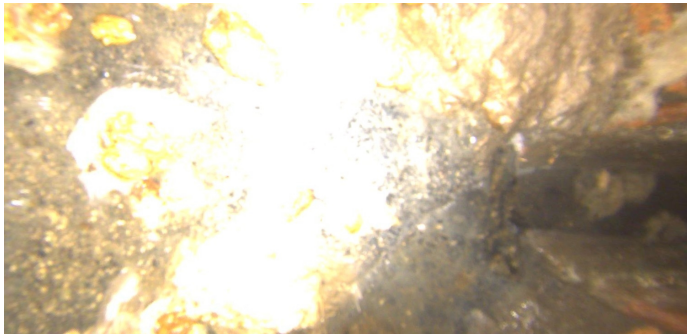
Code:	MGO
Description:	General Observation
Distance (ft):	6.8
Structural Grade:	0
O&M Grade:	0
Clock Start/From:	
Clock To:	
1st Value:	
2nd Value:	
Value Percent:	
Step:	NO
Remarks:	END SURVEY
