Manhole Inspection Report

| MH#: | M-804-005 | Owner: | NA | Len. Surveyed: | 5.4 |

| Street: | South of Jackson St. 614' West of H | Project: | Hobart, IN |

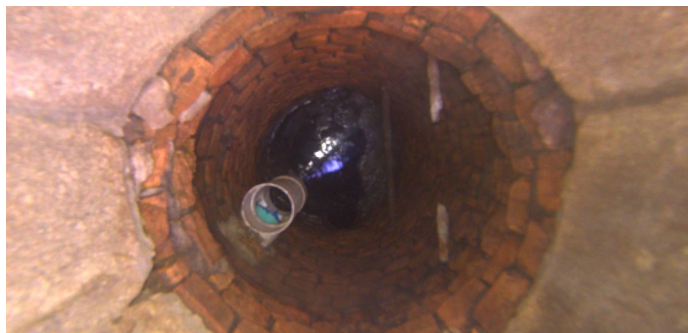
Code: **MGP**
Description: **General Photo**

Distance (ft): **.0**
Structural Grade: **0**
O&M Grade: **0**
Clock Start/From:
Clock To:
1st Value:
2nd Value:
Value Percent:
Step: **NO**
Remarks: **ACCESS MH**

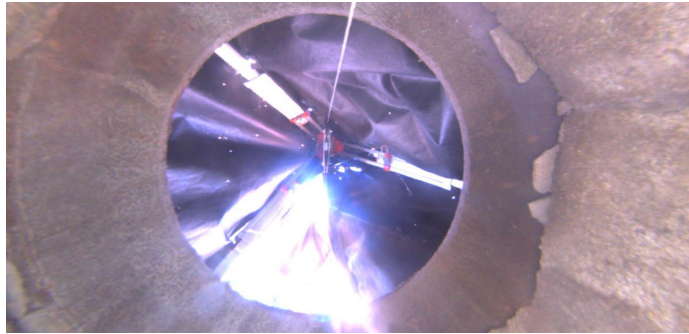
Code: **MGO**
Description: **General Observation**

Distance (ft): **1.8**
Structural Grade: **0**
O&M Grade: **0**
Clock Start/From:
Clock To:
1st Value:
2nd Value:
Value Percent:
Step: **NO**
Remarks: **UNDERSIDE OF FRAME**

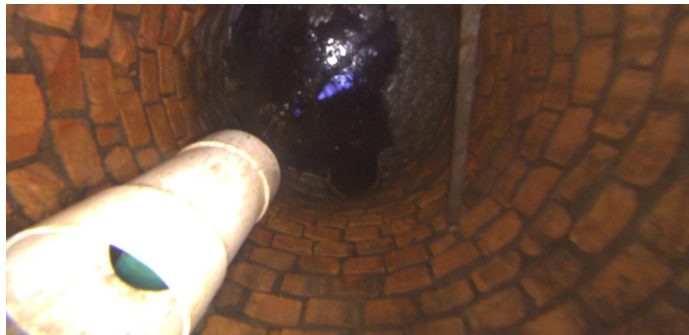
| | Position | Code | Observation | Video (sec) | Grade |
|--|---|---|---|---|---|
| | 2.6 | OBP | Obstacle External Pipe or Cable | 43 | M 2 |

Code: **OBP**
Description: **Obstacle External Pipe or Cable**

Distance (ft): **2.6**
Structural Grade: **0**
O&M Grade: **2**
Clock Start/From: **8**
Clock To:
1st Value:
2nd Value:
Value Percent: **10.000**
Step: **NO**
Remarks:

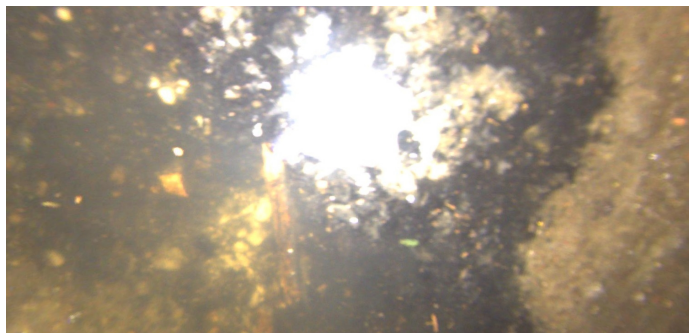
Code: **MGO**
Description: **General Observation**

Distance (ft): **5.4**
Structural Grade: **0**
O&M Grade: **0**
Clock Start/From:
Clock To:
1st Value:
2nd Value:
Value Percent:
Step: **NO**
Remarks: **END SURVEY**

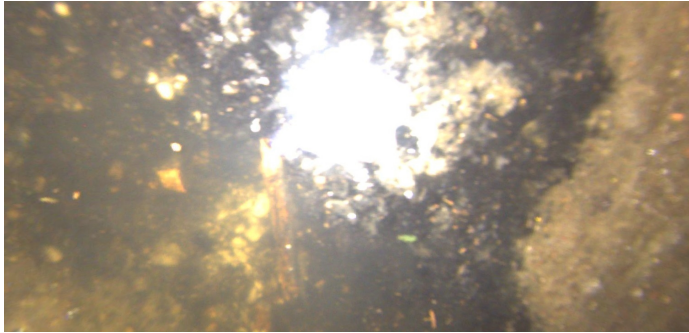
| | Position | Code | Observation | Video (sec) | Grade |
|--|---|---|---|---|---|
| | 5.4 | DSF | Deposits Settled Fine | 71 | M 2 |

| Code: | DSF |
| Description: | Deposits Settled Fine |
| Distance (ft): | 5.4 |
| O&M Grade: | 2 |
| Value Percent: | 5.000 |
