Manhole Inspection Report

Date:	05/07/2018	Weather:		Coding:	RZMACP
MH#:	M-804-009	Owner:	NA	Len. Surveyed:	7.7
P.O.#:		Surveyor:	Jen Costello	Rim to Invert:	8.2
Customer:		Cert. #:	U-907-5518	Wall Material:	Concrete (reinforced)

Street:	Intersection of Cleveland Ave. and J	Project:	Hobart, IN
City:	Hobart, IN	GPS Northing:	2908781.211
Location:		GPS Easting:	2908781.211
Drain Area:	South	GPS Accuracy:	Sub-Meter
Cover Shape:	Circular	Evidence of Surcharge:	No
Cover Size:	22.5	Potential for Runoff:	None
Comments:

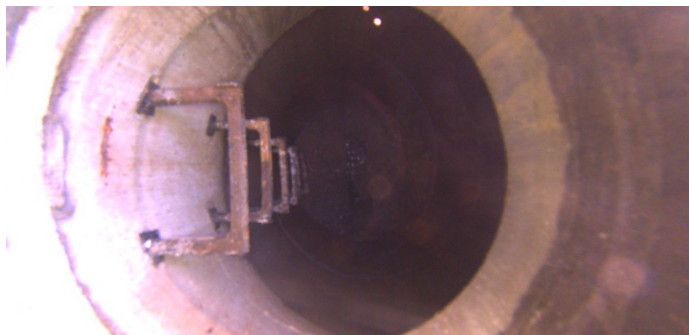
Code: **MGP**
Description: **General Photo**

Distance (ft): **.0**
Structural Grade: **0**
O&M Grade: **0**
Clock Start/From:
Clock To:
1st Value:
2nd Value:
Value Percent:
Step: **NO**
Remarks: **ACCESS MH**

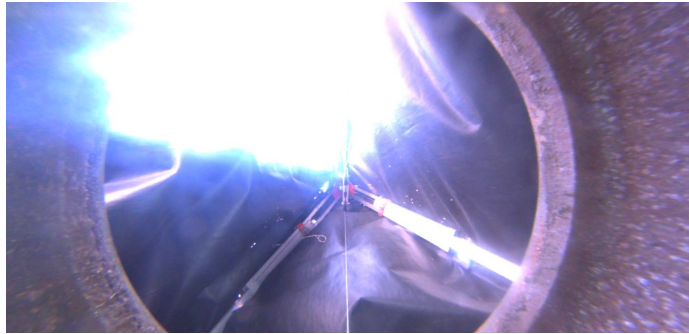
Code:	MGO
Description:	General Observation
Distance (ft):	1.1
Structural Grade:	0
O&M Grade:	0
Clock Start/From:	
Clock To:	
1st Value:	
2nd Value:	
Value Percent:	
Step:	NO
Remarks:	UNDERSIDE OF FRAME

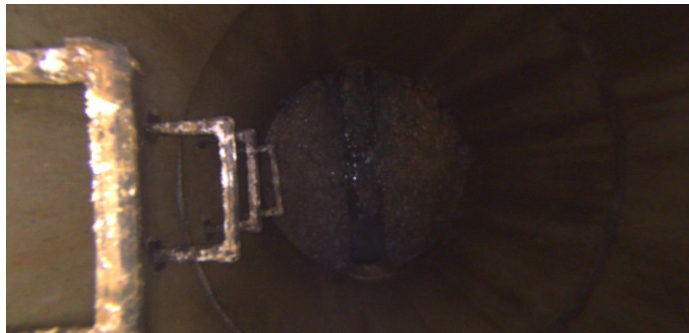
Code:	IS
Description:	Infil Stain
Distance (ft):	2.8
Structural Grade:	0
O&M Grade:	0
Clock Start/From:	1
Clock To:	6
1st Value:	
2nd Value:	
Value Percent:	
Step:	NO
Remarks:

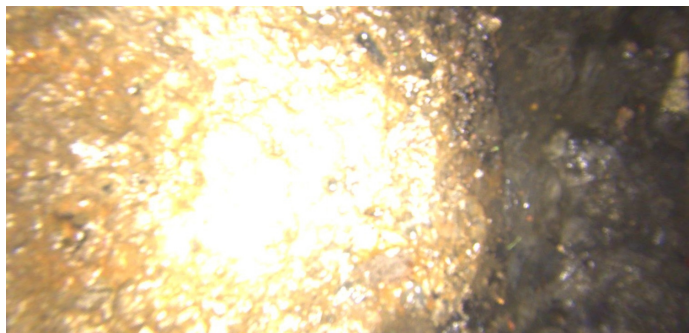
Code:	MGO
Description:	General Observation
Distance (ft):	7.7
Structural Grade:	0
O&M Grade:	0
Clock Start/From:	
Clock To:	
1st Value:	
2nd Value:	
Value Percent:	
Step:	NO
Remarks:	END SURVEY
