Manhole Inspection Report

Date:	05/07/2018	Weather:		Coding:	RZMACP
MH#:	M-804-011	Owner:	NA	Len. Surveyed:	7.2
P.O.#:		Surveyor:	Jen Costello	Rim to Invert:	7.7
Customer:		Cert. #:	U-907-5518	Wall Material:	Brick

Street:	Cleveland Ave. 454' East of Illinois St	Project:	Hobart, IN
City:	Hobart, IN	GPS Northing:	2907973.454
Location:		GPS Easting:	2907973.454
Drain Area:	South	GPS Accuracy:	Sub-Meter
Cover Shape:	Circular	Evidence of Surcharge:	No
Cover Size:	22.5	Potential for Runoff:	None
Comments:

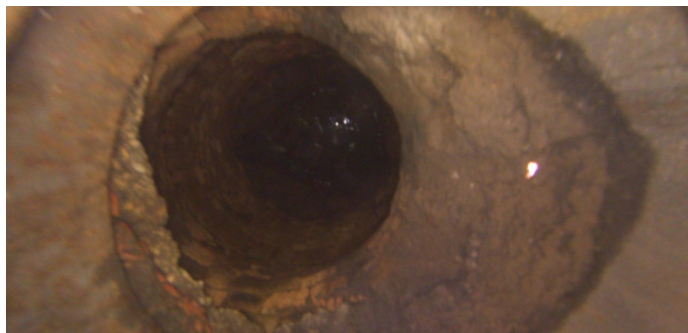
Code: **MGP**
Description: **General Photo**

Distance (ft): **.0**
Structural Grade: **0**
O&M Grade: **0**
Clock Start/From:
Clock To:
1st Value:
2nd Value:
Value Percent:
Step: **NO**
Remarks: **ACCESS MH**

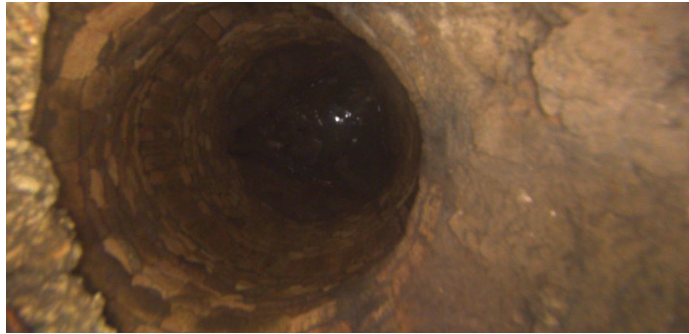
Code: **DAE**
Description: **Deposits Attached Encrustation**

Distance (ft): **.8**
Structural Grade: **0**
O&M Grade: **2**
Clock Start/From: **12**
Clock To: **12**
1st Value:
2nd Value:
Value Percent: **5.000**
Step: **NO**
Remarks:

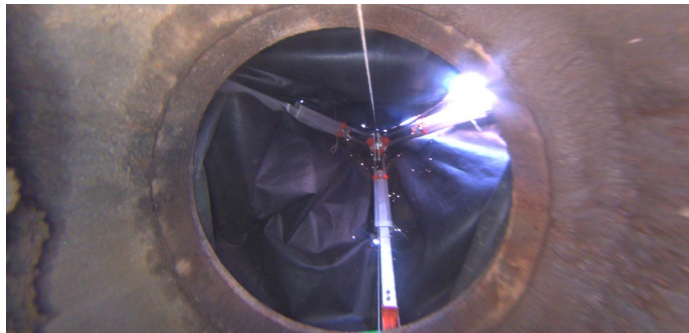
Code: **MGO**
Description: **General Observation**

Distance (ft): **1.5**
Structural Grade: **0**
O&M Grade: **0**
Clock Start/From:
Clock To:
1st Value:
2nd Value:
Value Percent:
Step: **NO**
Remarks: **END SURVEY**

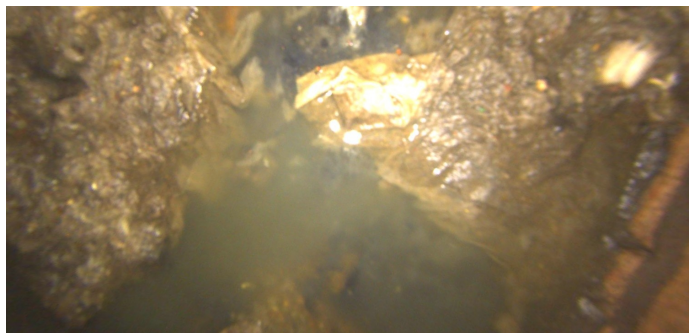
Code: **MGO**
Description: **General Observation**

Distance (ft): **6.9**
Structural Grade: **0**
O&M Grade: **0**
Clock Start/From:
Clock To:
1st Value:
2nd Value:
Value Percent:
Step: **NO**
Remarks: **END SURVEY**
