Manhole Inspection Report

Date:	05/06/2018	Weather:		Coding:	RZMACP
MH#:	M-804-012	Owner:	NA	Len. Surveyed:	3.2
P.O.#:		Surveyor:	Jen Costello	Rim to Invert:	4.1
Customer:		Cert. #:	U-907-5518	Wall Material:	Concrete (reinforced)

Street:	Cleveland Ave. 238' East of Illinois St	Project:	Hobart, IN
City:	Hobart, IN	GPS Northing:	2907762.96
Location:		GPS Easting:	2907762.96
Drain Area:	South	GPS Accuracy:	Sub-Meter
Cover Shape:	Circular	Evidence of Surcharge:	No
Cover Size:	22.5	Potential for Runoff:	None
Comments:

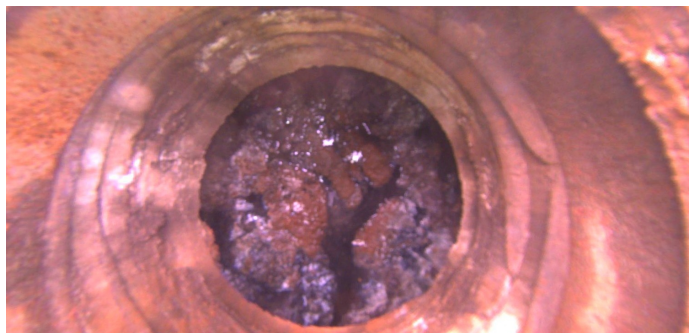
Code: **MGP**
Description: **General Photo**

Distance (ft): **.0**
Structural Grade: **0**
O&M Grade: **0**
Clock Start/From:
Clock To:
1st Value:
2nd Value:
Value Percent:
Step: **NO**
Remarks: **ACCESS MH**

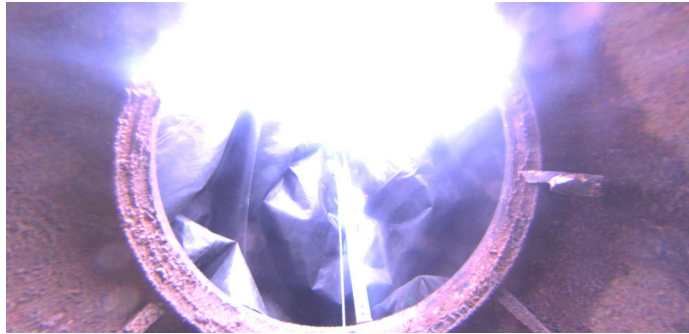
Code:	MGO
Description:	General Observation
Distance (ft):	1.3
Structural Grade:	0
O&M Grade:	0
Clock Start/From:	
Clock To:	
1st Value:	
2nd Value:	
Value Percent:	
Step:	NO
Remarks:	UNDERSIDE OF FRAME

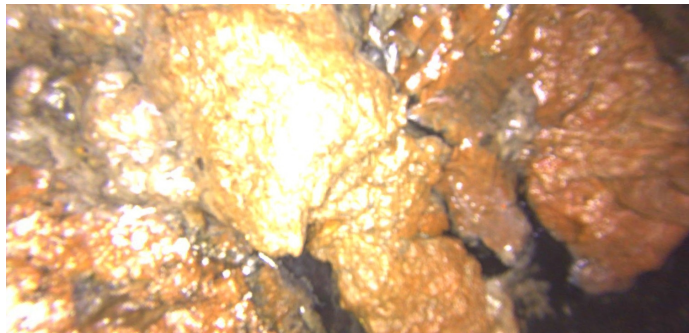
Code:	DSZ
Description:	Deposits Settled Other
Distance (ft):	3.2
Structural Grade:	0
O&M Grade:	2
Clock Start/From:	12
Clock To:	12
1st Value:	
2nd Value:	
Value Percent:	10.000
Step:	NO
Remarks:	BENCH IS SUBERGED

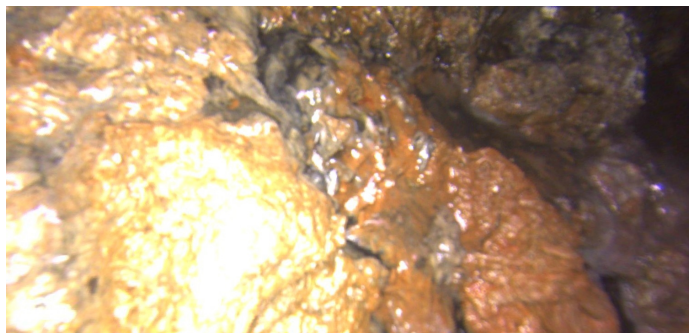
Code:	MGO
Description:	General Observation
Distance (ft):	3.2
Structural Grade:	0
O&M Grade:	0
Clock Start/From:	
Clock To:	
1st Value:	
2nd Value:	
Value Percent:	
Step:	NO
Remarks:	END SURVEY
