Manhole Inspection Report

Date:	05/06/2018	Weather:		Coding:	RZMACP
MH#:	M-804-013	Owner:	NA	Len. Surveyed:	9.7
P.O.#:		Surveyor:	Jen Costello	Rim to Invert:	10.4
Customer:		Cert. #:	U-907-5518	Wall Material:	Brick

Street:	Corner of Kelly St. and Home Ave.	Project:	Hobart, IN
City:	Hobart, IN	GPS Northing:	2907761.028
Location:		GPS Easting:	2907761.028
Drain Area:	Northeast	GPS Accuracy:	Sub-Meter
Cover Shape:	Circular	Evidence of Surcharge:	No
Cover Size:	22.5	Potential for Runoff:	None
Comments:

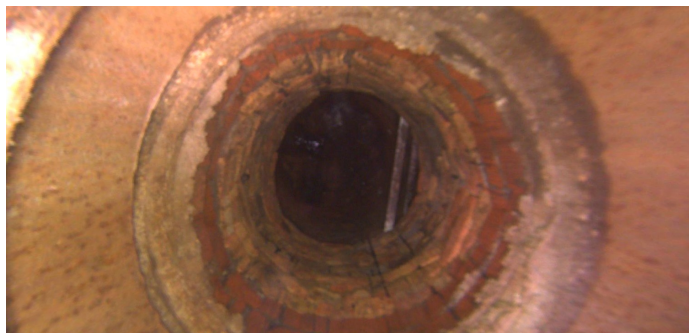
Code: **MGP**
Description: **General Photo**

Distance (ft): **.0**
Structural Grade: **0**
O&M Grade: **0**
Clock Start/From:
Clock To:
1st Value:
2nd Value:
Value Percent:
Step: **NO**
Remarks: **ACCESS MH**

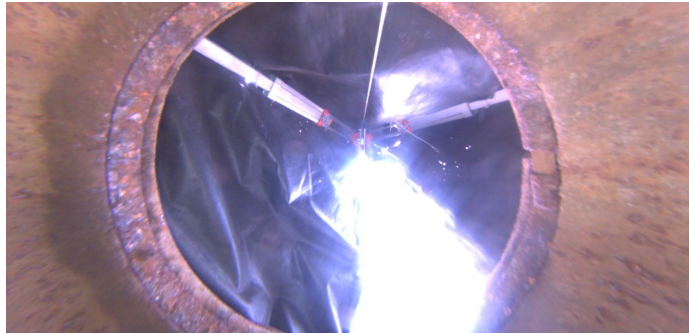
Code:	MGO
Description:	General Observation
Distance (ft):	1.4
Structural Grade:	0
O&M Grade:	0
Clock Start/From:	
Clock To:	
1st Value:	
2nd Value:	
Value Percent:	
Step:	NO
Remarks:	UNDERSIDE OF FRAME

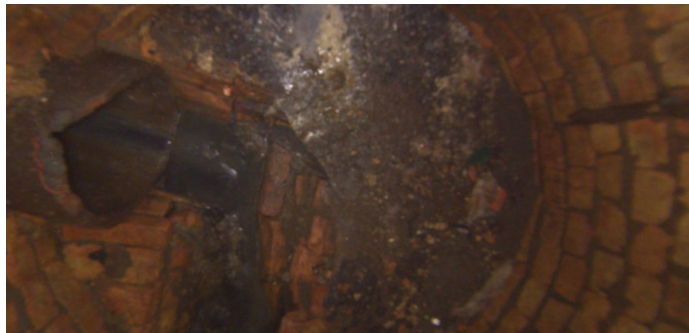
Code:	DSGV
Description:	Deposits Settled Gravel
Distance (ft):	8.3
Structural Grade:	0
O&M Grade:	2
Clock Start/From:	10
Clock To:	6
1st Value:	
2nd Value:	
Value Percent:	5.000
Step:	NO
Remarks:

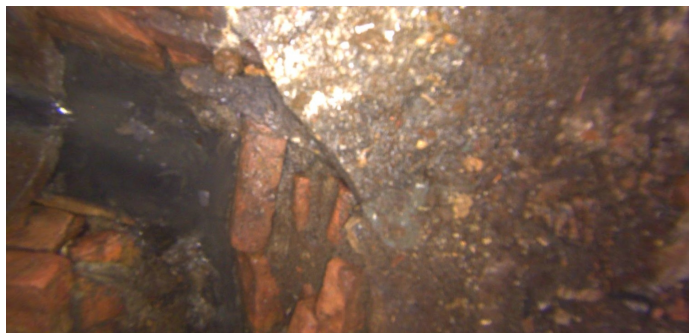
Code:	DB
Description:	Displaced Brick
Distance (ft):	9.7
Structural Grade:	3
O&M Grade:	0
Clock Start/From:	6
Clock To:	9
1st Value:	
2nd Value:	
Value Percent:	
Step:	NO
Remarks:
