Manhole Inspection Report

Date:	05/06/2018	Weather:		Coding:	RZMACP
MH#:	M-804-014	Owner:	NA	Len. Surveyed:	8.9
P.O.#:		Surveyor:	Jen Costello	Rim to Invert:	9.7
Customer:		Cert. #:	U-907-5518	Wall Material:	Brick

Street:	Home Ave. 56' West of Illinois St.	Project:	Hobart, IN
City:	Hobart, IN	GPS Northing:	2907376.015
Location:		GPS Easting:	2907376.015
Drain Area:	Northeast	GPS Accuracy:	Sub-Meter
Cover Shape:	Circular	Evidence of Surcharge:	No
Cover Size:	22.5	Potential for Runoff:	None
Comments:

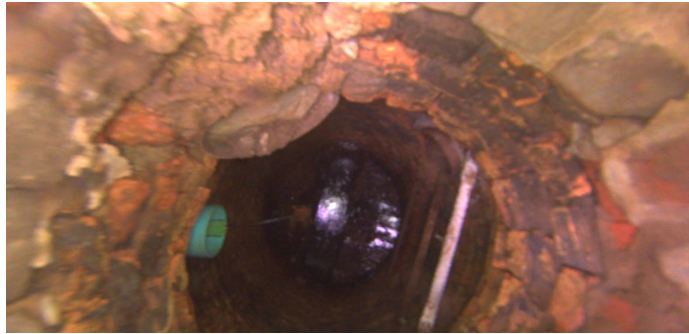
Code: **DAE**
Description: **Deposits Attached Encrustation**

Distance (ft): **1.1**
Structural Grade: **0**
O&M Grade: **2**
Clock Start/From: **11**
Clock To: **12**
1st Value:
2nd Value:
Value Percent: **5.000**
Step: **NO**
Remarks:

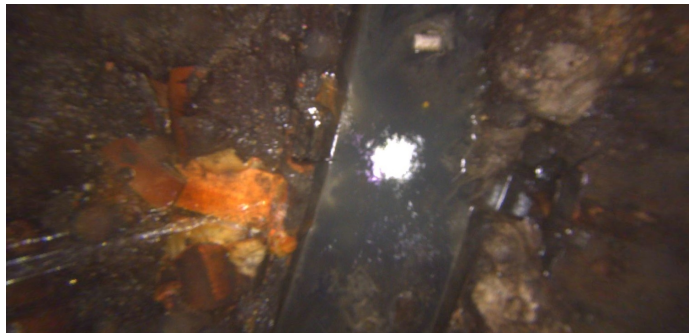
Code: **OBR**
Description: **Obstacle Rocks**

Distance (ft): **8.3**
Structural Grade: **0**
O&M Grade: **2**
Clock Start/From: **8**
Clock To: **10**
1st Value:
2nd Value:
Value Percent: **5.000**
Step: **NO**
Remarks:
