# Manhole Inspection Report

Date:	05/06/2018	Weather:		Coding:	RZMACP
MH#:	M-804-015	Owner:	NA	Len. Surveyed:	9.5
P.O.#:		Surveyor:	Jen Costello	Rim to Invert:	10.1
Customer:		Cert. #:	U-907-5518	Wall Material:	Brick

Street:	Home Ave. 115' West of Illinois St.	Project:	Hobart, IN
City:	Hobart, IN	GPS Northing:	2907267.207
Location:		GPS Easting:	2907267.207
Drain Area:	Northeast	GPS Accuracy:	Sub-Meter
Cover Shape:	Circular	Evidence of Surcharge:	No
Cover Size:	22.5	Potential for Runoff:	None
Comments:

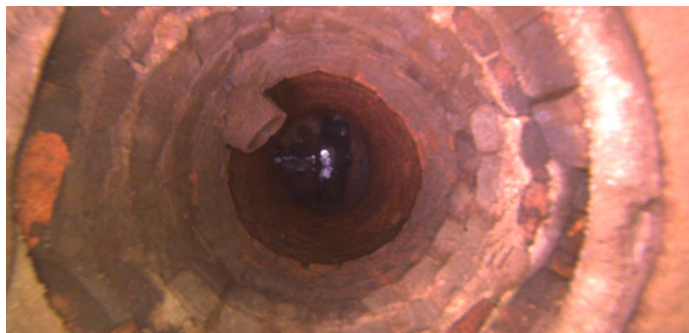
Code: **MGP**  
 Description: **General Photo**

Distance (ft): **.0**  
 Structural Grade: **0**  
 O&M Grade: **0**  
 Clock Start/From:  
 Clock To:  
 1st Value:  
 2nd Value:  
 Value Percent:  
 Step: **NO**  
 Remarks: **ACCESS MH**

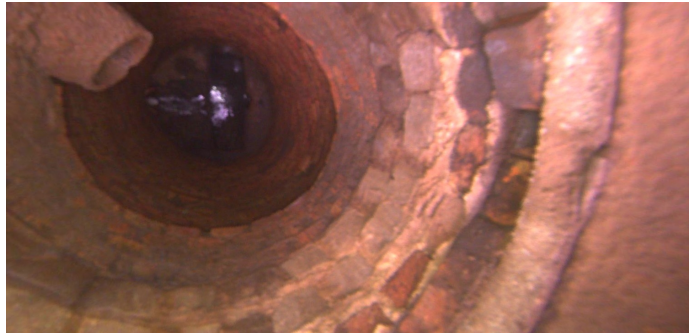
Code: **DB**  
Description: **Displaced Brick**

Distance (ft): **.4**  
Structural Grade: **3**  
O&M Grade: **0**  
Clock Start/From: **3**  
Clock To: **4**  
1st Value:  
2nd Value:  
Value Percent:  
Step: **NO**  
Remarks:

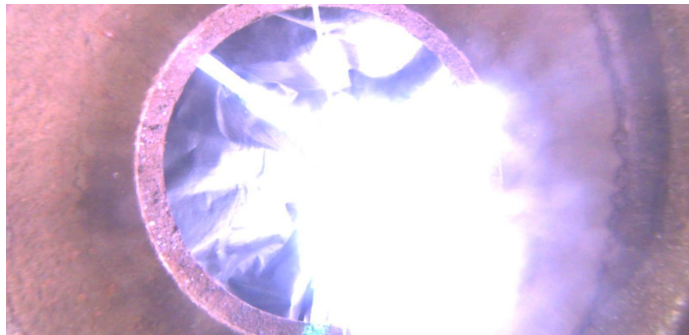
Code: **MGO**  
Description: **General Observation**

Distance (ft): **1.8**  
Structural Grade: **0**  
O&M Grade: **0**  
Clock Start/From:  
Clock To:  
1st Value:  
2nd Value:  
Value Percent:  
Step: **NO**  
Remarks: **UNDERSIDE OF FRAME**

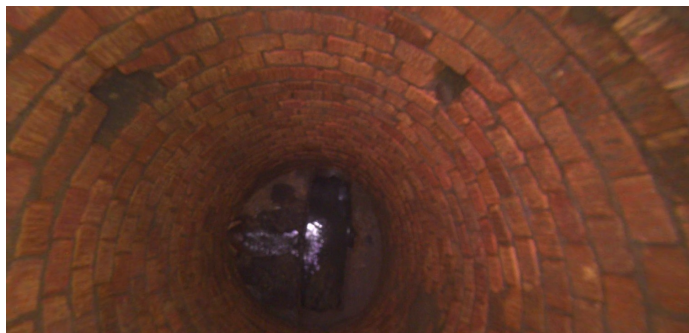
Code: **MB**  
Description: **Missing Brick**

Distance (ft): **3.3**  
Structural Grade: **4**  
O&M Grade: **0**  
Clock Start/From: **10**  
Clock To:  
1st Value:  
2nd Value:  
Value Percent:  
Step: **NO**  
Remarks:

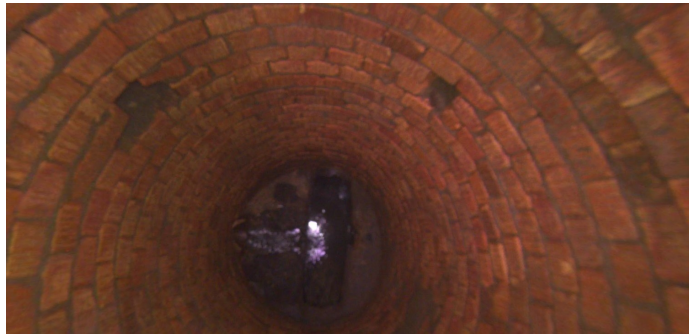
Code: **MB**  
Description: **Missing Brick**

Distance (ft): **3.3**  
Structural Grade: **4**  
O&M Grade: **0**  
Clock Start/From: **2**  
Clock To:  
1st Value:  
2nd Value:  
Value Percent:  
Step: **NO**  
Remarks:

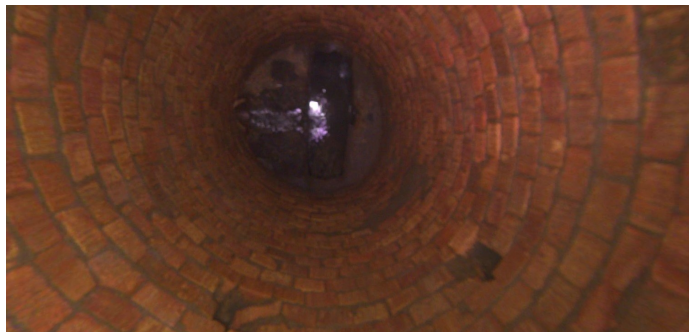
Code: **MB**  
Description: **Missing Brick**

Distance (ft): **3.3**  
Structural Grade: **4**  
O&M Grade: **0**  
Clock Start/From: **5**  
Clock To:  
1st Value:  
2nd Value:  
Value Percent:  
Step: **NO**  
Remarks:

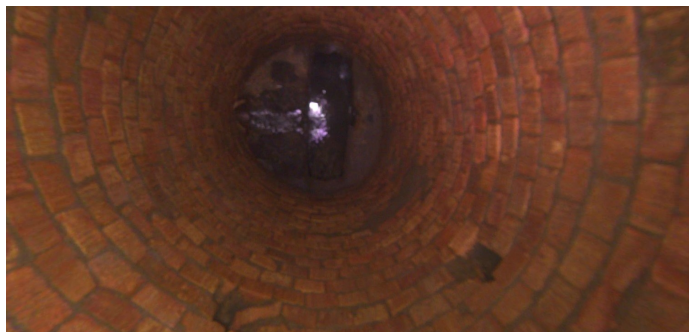
Code: **MB**  
Description: **Missing Brick**

Distance (ft): **3.3**  
Structural Grade: **4**  
O&M Grade: **0**  
Clock Start/From: **7**  
Clock To:  
1st Value:  
2nd Value:  
Value Percent:  
Step: **NO**  
Remarks:

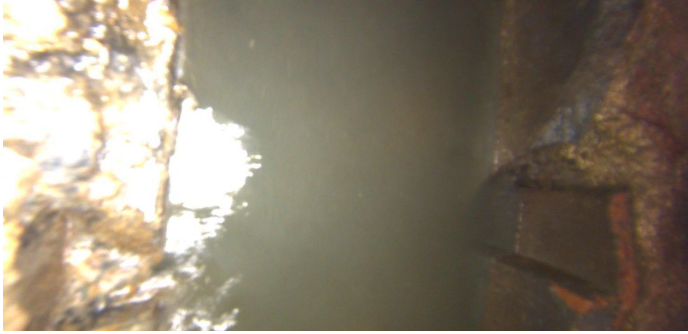
Code: **B**  
Description: **Broken**

Distance (ft): **9.5**  
Structural Grade: **3**  
O&M Grade: **0**  
Clock Start/From: **3**  
Clock To:  
1st Value:  
2nd Value:  
Value Percent:  
Step: **NO**  
Remarks:

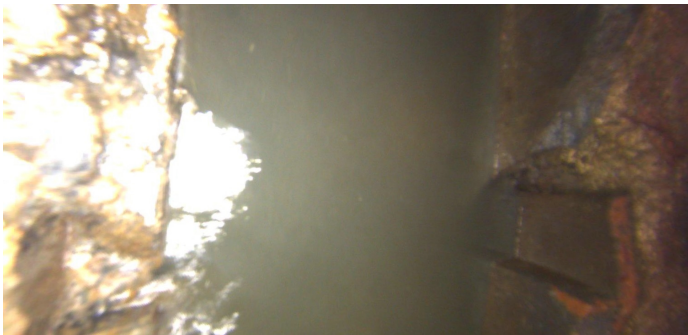
Code: **MGO**  
Description: **General Observation**

Distance (ft): **9.5**  
Structural Grade: **0**  
O&M Grade: **0**  
Clock Start/From:  
Clock To:  
1st Value:  
2nd Value:  
Value Percent:  
Step: **NO**  
Remarks: **END SURVEY**
