# Manhole Inspection Report

Date:	05/06/2018	Weather:		Coding:	RZMACP
MH#:	M-804-017	Owner:	NA	Len. Surveyed:	3.8
P.O.#:		Surveyor:	Jen Costello	Rim to Invert:	4.2
Customer:		Cert. #:	U-907-5518	Wall Material:	Concrete (reinforced)

Street:	353' South of Home Ave. 151' West	Project:	Hobart, IN
City:	Hobart, IN	GPS Northing:	2907236.244
Location:		GPS Easting:	2907236.244
Drain Area:	Northeast	GPS Accuracy:	Sub-Meter
Cover Shape:	Circular	Evidence of Surcharge:	No
Cover Size:	22.5	Potential for Runoff:	None
Comments:

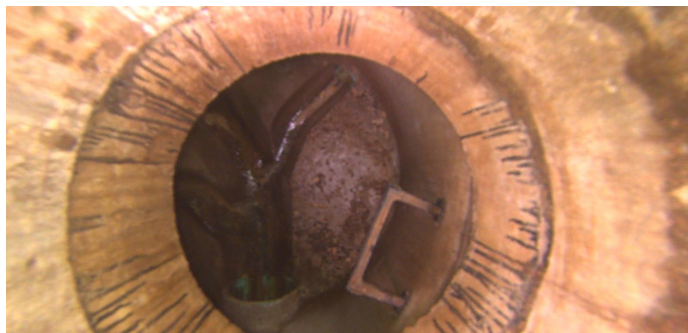
Code: **MGP**  
Description: **General Photo**

Distance (ft): **.0**  
Structural Grade: **0**  
O&M Grade: **0**  
Clock Start/From:  
Clock To:  
1st Value:  
2nd Value:  
Value Percent:  
Step: **NO**  
Remarks: **ACCESS MH**

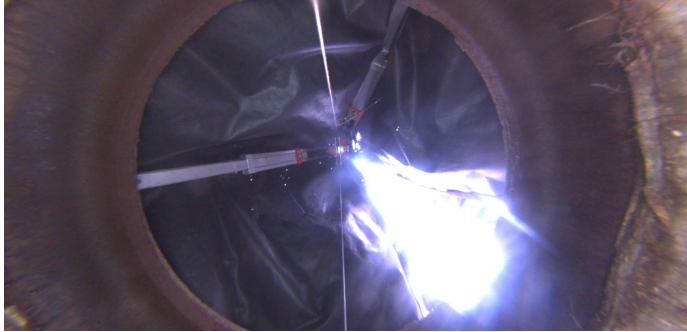
Code:	<b>MGO</b>
Description:	<b>General Observation</b>
Distance (ft):	<b>1.4</b>
Structural Grade:	<b>0</b>
O&M Grade:	<b>0</b>
Clock Start/From:	
Clock To:	
1st Value:	
2nd Value:	
Value Percent:	
Step:	<b>NO</b>
Remarks:	<b>UNDERSIDE OF FRAME</b>
