Manhole Inspection Report

Date:	05/06/2018	Weather:		Coding:	RZMACP
MH#:	M-804-018	Owner:	NA	Len. Surveyed:	8.5
P.O.#:		Surveyor:	Jen Costello	Rim to Invert:	10.1
Customer:		Cert. #:	U-907-5518	Wall Material:	Brick

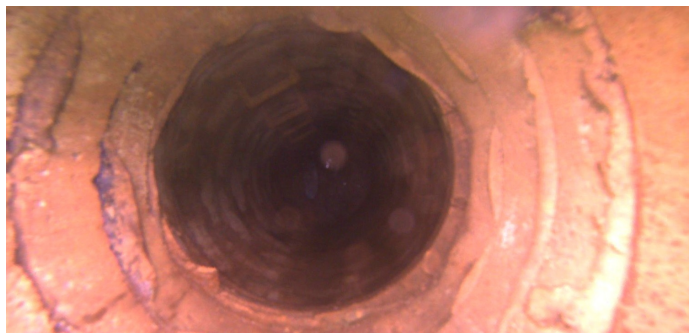
Code: **MGO**
Description: **General Observation**

Distance (ft): **.0**
Structural Grade: **0**
O&M Grade: **0**
Clock Start/From:
Clock To:
1st Value:
2nd Value:
Value Percent:
Step: **NO**
Remarks: **ACCESS MH**

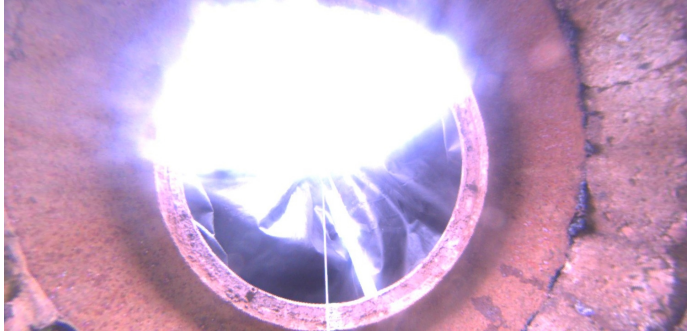
Code:	MGO
Description:	General Observation
Distance (ft):	1.6
Structural Grade:	0
O&M Grade:	0
Clock Start/From:	
Clock To:	
1st Value:	
2nd Value:	
Value Percent:	
Step:	NO
Remarks:	UNDERSIDE OF FRAME

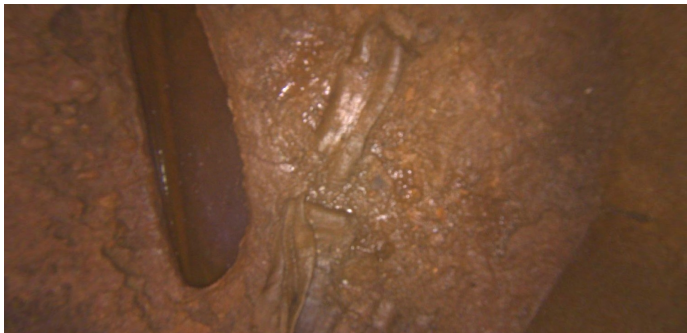
Code:	DSF
Description:	Deposits Settled Fine
Distance (ft):	8.5
Structural Grade:	0
O&M Grade:	2
Clock Start/From:	12
Clock To:	12
1st Value:	
2nd Value:	
Value Percent:	5.000
Step:	NO
Remarks:
