# Manhole Inspection Report

Date:	<b>05/16/2018</b>	Weather:		Coding:	<b>RZMACP</b>
MH#:	<b>M-804-020</b>	Owner:	<b>NA</b>	Len. Surveyed:	<b>6.1</b>
P.O.#:		Surveyor:	<b>Jen Costello</b>	Rim to Invert:	<b>6.8</b>
Customer:		Cert. #:	<b>U-907-5518</b>	Wall Material:	<b>Brick</b>

Street:	<b>308' South of Hickey St. and 167' We</b>	Project:	<b>Hobart, IN</b>
City:	<b>Hobart, IN</b>	GPS Northing:	<b>2907254.48</b>
Location:		GPS Easting:	<b>2907254.48</b>
Drain Area:	<b>Northeast</b>	GPS Accuracy:	<b>Sub-Meter</b>
Cover Shape:	<b>Circular</b>	Evidence of Surcharge:	<b>No</b>
Cover Size:	<b>22.5</b>	Potential for Runoff:	<b>None</b>
Comments:

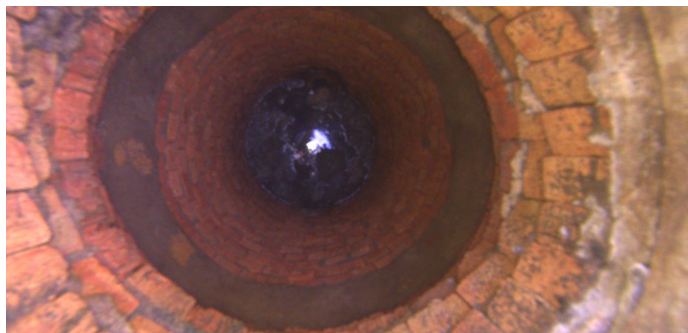
Code: **MGO**  
Description: **General Observation**

Distance (ft): **.0**  
Structural Grade: **0**  
O&M Grade: **0**  
Clock Start/From:  
Clock To:  
1st Value:  
2nd Value:  
Value Percent:  
Step: **NO**  
Remarks: **ACCESS MH**

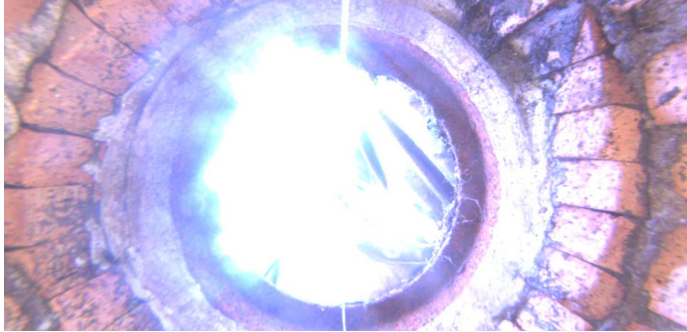
Code:	<b>MGO</b>
Description:	<b>General Observation</b>
Distance (ft):	<b>2.2</b>
Structural Grade:	<b>0</b>
O&M Grade:	<b>0</b>
Clock Start/From:	
Clock To:	
1st Value:	
2nd Value:	
Value Percent:	
Step:	<b>NO</b>
Remarks:	<b>UNDERSIDE OF FRAME</b>

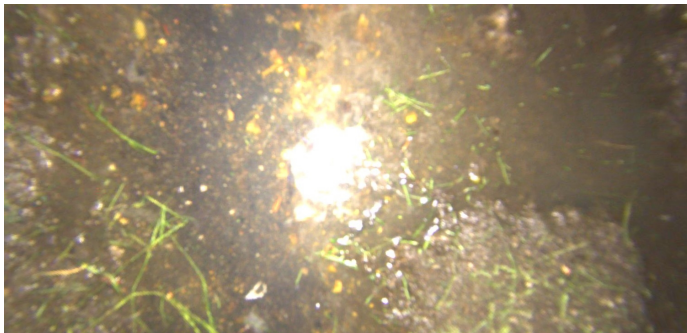
Code:	<b>MGO</b>
Description:	<b>General Observation</b>
Distance (ft):	<b>6.1</b>
Structural Grade:	<b>0</b>
O&M Grade:	<b>0</b>
Clock Start/From:	
Clock To:	
1st Value:	
2nd Value:	
Value Percent:	
Step:	<b>NO</b>
Remarks:	<b>END SURVEY</b>
