Manhole Inspection Report

Date:	10/11/2022	Weather:		Coding:	RZMACP
MH#:	M-804-022	Owner:	NA	Len. Surveyed:	15.7
P.O.#:		Surveyor:	Jen Costello	Rim to Invert:	17.5
Customer:		Cert. #:	U-907-5518	Wall Material:	Concrete (precast)

Street:	Illinois St. and Hickey St.	Project:	Hobart, IN
City:	Hobart, IN	GPS Northing:	2291738.647
Location:	Yard	GPS Easting:	2907422.002
Drain Area:	Northeast	GPS Accuracy:	Sub-Meter
Cover Shape:	Circular	Evidence of Surcharge:	No
Cover Size:	24.0	Potential for Runoff:	None
Comments:

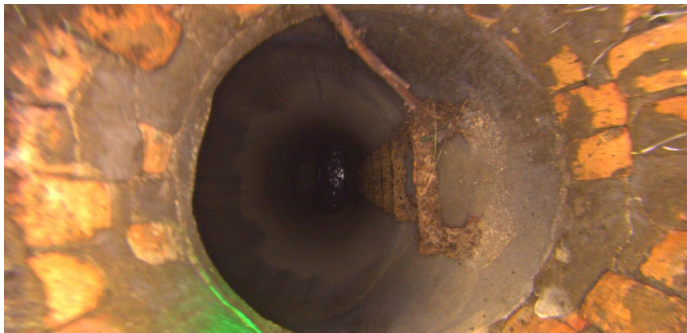
Code: **MGO**
Description: **General Observation**

Distance (ft): **.0**
Structural Grade: **0**
O&M Grade: **0**
Clock Start/From:
Clock To:
1st Value:
2nd Value:
Value Percent:
Step: **NO**
Remarks: **access mh**

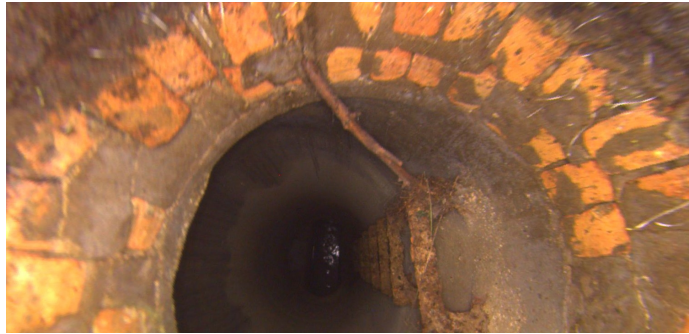
Code: **OBZ**
Description: **Obstacle Other**

Distance (ft): **.0**
Structural Grade: **0**
O&M Grade: **2**
Clock Start/From: **12**
Clock To:
1st Value:
2nd Value:
Value Percent: **5.000**
Step: **NO**
Remarks: **stick**

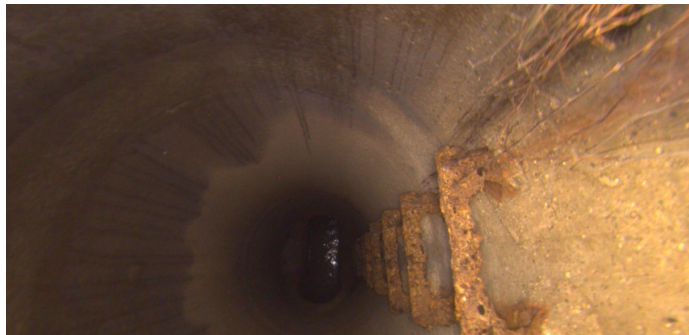
Code: **MMC**
Description: **Material Change**

Distance (ft): **2.0**
Structural Grade: **0**
O&M Grade: **0**
Clock Start/From:
Clock To:
1st Value:
2nd Value:
Value Percent:
Step: **NO**
Remarks: **concrete**

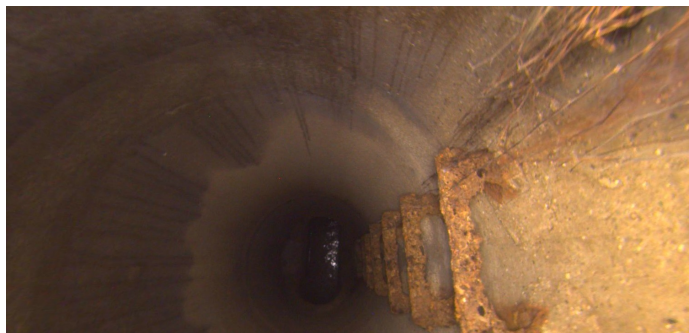
Code: **SRI**
Description: **Surface Roughness Increased**

Distance (ft): **2.0**
Structural Grade: **1**
O&M Grade: **0**
Clock Start/From: **12**
Clock To: **12**
1st Value:
2nd Value:
Value Percent:
Step: **NO**
Remarks:

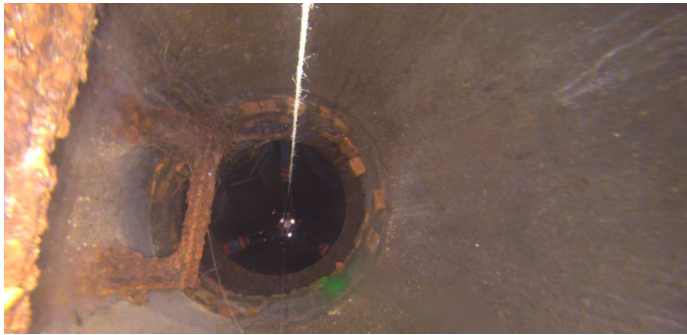
Code: **MGO**
Description: **General Observation**

Distance (ft): **4.2**
Structural Grade: **0**
O&M Grade: **0**
Clock Start/From:
Clock To:
1st Value:
2nd Value:
Value Percent:
Step: **NO**
Remarks: **underside of frame**

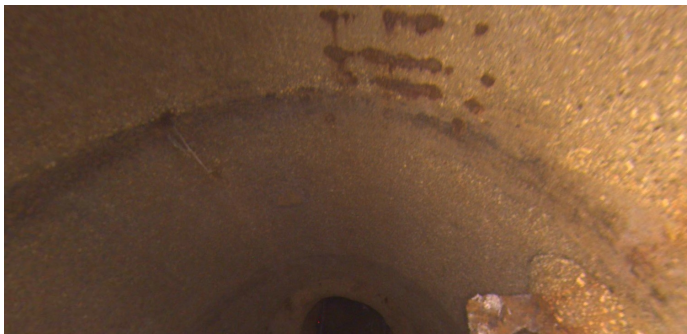
Code: **SRV**
Description: **Surface Reinforcement Visible**

Distance (ft): **9.6**
Structural Grade: **5**
O&M Grade: **0**
Clock Start/From: **12**
Clock To: **1**
1st Value:
2nd Value:
Value Percent:
Step: **NO**
Remarks:

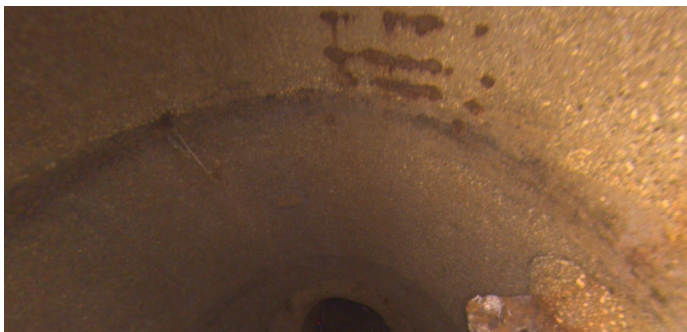
Code: **RFJ**
Description: **Roots Fine Joint**

Distance (ft): **9.6**
Structural Grade: **0**
O&M Grade: **1**
Clock Start/From: **12**
Clock To:
1st Value:
2nd Value:
Value Percent:
Step: **NO**
Remarks:

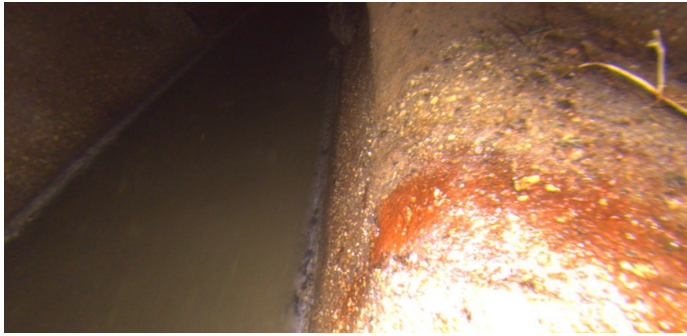
Code: **SAV**
Description: **Surface Aggregate Visible**

Distance (ft): **15.7**
Structural Grade: **3**
O&M Grade: **0**
Clock Start/From: **12**
Clock To: **12**
1st Value:
2nd Value:
Value Percent:
Step: **NO**
Remarks:

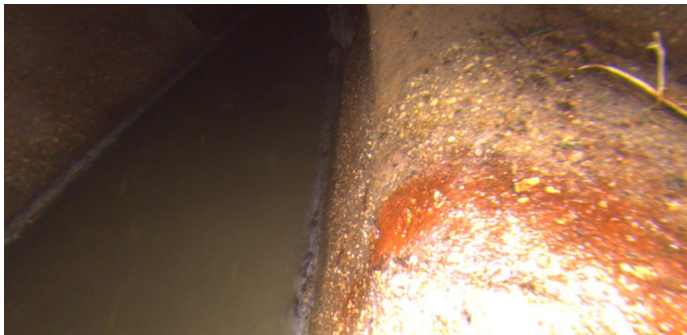
Code: **SAV**
Description: **Surface Aggregate Visible**

Distance (ft): **15.7**
Structural Grade: **3**
O&M Grade: **0**
Clock Start/From: **3**
Clock To: **9**
1st Value:
2nd Value:
Value Percent:
Step: **NO**
Remarks:

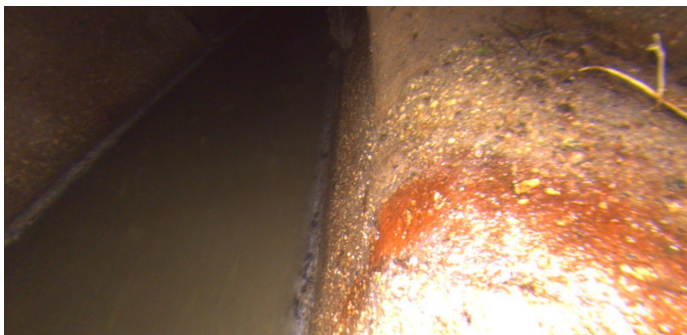
Code: **SRI**
Description: **Surface Roughness Increased**

Distance (ft): **15.7**
Structural Grade: **1**
O&M Grade: **0**
Clock Start/From: **12**
Clock To: **12**
1st Value:
2nd Value:
Value Percent:
Step: **NO**
Remarks:

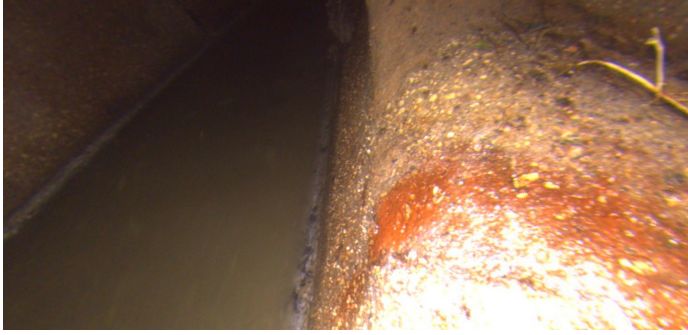
Code:	MGO
Description:	General Observation
Distance (ft):	15.7
Structural Grade:	0
O&M Grade:	0
Clock Start/From:	
Clock To:	
1st Value:	
2nd Value:	
Value Percent:	
Step:	NO
Remarks:	end of survey
