# Manhole Inspection Report

Date:	05/15/2018	Weather:		Coding:	RZMACP
MH#:	M-804-029	Owner:	NA	Len. Surveyed:	13.1
P.O.#:		Surveyor:	Jen Costello	Rim to Invert:	14.7
Customer:		Cert. #:	U-907-5518	Wall Material:	Concrete (reinforced)

Street:	Intersection of Hickey St. and Lawre	Project:	Hobart, IN
City:	Hobart, IN	GPS Northing:	2909399.889
Location:		GPS Easting:	2909399.889
Drain Area:	Northeast	GPS Accuracy:	Sub-Meter
Cover Shape:	Circular	Evidence of Surcharge:	No
Cover Size:	22.5	Potential for Runoff:	None
Comments:

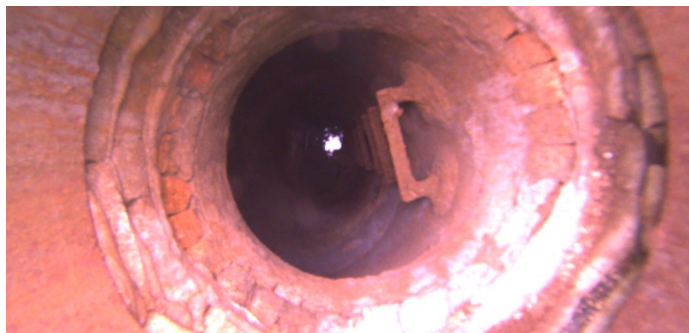
Code: **MGP**  
 Description: **General Photo**

Distance (ft): **.0**  
 Structural Grade: **0**  
 O&M Grade: **0**  
 Clock Start/From:  
 Clock To:  
 1st Value:  
 2nd Value:  
 Value Percent:  
 Step: **NO**  
 Remarks: **ACCESS MH**

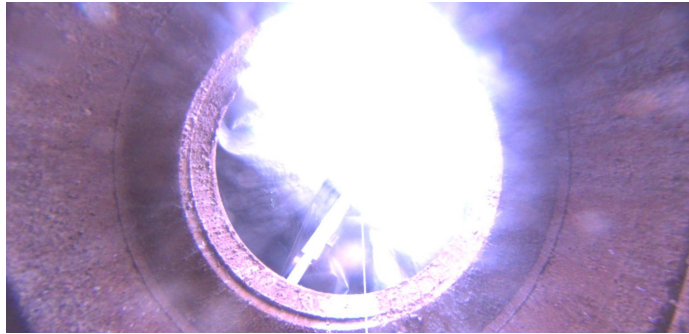
Code: **MGO**  
Description: **General Observation**

Distance (ft): **1.6**  
Structural Grade: **0**  
O&M Grade: **0**  
Clock Start/From:  
Clock To:  
1st Value:  
2nd Value:  
Value Percent:  
Step: **NO**  
Remarks: **UNDERSIDE OF FRAME**

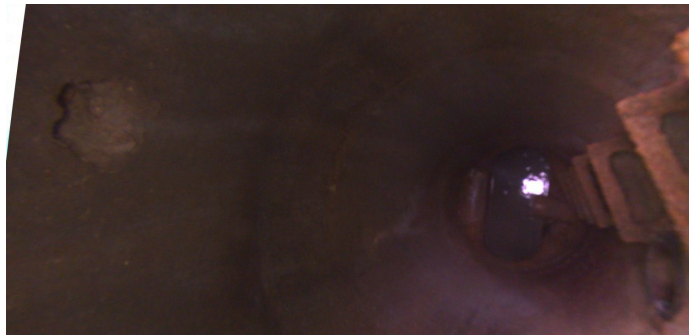
Code: **HSV**  
Description: **Hole Soil Visible**

Distance (ft): **2.6**  
Structural Grade: **5**  
O&M Grade: **0**  
Clock Start/From: **9**  
Clock To:  
1st Value:  
2nd Value:  
Value Percent:  
Step: **NO**  
Remarks:

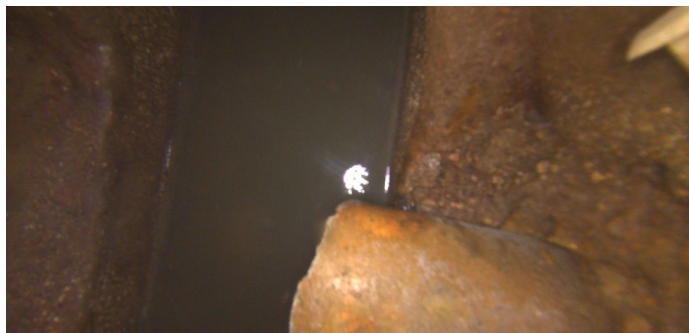
Code: **MGO**  
Description: **General Observation**

Distance (ft): **13.1**  
Structural Grade: **0**  
O&M Grade: **0**  
Clock Start/From:  
Clock To:  
1st Value:  
2nd Value:  
Value Percent:  
Step: **NO**  
Remarks: **END SURVEY**
