Manhole Inspection Report

Date:	05/15/2018	Weather:		Coding:	RZMACP
MH#:	M-804-032	Owner:	NA	Len. Surveyed:	12.0
P.O.#:		Surveyor:	Jen Costello	Rim to Invert:	12.3
Customer:		Cert. #:	U-907-5518	Wall Material:	Concrete (reinforced)

Street:	Hickey St. 43' West of Hwy 51.	Project:	Hobart, IN
City:	Hobart, IN	GPS Northing:	2909694.402
Location:		GPS Easting:	2909694.402
Drain Area:	Northeast	GPS Accuracy:	Sub-Meter
Cover Shape:	Circular	Evidence of Surcharge:	No
Cover Size:	22.5	Potential for Runoff:	None
Comments:

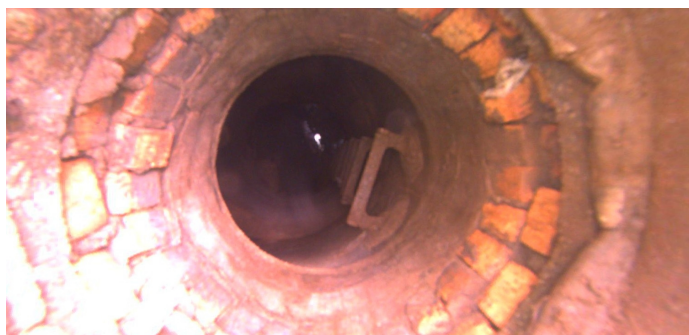
Code: **MGP**
Description: **General Photo**

Distance (ft): **.0**
Structural Grade: **0**
O&M Grade: **0**
Clock Start/From:
Clock To:
1st Value:
2nd Value:
Value Percent:
Step: **NO**
Remarks: **ACCESS MH**

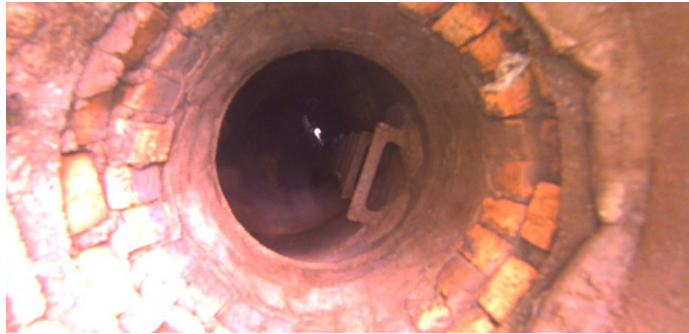
Code: **DB**
Description: **Displaced Brick**

Distance (ft): **.0**
Structural Grade: **3**
O&M Grade: **0**
Clock Start/From: **12**
Clock To: **12**
1st Value:
2nd Value:
Value Percent:
Step: **NO**
Remarks:

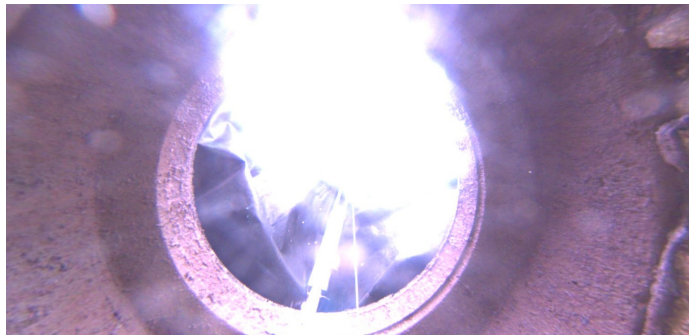
Code: **MGO**
Description: **General Observation**

Distance (ft): **1.5**
Structural Grade: **0**
O&M Grade: **0**
Clock Start/From:
Clock To:
1st Value:
2nd Value:
Value Percent:
Step: **NO**
Remarks: **UNDERSIDE OF FRAME**

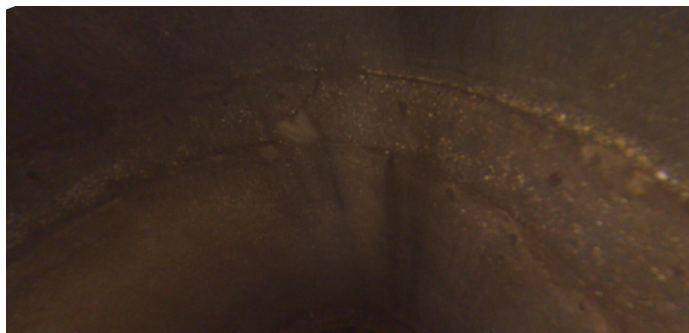
Code: **IW**
Description: **Infil Weeper**

Distance (ft): **4.5**
Structural Grade: **0**
O&M Grade: **2**
Clock Start/From: **12**
Clock To:
1st Value:
2nd Value:
Value Percent:
Step: **NO**
Remarks:

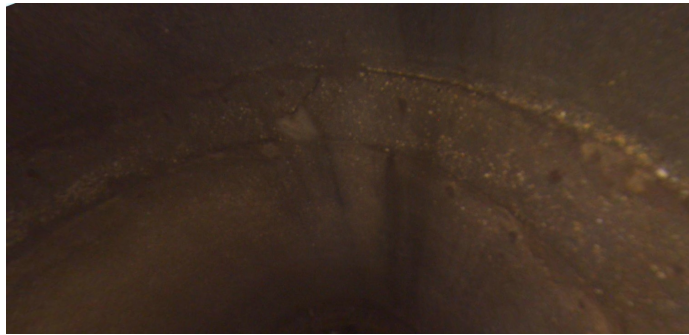
Code: **FS**
Description: **Fracture Spiral**

Distance (ft): **4.5**
Structural Grade: **3**
O&M Grade: **0**
Clock Start/From: **11**
Clock To: **12**
1st Value:
2nd Value:
Value Percent:
Step: **NO**
Remarks:

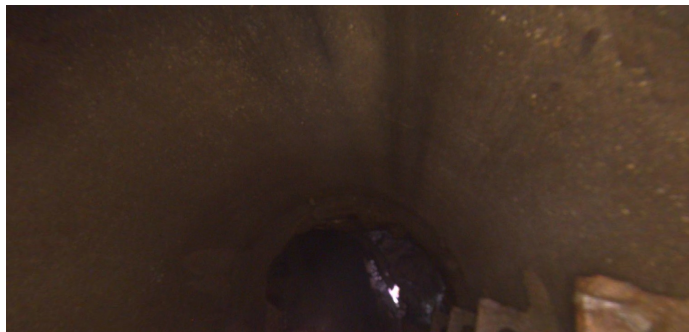
Code: **SAV**
Description: **Surface Aggregate Visible**

Distance (ft): **5.4**
Structural Grade: **3**
O&M Grade: **0**
Clock Start/From: **12**
Clock To: **12**
1st Value:
2nd Value:
Value Percent:
Step: **NO**
Remarks:

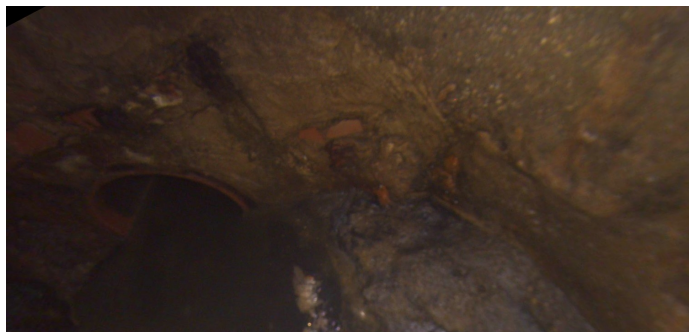
Code: **DAE**
Description: **Deposits Attached Encrustation**

Distance (ft): **10.9**
Structural Grade: **0**
O&M Grade: **2**
Clock Start/From: **11**
Clock To: **3**
1st Value:
2nd Value:
Value Percent: **5.000**
Step: **NO**
Remarks:

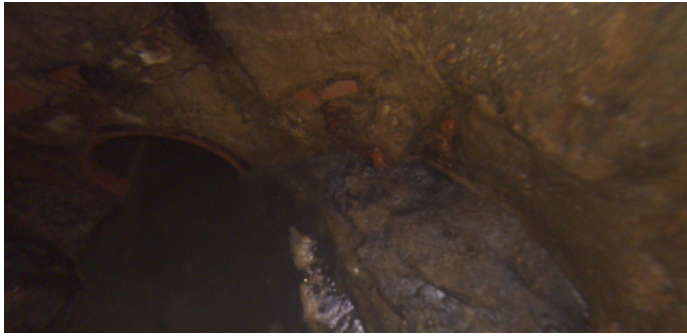
Code: **IW**
Description: **Infil Weeper**

Distance (ft): **10.9**
Structural Grade: **0**
O&M Grade: **2**
Clock Start/From: **12**
Clock To:
1st Value:
2nd Value:
Value Percent:
Step: **NO**
Remarks:

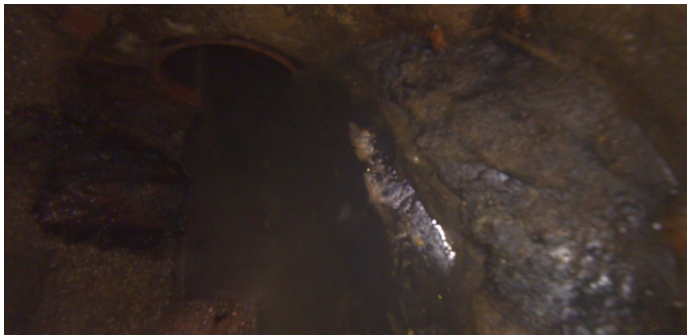
Code: **IW**
Description: **Infil Weeper**

Distance (ft): **10.9**
Structural Grade: **0**
O&M Grade: **2**
Clock Start/From: **9**
Clock To:
1st Value:
2nd Value:
Value Percent:
Step: **NO**
Remarks:

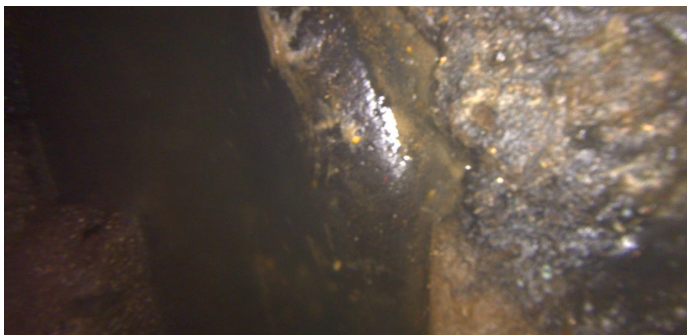
Code: **MGO**
Description: **General Observation**

Distance (ft): **12.0**
Structural Grade: **0**
O&M Grade: **0**
Clock Start/From:
Clock To:
1st Value:
2nd Value:
Value Percent:
Step: **NO**
Remarks: **END SURVEY**
