# Manhole Inspection Report

Date:	<b>05/15/2018</b>	Weather:		Coding:	<b>RZMACP</b>
MH#:	<b>M-804-033</b>	Owner:	<b>NA</b>	Len. Surveyed:	<b>13.8</b>
P.O.#:		Surveyor:	<b>Jen Costello</b>	Rim to Invert:	<b>14.3</b>
Customer:		Cert. #:	<b>U-907-5518</b>	Wall Material:	<b>Concrete (reinforced)</b>

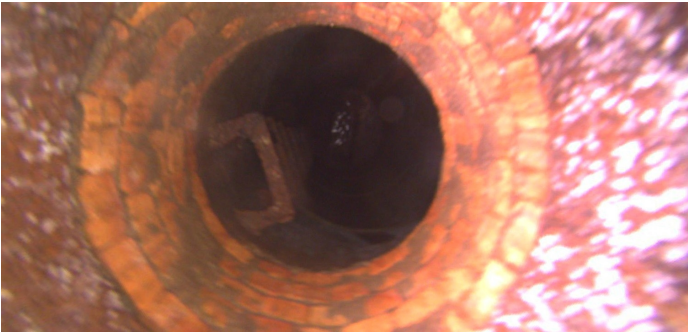
Code:	MGP
Description:	General Photo
Distance (ft):	.0
Structural Grade:	0
O&M Grade:	0
Clock Start/From:	
Clock To:	
1st Value:	
2nd Value:	
Value Percent:	
Step:	NO
Remarks:	access MH

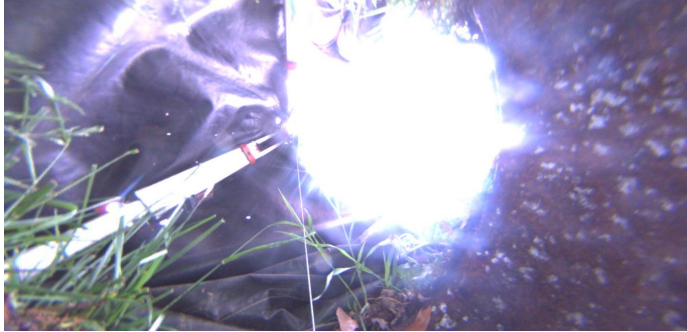
Code: **MGO**  
Description: **General Observation**

Distance (ft): **1.1**  
Structural Grade: **0**  
O&M Grade: **0**  
Clock Start/From:  
Clock To:  
1st Value:  
2nd Value:  
Value Percent:  
Step: **NO**  
Remarks: **UNDERSIDE OF FRAME**

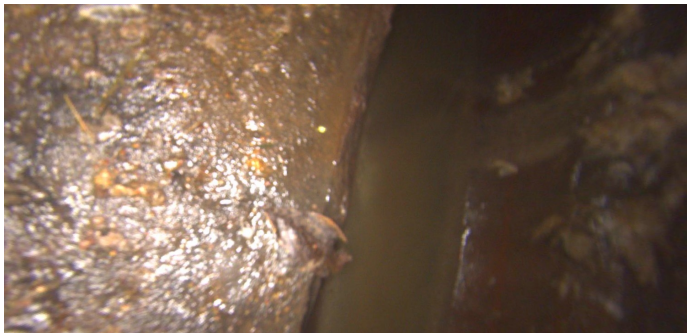
Code: **MGO**  
Description: **General Observation**

Distance (ft): **13.8**  
Structural Grade: **0**  
O&M Grade: **0**  
Clock Start/From:  
Clock To:  
1st Value:  
2nd Value:  
Value Percent:  
Step: **NO**  
Remarks: **END SURVEY**
