# Manhole Inspection Report

Date:	05/15/2018	Weather:		Coding:	RZMACP
MH#:	M-804-035	Owner:	NA	Len. Surveyed:	13.4
P.O.#:		Surveyor:	Jen Costello	Rim to Invert:	15.3
Customer:		Cert. #:	U-907-5518	Wall Material:	Concrete (reinforced)

Street:	129' South of Division St. 208' West	Project:	Hobart, IN
City:	Hobart, IN	GPS Northing:	2909522.997
Location:		GPS Easting:	2909522.997
Drain Area:	Northeast	GPS Accuracy:	Sub-Meter
Cover Shape:	Circular	Evidence of Surcharge:	No
Cover Size:	22.5	Potential for Runoff:	None
Comments:

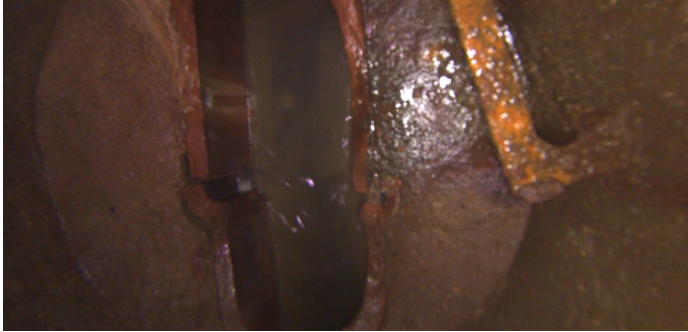
Code:	<b>MGO</b>
Description:	<b>General Observation</b>
Distance (ft):	<b>13.4</b>
Structural Grade:	<b>0</b>
O&M Grade:	<b>0</b>
Clock Start/From:	
Clock To:	
1st Value:	
2nd Value:	
Value Percent:	
Step:	<b>NO</b>
Remarks:	<b>ACCESS MH</b>
