Manhole Inspection Report

Date:	05/15/2018	Weather:		Coding:	RZMACP
MH#:	M-804-039	Owner:	NA	Len. Surveyed:	8.5
P.O.#:		Surveyor:	Jen Costello	Rim to Invert:	9.2
Customer:		Cert. #:	U-907-5518	Wall Material:	Concrete (reinforced)

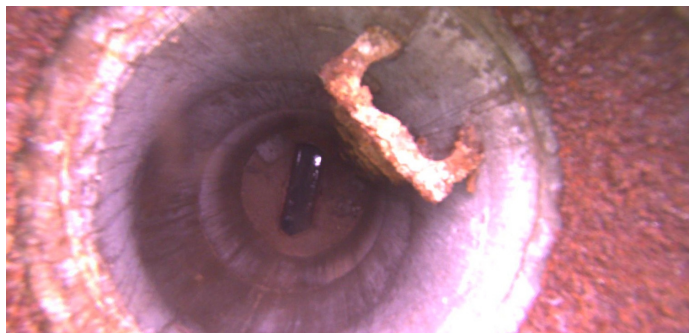
Code: **MGP**
Description: **General Photo**

Distance (ft): **.0**
Structural Grade: **0**
O&M Grade: **0**
Clock Start/From:
Clock To:
1st Value:
2nd Value:
Value Percent:
Step: **NO**
Remarks: **ACCESS MH**

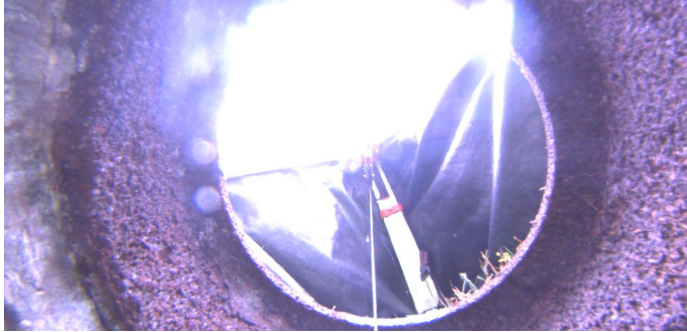
Code:	MGO
Description:	General Observation
Distance (ft):	1.9
Structural Grade:	0
O&M Grade:	0
Clock Start/From:	
Clock To:	
1st Value:	
2nd Value:	
Value Percent:	
Step:	NO
Remarks:	UNDERSIDE OF FRAME

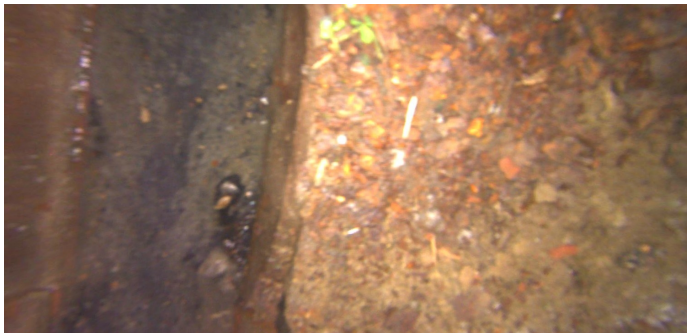
Code:	MGO
Description:	General Observation
Distance (ft):	8.5
Structural Grade:	0
O&M Grade:	0
Clock Start/From:	
Clock To:	
1st Value:	
2nd Value:	
Value Percent:	
Step:	NO
Remarks:	END SURVEY
