Manhole Inspection Report

Date:	05/15/2018	Weather:		Coding:	RZMACP
MH#:	M-804-040	Owner:	NA	Len. Surveyed:	8.0
P.O.#:		Surveyor:	Jen Costello	Rim to Invert:	8.4
Customer:		Cert. #:	U-907-5518	Wall Material:	Concrete (reinforced)

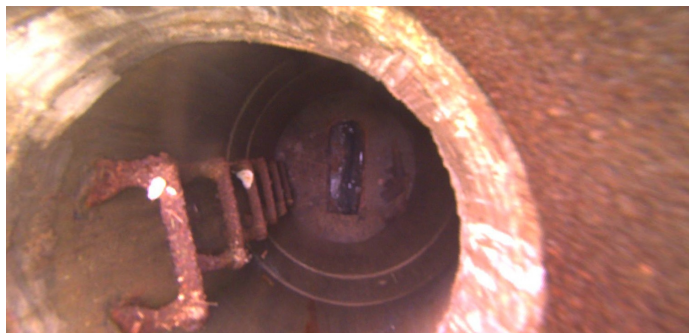
Code: **MGP**
Description: **General Photo**

Distance (ft): **.0**
Structural Grade: **0**
O&M Grade: **0**
Clock Start/From:
Clock To:
1st Value:
2nd Value:
Value Percent:
Step: **NO**
Remarks: **ACCESS MH**

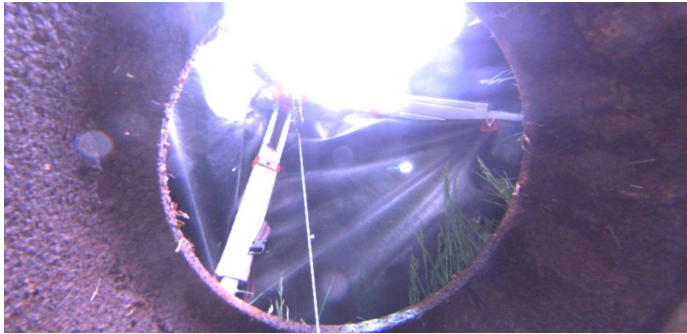
Code: **MGO**
Description: **General Observation**

Distance (ft): **1.5**
Structural Grade: **0**
O&M Grade: **0**
Clock Start/From:
Clock To:
1st Value:
2nd Value:
Value Percent:
Step: **NO**
Remarks: **UNDERSIDE OF FRAME**

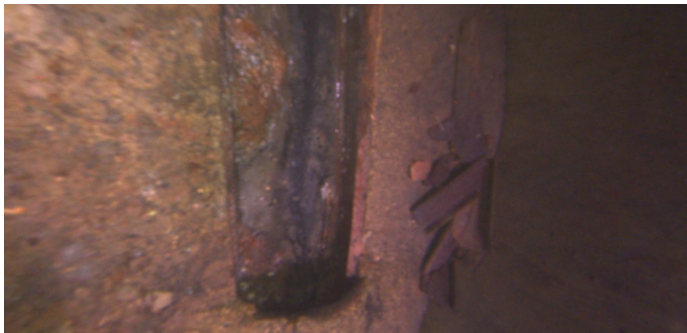
Code: **OBZ**
Description: **Obstacle Other**

Distance (ft): **6.3**
Structural Grade: **0**
O&M Grade: **2**
Clock Start/From: **3**
Clock To: **4**
1st Value:
2nd Value:
Value Percent: **5.000**
Step: **NO**
Remarks: **MISC**

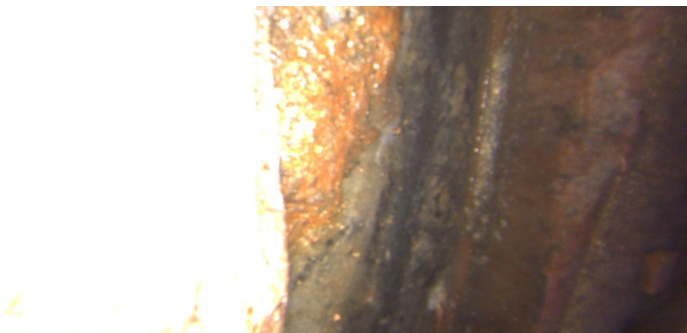
Code: **MGO**
Description: **General Observation**

Distance (ft): **8.0**
Structural Grade: **0**
O&M Grade: **0**
Clock Start/From:
Clock To:
1st Value:
2nd Value:
Value Percent:
Step: **NO**
Remarks: **END SURVEY**
