Manhole Inspection Report

Date:	10/08/2022	Weather:		Coding:	RZMACP
MH#:	M-804-042	Owner:	NA	Len. Surveyed:	8.8
P.O.#:		Surveyor:	Jen Costello	Rim to Invert:	9.5
Customer:		Cert. #:	U-907-5518	Wall Material:	Concrete (cast in place)

Street:	98' East of Liberty Pl. 168' South of	Project:	Hobart, IN
City:	Hobart, IN	GPS Northing:	2292892.314
Location:	Other	GPS Easting:	2909147.042
Drain Area:	Northeast	GPS Accuracy:	Sub-Meter
Cover Shape:	Circular	Evidence of Surcharge:	No
Cover Size:	24.0	Potential for Runoff:	None
Comments:

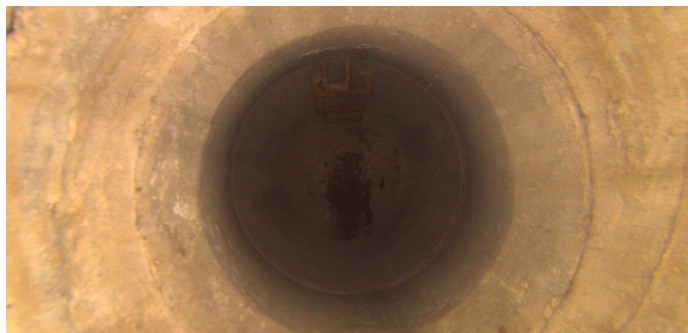
Code: **MGO**
Description: **General Observation**

Distance (ft): **.0**
Structural Grade: **0**
O&M Grade: **0**
Clock Start/From:
Clock To:
1st Value:
2nd Value:
Value Percent:
Step: **NO**
Remarks: **access mh**

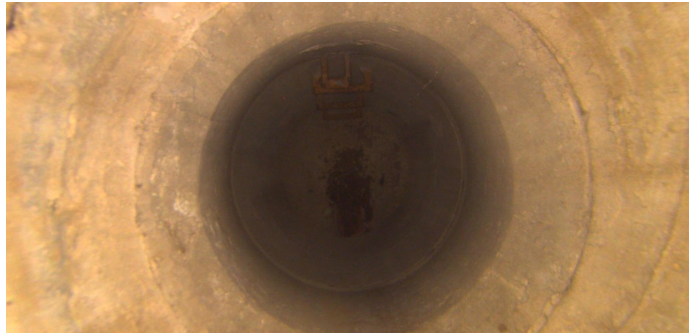
Code: **SRI**
Description: **Surface Roughness Increased**

Distance (ft): **.0**
Structural Grade: **1**
O&M Grade: **0**
Clock Start/From: **12**
Clock To: **12**
1st Value:
2nd Value:
Value Percent:
Step: **NO**
Remarks:

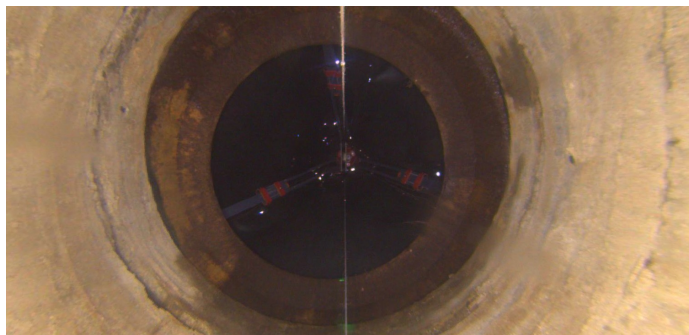
Code: **MGO**
Description: **General Observation**

Distance (ft): **2.1**
Structural Grade: **0**
O&M Grade: **0**
Clock Start/From:
Clock To:
1st Value:
2nd Value:
Value Percent:
Step: **NO**
Remarks: **underside of frame**

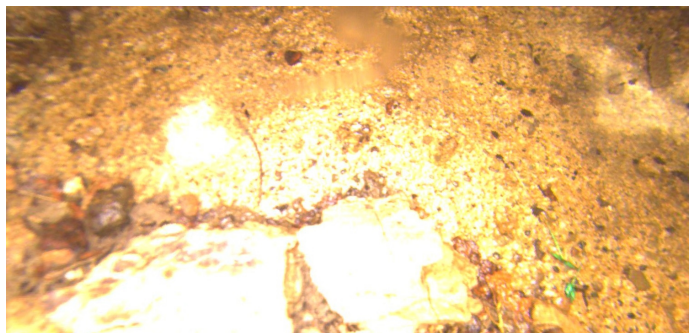
Code: **SAV**
Description: **Surface Aggregate Visible**

Distance (ft): **8.8**
Structural Grade: **3**
O&M Grade: **0**
Clock Start/From: **12**
Clock To: **12**
1st Value:
2nd Value:
Value Percent:
Step: **NO**
Remarks:

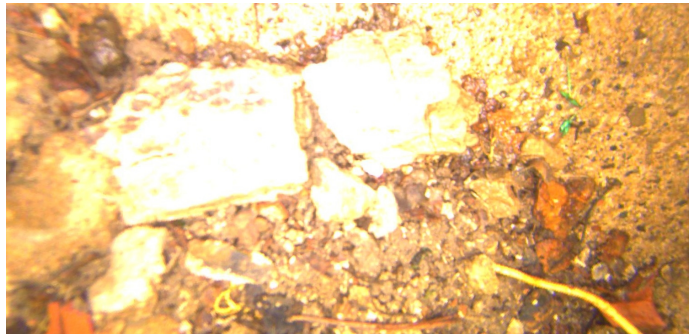
Code: **OBR**
Description: **Obstacle Rocks**

Distance (ft): **8.8**
Structural Grade: **0**
O&M Grade: **5**
Clock Start/From: **3**
Clock To: **9**
1st Value:
2nd Value:
Value Percent: **40.000**
Step: **NO**
Remarks:

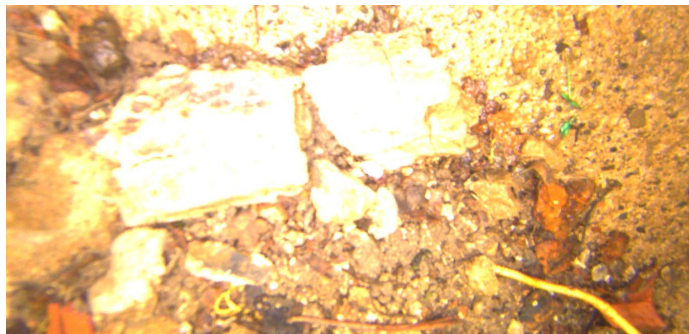
Code: **MGO**
Description: **General Observation**

Distance (ft): **8.8**
Structural Grade: **0**
O&M Grade: **0**
Clock Start/From:
Clock To:
1st Value:
2nd Value:
Value Percent:
Step: **NO**
Remarks: **end of survey**

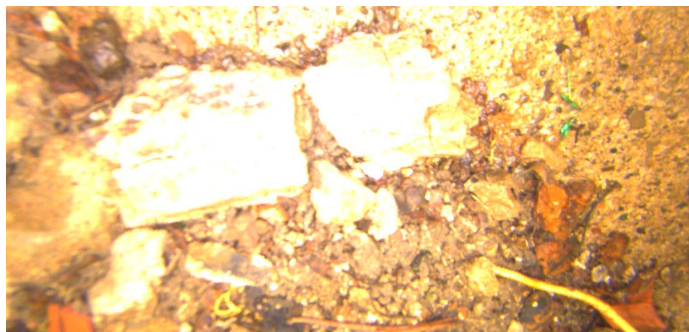
Code: **SRI**
Description: **Surface Roughness Increased**

Distance (ft): **8.8**
Structural Grade: **1**
O&M Grade: **0**
Clock Start/From: **12**
Clock To: **12**
1st Value:
2nd Value:
Value Percent:
Step: **NO**
Remarks:
