Manhole Inspection Report

Date:	05/15/2018	Weather:		Coding:	RZMACP
MH#:	M-804-046	Owner:	NA	Len. Surveyed:	4.7
P.O.#:		Surveyor:	Jen Costello	Rim to Invert:	5.3
Customer:		Cert. #:	U-907-5518	Wall Material:	Concrete (reinforced)

Street:	166' South of High St. 367' West of L	Project:	Hobart, IN
City:	Hobart, IN	GPS Northing:	2908686.338
Location:		GPS Easting:	2908686.338
Drain Area:	Northeast	GPS Accuracy:	Sub-Meter
Cover Shape:	Circular	Evidence of Surcharge:	No
Cover Size:	22.5	Potential for Runoff:	None
Comments:

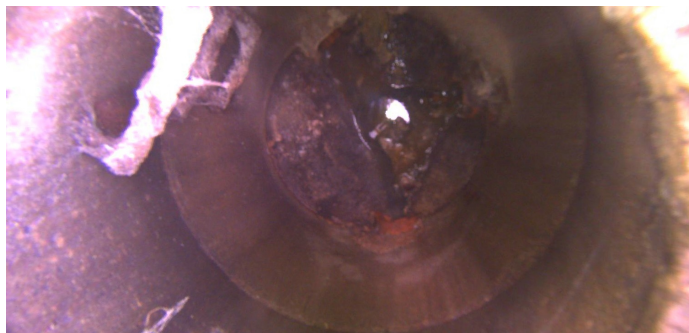
Code: **MGP**
Description: **General Photo**

Distance (ft): **.0**
Structural Grade: **0**
O&M Grade: **0**
Clock Start/From:
Clock To:
1st Value:
2nd Value:
Value Percent:
Step: **NO**
Remarks: **ACCESS MH**

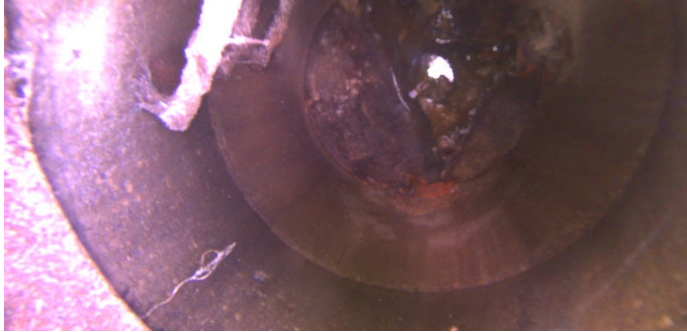
Code: **RFJ**
Description: **Roots Fine Joint**

Distance (ft): **.0**
Structural Grade: **0**
O&M Grade: **1**
Clock Start/From: **7**
Clock To:
1st Value:
2nd Value:
Value Percent:
Step: **NO**
Remarks:

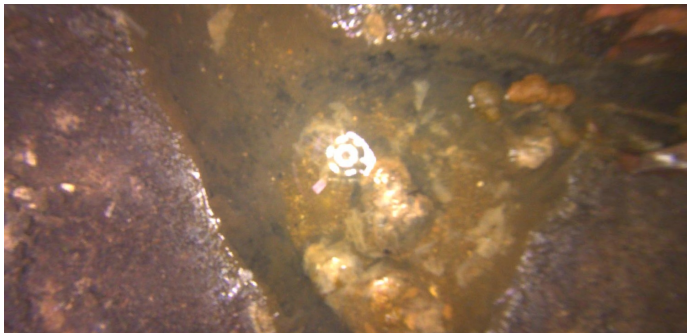
Code: **DSF**
Description: **Deposits Settled Fine**

Distance (ft): **4.3**
Structural Grade: **0**
O&M Grade: **2**
Clock Start/From: **12**
Clock To: **12**
1st Value:
2nd Value:
Value Percent: **5.000**
Step: **NO**
Remarks:

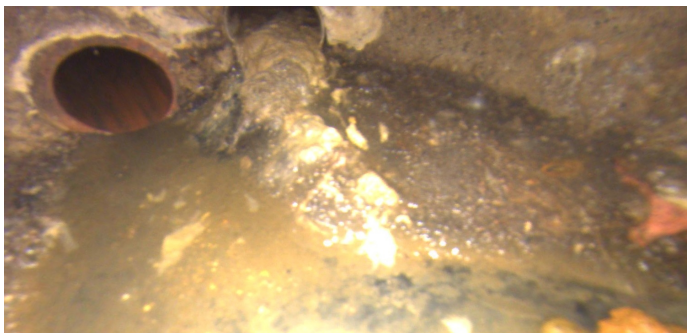
Code: **MGO**
Description: **General Observation**

Distance (ft): **4.7**
Structural Grade: **0**
O&M Grade: **0**
Clock Start/From:
Clock To:
1st Value:
2nd Value:
Value Percent:
Step: **NO**
Remarks: **END SURVEY**
