Manhole Inspection Report

Date:	05/15/2018	Weather:		Coding:	RZMACP
MH#:	M-804-049	Owner:	NA	Len. Surveyed:	6.9
P.O.#:		Surveyor:	Jen Costello	Rim to Invert:	7.4
Customer:		Cert. #:	U-907-5518	Wall Material:	Concrete (reinforced)

Street:	Ohio St. 602' South of High St.	Project:	Hobart, IN
City:	Hobart, IN	GPS Northing:	2908402.149
Location:		GPS Easting:	2908402.149
Drain Area:	Northeast	GPS Accuracy:	Sub-Meter
Cover Shape:	Circular	Evidence of Surcharge:	No
Cover Size:	22.5	Potential for Runoff:	None
Comments:

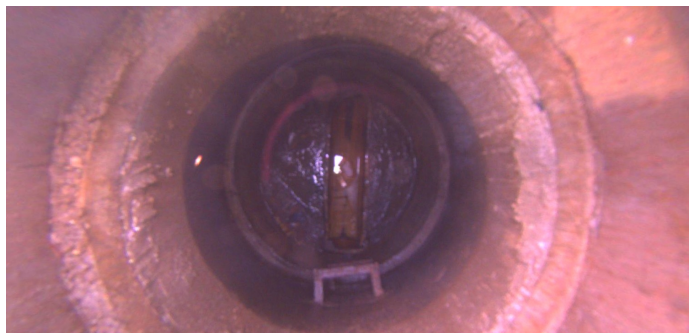
Code: **MGP**
Description: **General Photo**

Distance (ft): **.0**
Structural Grade: **0**
O&M Grade: **0**
Clock Start/From:
Clock To:
1st Value:
2nd Value:
Value Percent:
Step: **NO**
Remarks: **ACCESS MH**

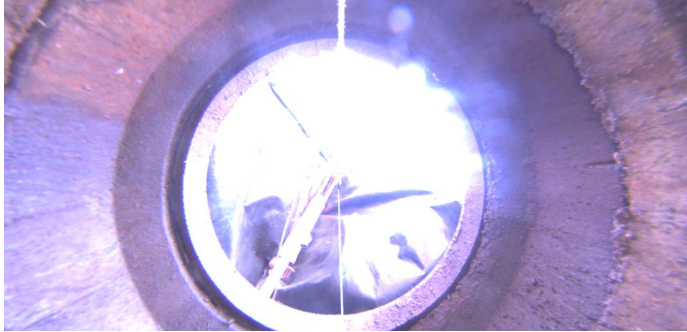
Code: **MGO**
Description: **General Observation**

Distance (ft): **1.7**
Structural Grade: **0**
O&M Grade: **0**
Clock Start/From:
Clock To:
1st Value:
2nd Value:
Value Percent:
Step: **NO**
Remarks: **UNDERSIDE OF FRAME**

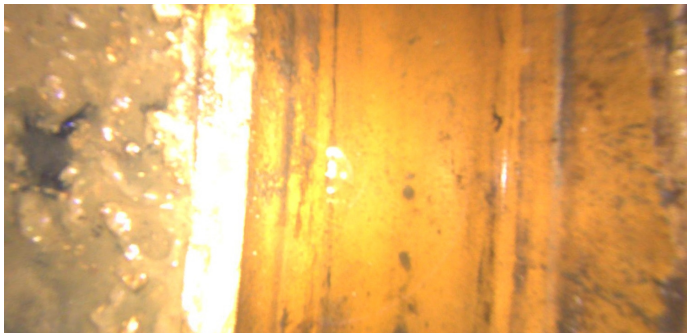
Code: **MGO**
Description: **General Observation**

Distance (ft): **6.9**
Structural Grade: **0**
O&M Grade: **0**
Clock Start/From:
Clock To:
1st Value:
2nd Value:
Value Percent:
Step: **NO**
Remarks: **END SURVEY**
