# Manhole Inspection Report

Date:	<b>05/16/2018</b>	Weather:		Coding:	<b>RZMACP</b>
MH#:	<b>M-804-054</b>	Owner:	<b>NA</b>	Len. Surveyed:	<b>8.1</b>
P.O.#:		Surveyor:	<b>Jen Costello</b>	Rim to Invert:	<b>8.7</b>
Customer:		Cert. #:	<b>U-907-5518</b>	Wall Material:	<b>Brick</b>

Street:	<b>Kelly St. 655' North of Hickey St.</b>	Project:	<b>Hobart, IN</b>
City:	<b>Hobart, IN</b>	GPS Northing:	<b>2907741.884</b>
Location:		GPS Easting:	<b>2907741.884</b>
Drain Area:	<b>Northeast</b>	GPS Accuracy:	<b>Sub-Meter</b>
Cover Shape:	<b>Circular</b>	Evidence of Surcharge:	<b>No</b>
Cover Size:	<b>22.5</b>	Potential for Runoff:	<b>None</b>
Comments:

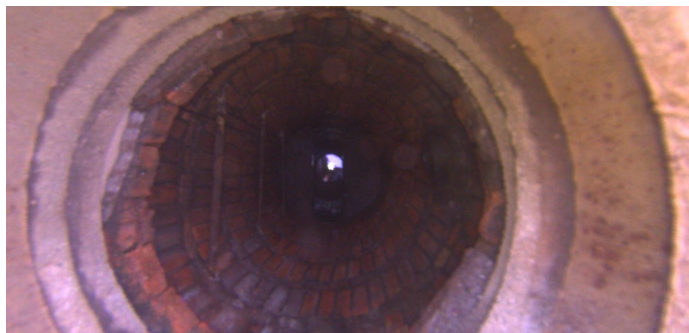
Code: **MGP**  
Description: **General Photo**

Distance (ft): **.0**  
Structural Grade: **0**  
O&M Grade: **0**  
Clock Start/From:  
Clock To:  
1st Value:  
2nd Value:  
Value Percent:  
Step: **NO**  
Remarks: **access mh**

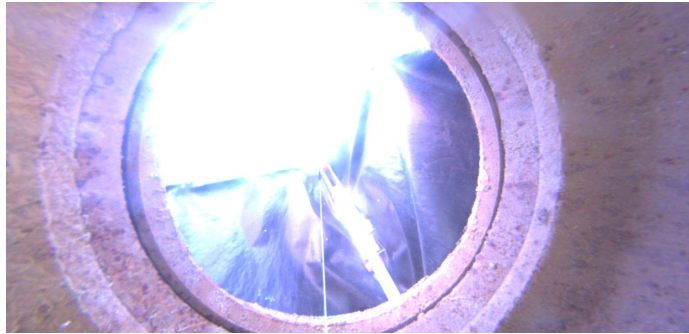
Code:	<b>MGO</b>
Description:	<b>General Observation</b>
Distance (ft):	<b>1.3</b>
Structural Grade:	<b>0</b>
O&M Grade:	<b>0</b>
Clock Start/From:	
Clock To:	
1st Value:	
2nd Value:	
Value Percent:	
Step:	<b>NO</b>
Remarks:	<b>underside of frame</b>

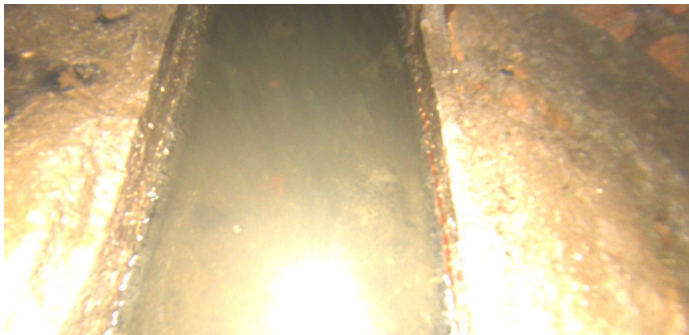
Code:	<b>MGO</b>
Description:	<b>General Observation</b>
Distance (ft):	<b>8.1</b>
Structural Grade:	<b>0</b>
O&M Grade:	<b>0</b>
Clock Start/From:	
Clock To:	
1st Value:	
2nd Value:	
Value Percent:	
Step:	<b>NO</b>
Remarks:	<b>end survey</b>
